TRANSPORTATION RESEARCH CENTER

ON-SITE AIR BAG INVESTIGATION

CASE NUMBER - IN97-022
LOCATION - MISSISSIPPI
VEHICLE - 1993 FORD TAURUS GL
CRASH DATE - June, 1997

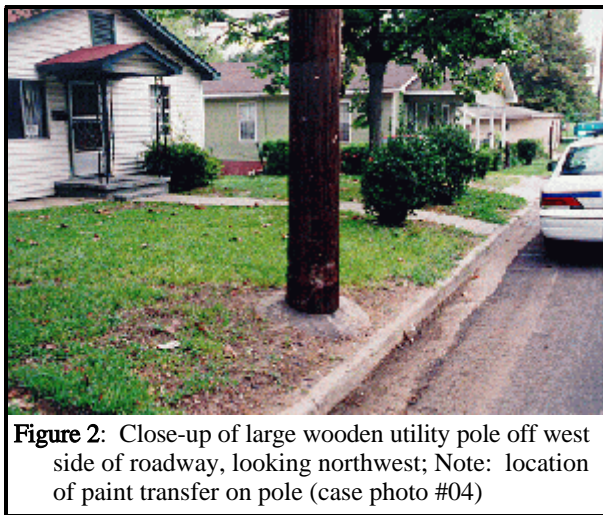
Figure 2: Close-up of large wooden utility pole off west side of roadway, looking northwest; Note: location of paint transfer on pole (case photo #04)

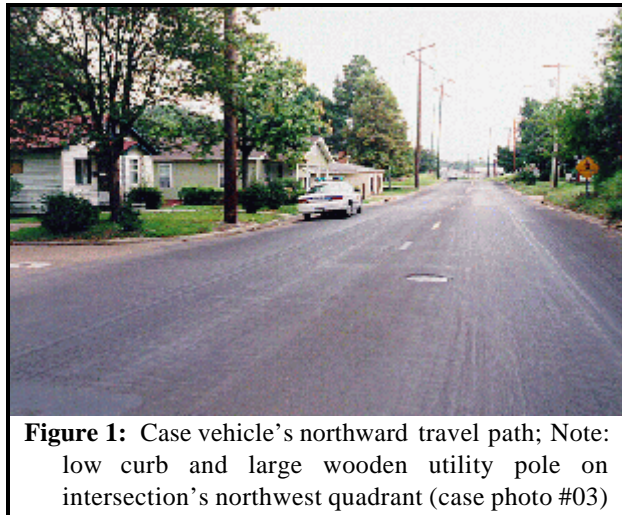
The case vehicle was northbound on a two-lane, undivided, city street and intended to continue its northerly travel path (see **Figure 1** below). It crossed over the single, broken yellow centerline, continued across the southbound lane, struck the west curb [concrete, 10 centimeters (4 inches) high], impacted a wooden utility pole (see **Figure 2** below), and came to rest facing north-northwest. The pavement was new asphalt--0.85 estimated coefficient of friction, perpendicular to the pole impact. The ambient weather conditions at the time of the crash were daylight, cloudy (no precipitation), and a dry pavement. The roadway was undivided, straight, and level (i.e., actual slope was 0.5% negative to the north). There were no view obstructions, traffic controls, or roadway defects. Although two of the witnesses indicated that the case vehicle was moving slowly (i.e., slowly enough to pass), they would not estimate its travel speed. The posted speed limit was 48 km.p.h. (30 m.p.h.).

Figure 1: Case vehicle's northward travel path; Note: low curb and large wooden utility pole on intersection's northwest quadrant (case photo #03)

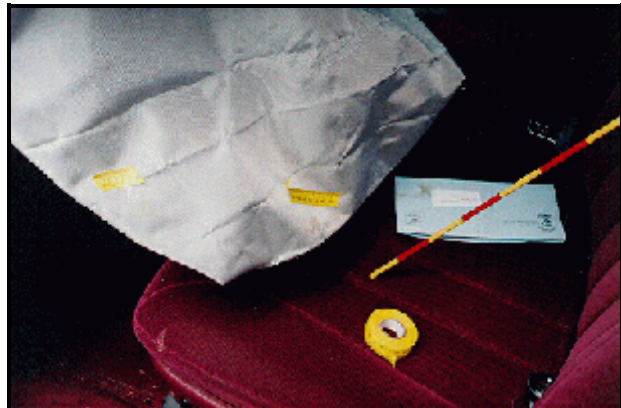
Possible driver contacts were detected on both cover flaps: a "dot" scratch was noted near the center of the upper flap (see **Figure 5** above) and a half-circle of body oil/fluid was detected at the center of the horizontal tear seam of the lower flap (see **Figure 6**). Buttons on the driver's blouse are suspected of causing the top mark and body contact causing the lower mark. As the driver air bag deployed, the close proximity of the driver's body to the steering wheel likely directed the air

Figure 6: Case vehicle's driver-side air bag (steering wheel is rotated 90 degrees clockwise); Note: yellow tape locates areas of body oil/fluid on the lower right quadrant of the air bag's front surface (case photo #22)

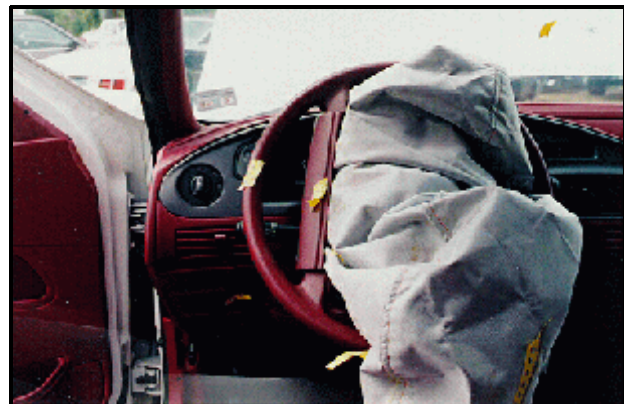
Figure 7: Lower cover flap of case vehicle's driver side air bag module (steering wheel rotated 90 degrees clockwise); Note: yellow tape indicates suspected occupant contact points (case photo #23)

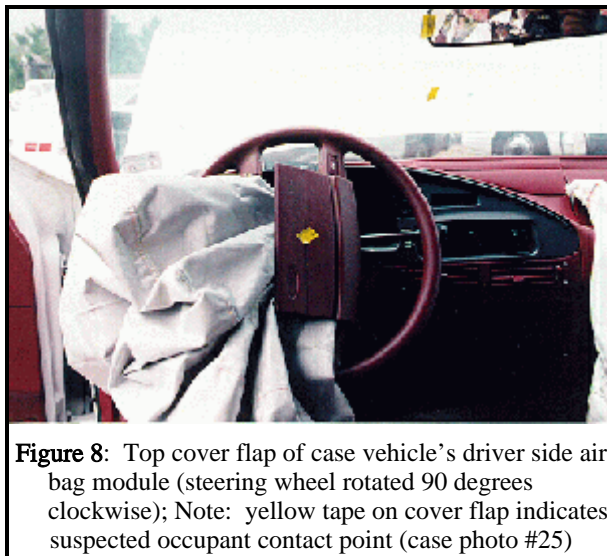
Figure 8: Top cover flap of case vehicle's driver side air bag module (steering wheel rotated 90 degrees clockwise); Note: yellow tape on cover flap indicates suspected occupant contact point (case photo #25)

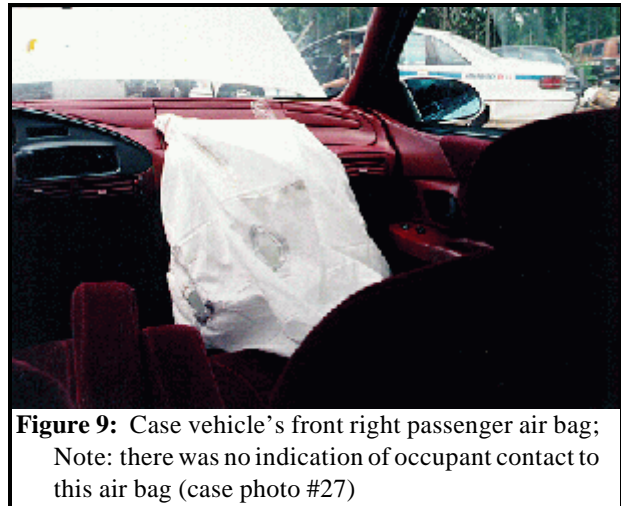
The front right passenger air bag also deployed when the case vehicle impacted the wooden utility pole. The front right passenger air bag module's assembly was mounted at the top of the instrument panel's right side. The tear seams of the front right module were in a symmetrical "H" configuration, with both the upper and lower cover flaps measuring 31 centimeters (12.2 inches) horizontally and 3 centimeters (1.2 inches) vertically. The front right air bag opened along the designated tear seams. The front right air bag fabric was rectangular in shape, measuring 30 centimeters (11.8 inches) high and 89 centimeters (35.0 inches) wide. No tether straps were detected, but two vent ports, 2.5 centimeters (1.0 inch) in diameter, were located at the 6 and 8 clock positions. The leading edge of the lower cover flap was 6 centimeters (2.4 inches) forward of the front of the instrument panel. There was no evidence of occupant contact to the front right passenger air bag. This module's top cover flap did not contact the windshield.

Figure 9: Case vehicle's front right passenger air bag; Note: there was no indication of occupant contact to this air bag (case photo #27)

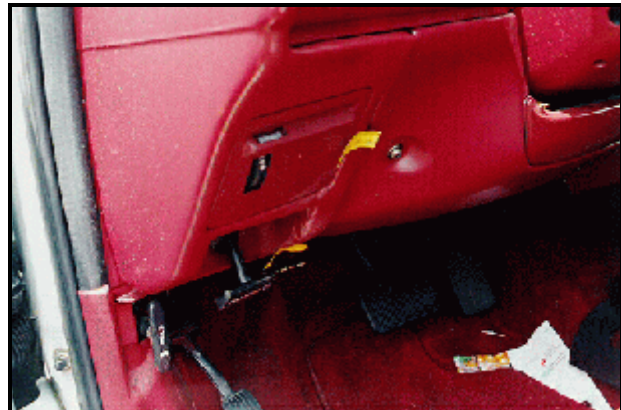
Figure #10: Case vehicle's left lower instrument panel; Note: indications of occupant contact and the down-ward displacement of the parking brake release handle (case photo #18)

The case vehicle's primary impact with the wooden utility pole not only deployed the driver and front right air bags, but thrust the driver upward and against the steering wheel containing the driver air bag module as she moved forward towards the zero degree direction of principle force (PDOF). As the driver's air bag deployed, the unbelted driver's abdominal and thoracic areas were struck by the deploying driver air bag module's cover flaps. The cover flaps caused injury to her lungs, sternum, ribs, liver, and spleen. Based on the available evidence, the left knee or leg of the driver stuck the left lower side of the instrument panel, bending the brake release handle downward (see **Figure 10**); however, no lower extremity injuries were cited.

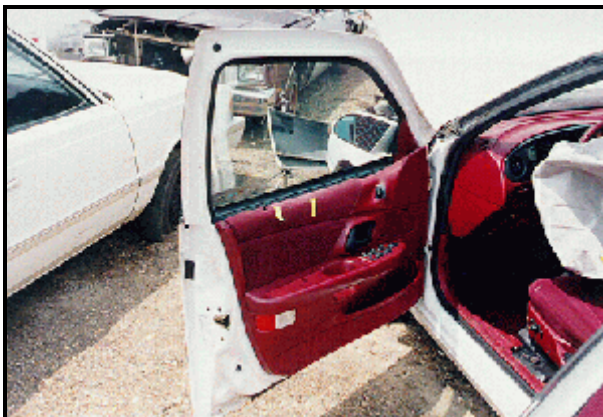
Figure 11: Interior view of case vehicle's left front door; Note: yellow tape defines area of skin transfer and body oil deposits; also note the absence of heavy im-pact to the door panel and door latch (case photo #14)

The unfolding air bag propelled the case vehicle's driver backwards into her seat back. The case vehicle's driver contacted the interior surface of the driver's door (see **Figure 11** above and **Figure 12**) causing some skin transfer near the window sill area. This contact coincides with the investigating police officer verbally reporting that the driver was laying partially out of an open left front door at final rest.

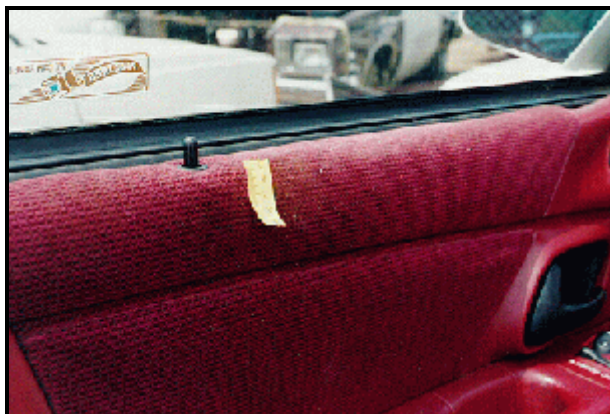
Figure 12: Close-up of case vehicle's left front door panel; Note: yellow tape indicates beginning (on towards the front) of skin transfer and body oil deposits on the window sill; note also the absence of heavy contact to the door panel(case photo #15)

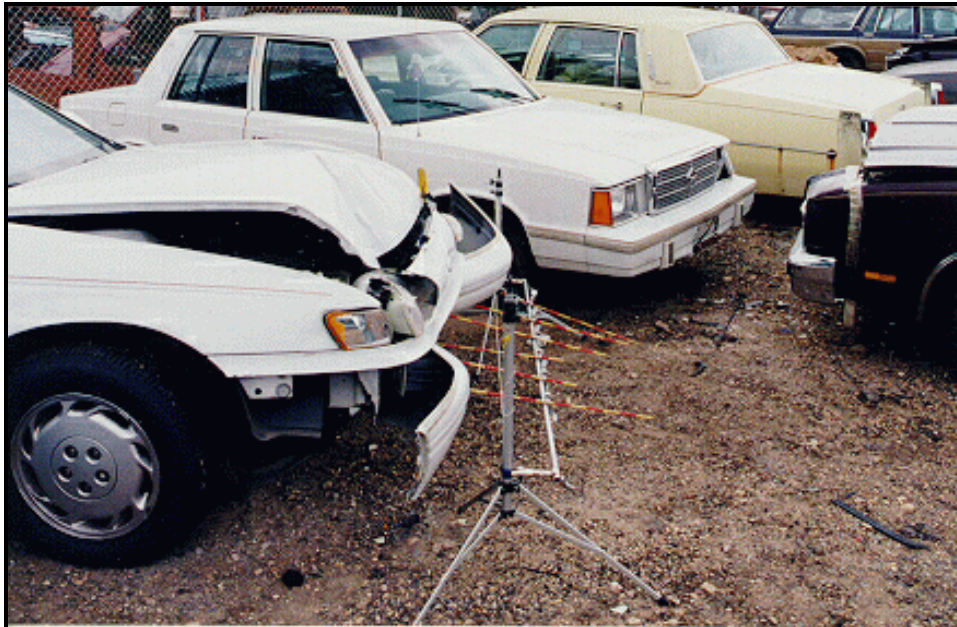
Figure 14: Reference line view of case vehicle's frontal damage from right (case photo #13)
