## ON-SITE AIR BAG INVESTIGATION

CASE NUMBER - IN97-032  
LOCATION - OKLAHOMA  
VEHICLE - 1995 MITSUBISHI GALANT S  
CRASH DATE - August, 1997

1. <i>Report No.</i> IN97-032		2. <i>Government Accession No.</i>		3. <i>Recipient's Catalog No.</i>	
4. <i>Title and Subtitle</i> On-Site Air Bag Fatality Investigation Vehicle - 1995 Mitsubishi Galant S Location - Oklahoma				5. <i>Report Date:</i> January 2, 2001; March 18, 2002

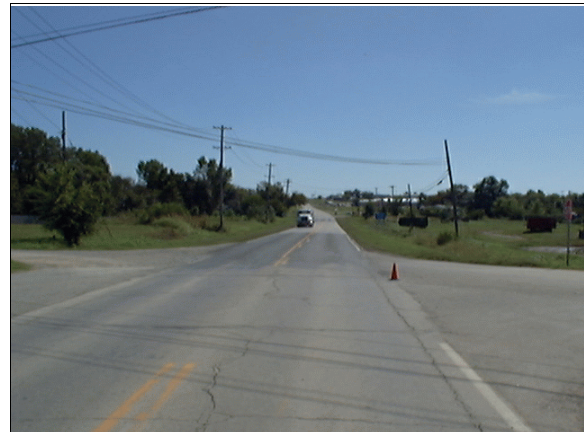
**Figure 1:** Case vehicle's southward travel path toward five-lane intersection showing approximate point of impact (i.e., red cone) with Dodge truck (case photo #02)

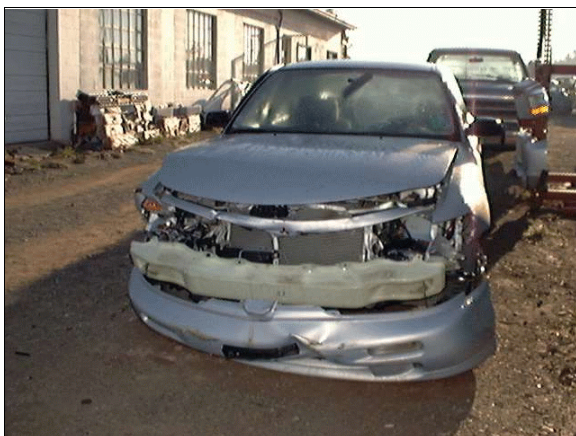
**Figure 2:** Case vehicle's frontal underride damage from impact with back of Dodge truck (case photo #05)

The front (**Figure 2** and **3**) of the case vehicle impacted the back (**Figure 4** below) of the Dodge truck, causing the case vehicle's driver and front right passenger supplemental restraints (air bags) to deploy. The case vehicle veered

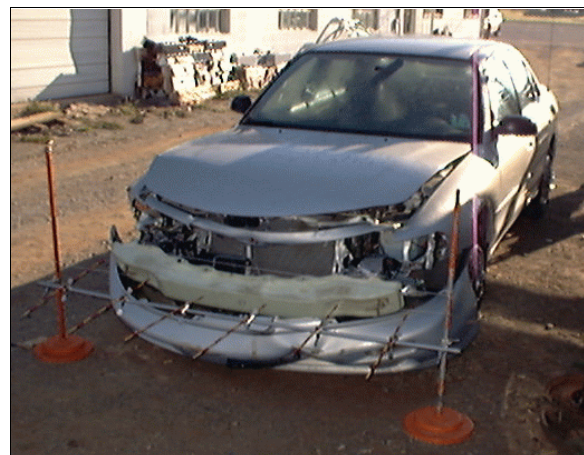
**Figure 3:** Case vehicle's front underride deformation viewed from left of front with contour gauge present (case photo #09)

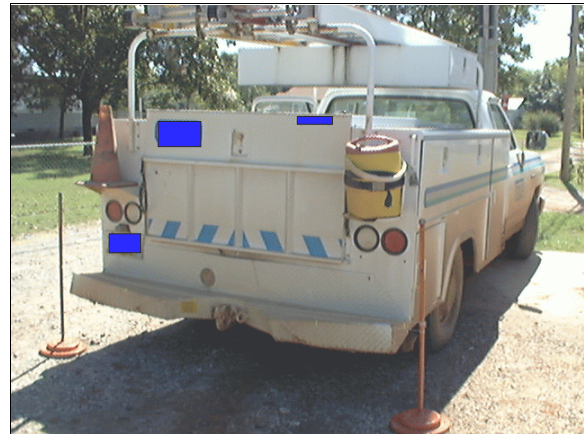
**Figure 4:** Damaged back of Dodge truck viewed from right of back; Note: direct damage begins at back right bumper corner and extends to left (case photo #63)

The Dodge truck's contact with the case vehicle involved its back right two-thirds. Direct damage began at the back right bumper corner and extended inward, a measured distance of 155 centimeters (61.0 inches), along the back bumper. The maximum crush was measured 2 centimeters (0.8 inches) at C<sub>3</sub>--near the tow ball (**Figure 4** above). The rear bumper was slightly rotated upwards (**Figure 16**). There was no other visible damage to this vehicle sustained during this crash.

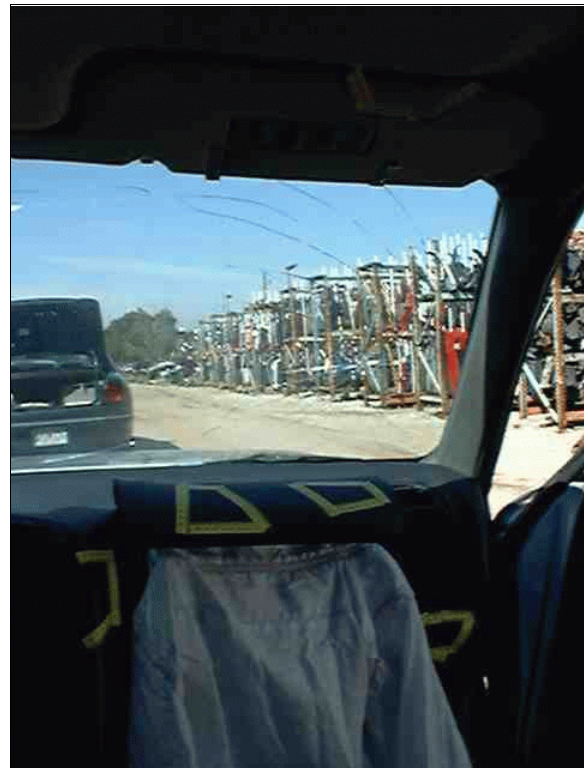
**Figure 5:** Case vehicle's front right seating area showing deployed front right passenger air bag, cracked windshield glazing, and possible contact evidence on cover flap, center instrument panel, lower right instrument panel, and sun visor (case photo #22)

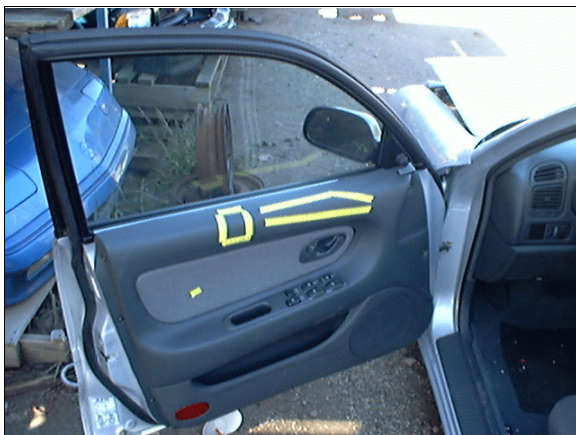
**Figure 6:** Interior surface of case vehicle's driver door showing blood and skin transfers along window sill (case photo #23)

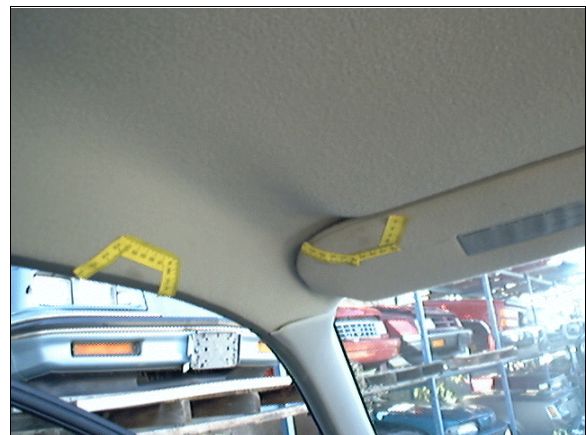
**Figure 7:** Contact evidence to case vehicle's left roof side rail and driver's sun visor (case photo #26)

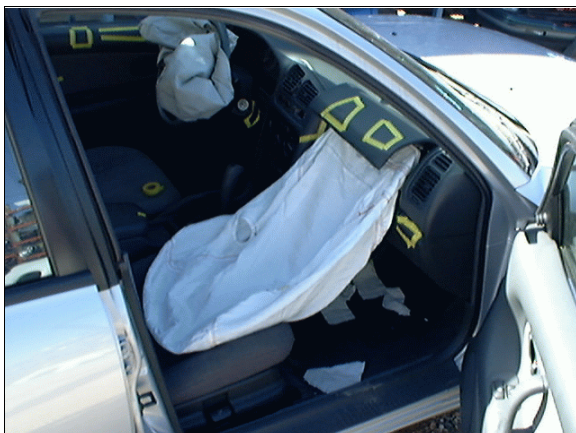
**Figure 8:** Case vehicle's front seating area showing deployed driver and front right passenger air bags and front right air bag module's cover flap with discounted evidence of contact (case photo #20)

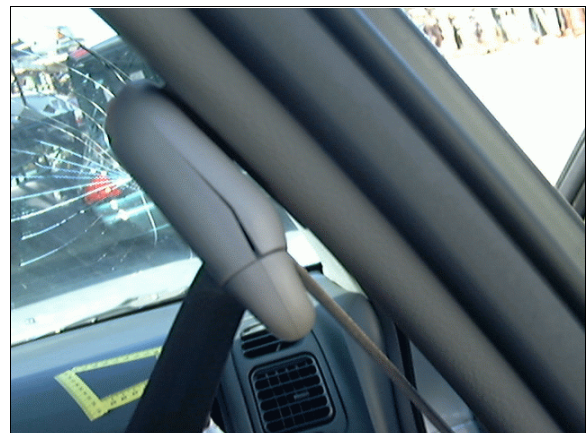
Inspection of the case vehicle's interior revealed that during the front right air bag module's deployment, the air bag's fabric had contacted the rearview mirror, tilting it towards the driver's side of the windshield. Furthermore, the deploying air bag contacted the right side of the center instrument panel, depositing a brush abrasion (**Figure 5** above). Possible contacts (i.e., scuff, oil transfer) were identified to the right knee bolster from the front right passenger's knee (**Figure 5** above) and just to the right of the steering column (i.e., a scuff) most likely from the driver's right knee. There was a skin transfer and blood evidence along the interior surface of the driver's door (**Figure 6**), a black transfer to the left roof side rail, a possible oil smear to the driver's sun visor (**Figure 7**), and a probable contact to the right sun visor (**Figure 5** above). Initially there was thought to be evidence of contact on the front right air bag module's cover flap (i.e., two oil smears), but these areas were later discounted as a direct contact from the front right passenger because there were no corresponding injuries (**Figure 8**). Finally, inspection of the "D"-ring encasement for the front right passenger's seat belt system revealed an anomaly (i.e., slight separation), indicating either a possible manufacturer's defect or a contact by the head of the front right passenger during this passenger's reward, rebounding movement (**Figure 9**).

**Figure 9:** Case vehicle's front right safety belt showing separation to "D"-ring's encasement; Note: cracked windshield glazing in background (case photo #31)

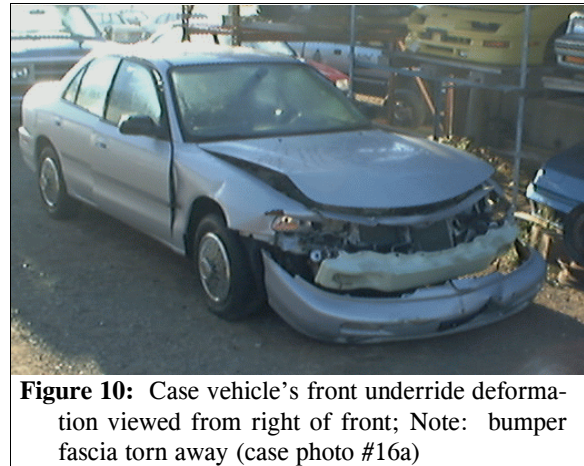
The case vehicle's contact with the Dodge truck involved its front with direct damage extending across the entire front, both above and at the bumper levels (**Figure 10**). This impact resulted in an uneven damage pattern, indicating it underrode the rear bumper of the Dodge truck. The field L and direct damage went from bumper corner to bumper corner, a measured distance of 153 centimeters (60.2 inches). Maximum crush was measured as 23 centimeters (9.1 inches) at C<sub>5</sub>-C<sub>6</sub>. The residual crush across the entire front bumper was measured at approximately 7 centimeters (2.8 inches). The residual crush across the entire grille ranged from 19 centimeters (7.5 inches) at C<sub>1</sub> to 23 centimeters (9.1 inches) at C<sub>6</sub>. The wheelbase on the case vehicle's was not shortened on either the left or the right side. The front bumper, bumper fascia, grille, hood, radiator, and right and left headlight and turn signal assemblies were directly damaged and crushed rearward. Neither of the front tires were physically restricted from the frontal damage. The case vehicle's right windshield sustained induced damage (i.e., a spider web crack) as well as both the right and left fenders from the frontal impact.

**Figure 10:** Case vehicle's front underride deformation viewed from right of front; Note: bumper fascia torn away (case photo #16a)

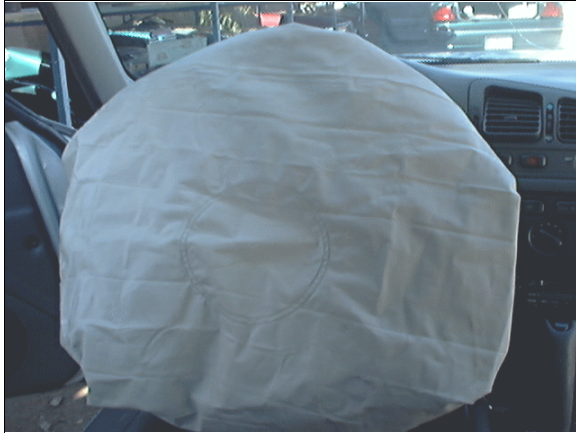
air bag; however, there were numerous black scuff marks from the cover flaps consistent with evidence of occupant loading (**Figure 11**).

**Figure 11:** Case vehicle's deployed driver air bag showing no visible evidence of contact on air bag's fabric (case photo #38)

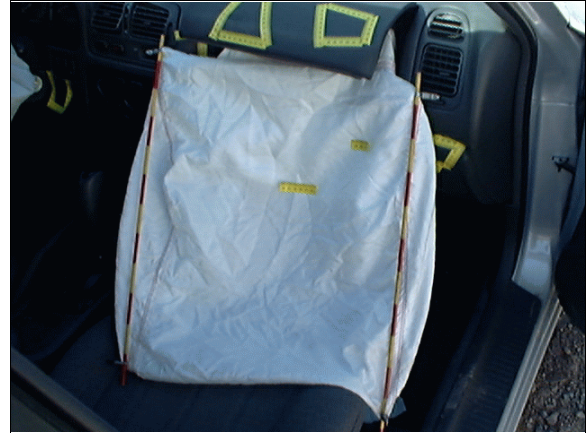
**Figure 12:** Case vehicle's front right passenger air bag showing areas (i.e., yellow tape) of oil and skin transfers to fabric's upper right quadrant from front right passenger; Note: highlighted possible contact evidence on cover flap was discounted (case photo #44)

There was a single, essentially rectangular, modular cover flap. The cover flap was made of a thick vinyl over a thick cardboard type frame which acted as the hinge point for the deploying flap. The flap's dimensions were 35 centimeters (13.8 inches) at the lower horizontal seam and 22 centimeters (8.7 inches) along both vertical seams. The profile of the case vehicle's instrument panel was flush with the leading edge of the cover flap. An inspection of the front right air bag module's cover flap and air bag revealed that the cover flap opened at the designated tear points, and there was no evidence of damage during the deployment to the air bag or the cover flap (**Figure 12**). Although there was a crack to the right windshield's glazing (**Figure 9** above), this contractor determined that the front right air bag module's cover flap could not reach the windshield during the module's deployment. The front right air bag module's cover flap had two areas of what looked like oily smears but were later discounted because of the lack of corresponding injuries. The front right passenger's air bag was designed without any tethers. The front right air bag had two vent ports, approximately 6 centimeters (2.4 inches) in diameter, located at the 10 and 2 o'clock positions. The deployed front right air bag was rectangular with a height of approximately 50 centimeters (19.7 inches) and a width of approximately 48 centimeters (18.9 inches). Examination of the front right passenger air bag revealed two small (i.e., oil smears and skin flakes) transfers to the right side of the front portion of the air bag (**Figure 12**). One of the areas of oil/skin evidence on the front of the air bag was approximately 3 x 2 centimeters (1.2 x 0.8 inches). This evidence started 17 centimeters (6.7 inches) down from the top horizontal edge of the air bag and 10 centimeters (3.9 inches) in from the right edge of the air bag. The second area was approximately 2 x 4 centimeters (0.8 x 1.6 inches). This evidence started 25 centimeters (9.8 inches) down from the top horizontal edge of the air bag and 22 centimeters (8.7 inches) in from the right edge of the air bag. There was also several black scuffs to the top portion of the air bag, towards the left side, from contact with the cover flap and/or lower right corner of the rear view mirror.

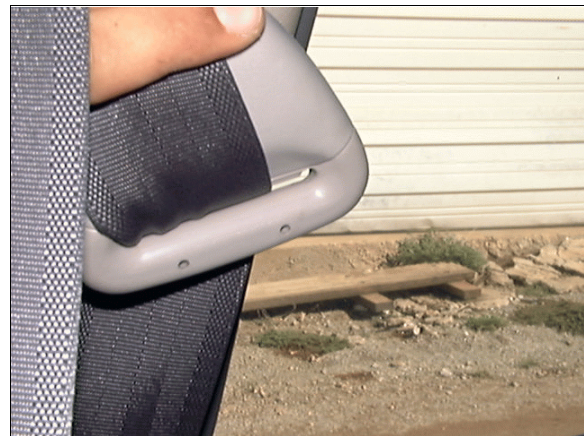
The case vehicle's front right passenger [94 centimeters and 14 kilograms (37 inches, 31 pounds)] was not using either a child safety seat or her available, active, three-point, lap-and-shoulder, safety belt system. The upper anchorage for the front right passenger's torso belt was adjusted between its middle and full up positions. Further, there were abrasions to the undersurface of the front right passenger's chin and anterior neck. Initially these abrasions were interpreted as belt pattern abrasions and suggested evidence of safety belt usage (i.e., torso portion); however, based on this contractor's experience in Special Crash Investigations, these abrasions were from interaction with the fabric of the deploying front right passenger's air bag. In addition, the inspection of the front right passenger's seat belt webbing, "D"-ring, and latch plate showed no definite evidence of loading (**Figure 13**).

**Figure 13:** Close-up of "D"-ring for case vehicle's front right safety belt showing no evidence of loading (case photo #29A)

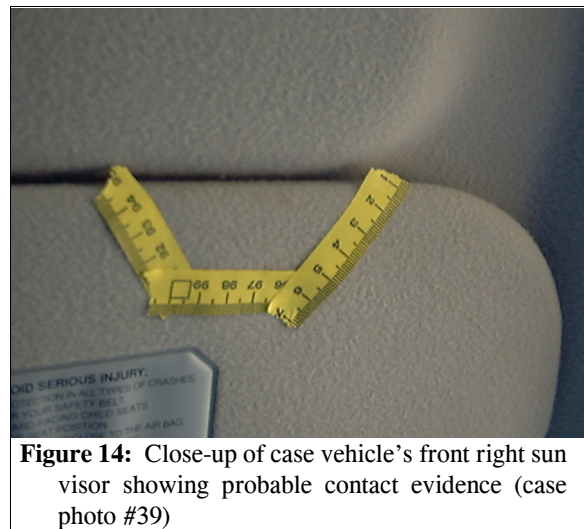
**Figure 14:** Close-up of case vehicle's front right sun visor showing probable contact evidence (case photo #39)

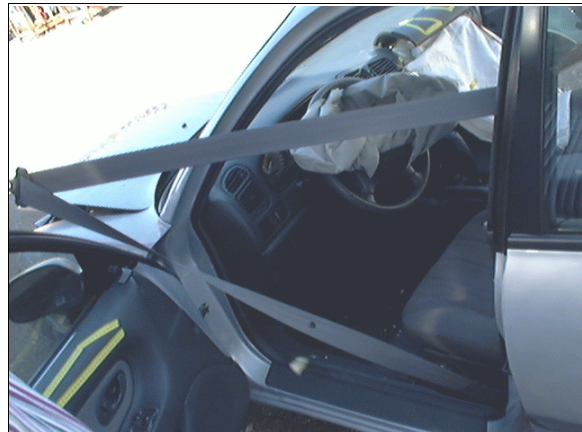
latch plate showed no definite evidence of loading (**Figure 15**) . The driver's adjustable "D"-ring was located between its middle and full-up position. Due to low severity of the crash and the driver's close proximity to the steering wheel, this contractor would not expect to find conclusive evidence of loading to the restraint system.

**Figure 15:** Case vehicle's driver safety belt showing no visible evidence of loading on belt's webbing (case photo #52)

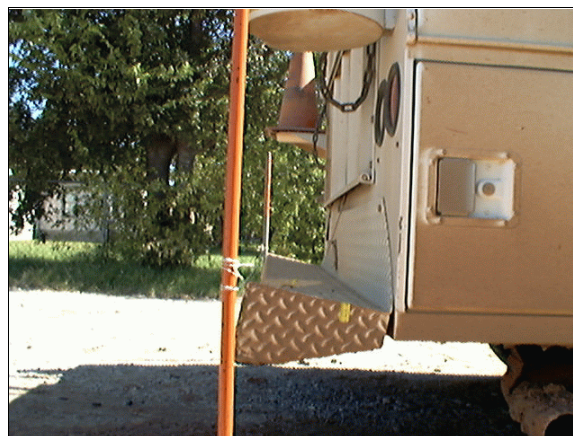
**Figure 16:** Reference line view from right of Dodge truck showing back bumper's upward rotation (case photo #61)
