**CALSPAN ON-SITE AIR BAG/CHILD FATALITY INVESTIGATION**

**CALSPAN CASE NO. CA97-033**

**VEHICLE - 1994 FORD CROWN VICTORIA**

**CRASH DATE - SEPTEMBER, 1997**

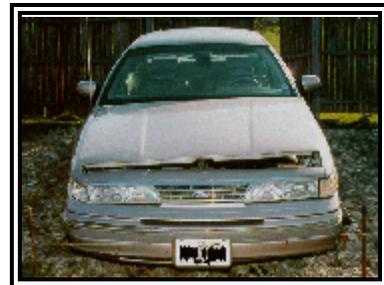
The Collision Deformation Classification (CDC) of the Ford was 01-FZEW -1. The direct contact damage began 12.0 cm (4.7 in) left of center and extended 97.0 cm (38.2 in) to the front bumper's right corner. There was 2.5 cm (1.0 in) of resultant deformation at the bumper elevation across the full frontal width of the vehicle. There was additional deformation to the right front corner area of the Ford surrounding the headlamp structure that extended onto the right front corner of the hood. The Ford's entire front structure was displaced laterally (slightly) to the left causing the left front door to be jammed. A traditional engineering analysis using the principles of energy and momentum conservation was used to calculate the delta V's of the respective vehicles. Both vehicular damage and trajectory data were incorporated into this analysis. These calculations determined the (total) delta V of the Ford was 19 to 24 km/h (12 to 15 mph). The principle direction of force was in the 1 o'clock sector. The longitudinal component of the delta V was -16 to -21 km/h (-10 to -13 mph), indicating the collision severity was in the threshold for air bag deployment. An official of the Ford Motor Company indicated that it is possible that an asymmetrical deployment may occur in a crash where the severity of the collision lies in the air bag deployment threshold. The lateral delta V component was -10 to -11 km/h (-6 to -7 mph).

**Figure 2.** Front view of the Ford Crown Victoria.

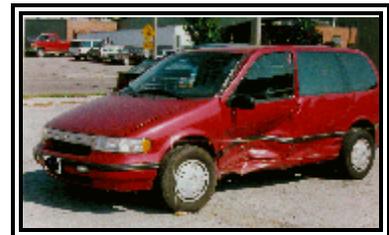
The CDC of the Mercury was 10-LPEW-3. The direct damage began 49.0 cm (19.3 in) rearward of the left front axle and extended 217.0 cm (85.4 in) rearward along the left side of the Mercury. The maximum lateral deformation was 23.5 cm (9.3 in) measured at the mid-door elevation. The left front door was jammed due to the deformation. The sidewall of the left front tire was scuffed. This scuffing was matched to the tire scuffs on the front license plate of the

**Figure 3.** Left front view of the Mercury Villager.

Ford. The sidewall of the left rear tire was also scuffed and related to the minor sideslap contact with the Ford's right front fender. The delta V of the Mercury calculated by the aforementioned analysis was 19 to 23 km/h (12 to 14 mph).

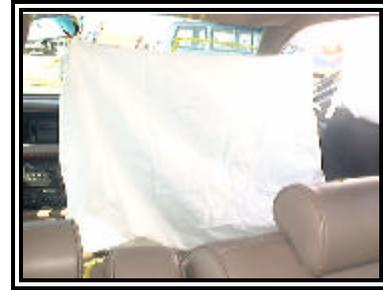
The front outboard restraint systems in the 1994 Ford Crown Victoria consisted of 3-point manual lap and shoulder belt systems with continuous loop webbings, adjustable D-rings, and locking retractors. There was a lap belt in the center front position. The vehicle was equipped with a Supplemental Restraint System (SRS) consisting of driver and front passenger air bags. The driver air bag was housed in the typical configuration in the steering wheel hub. As noted earlier there was no sign of partial/attempted deployment of the driver air bag. The front passenger air bag was a mid-mount design with a top hinged vinyl rectangular shaped cover flap. The cover flap measured 37.5 cm (14.8 in) laterally by 11.0 cm (4.3 in) vertically. The air bag was not tethered and had a single 5.5 cm (2.2 in) diameter vent port at the 2 o'clock position on the inboard side of the bag. The face of the front passenger air bag was rectangular and measured 90.0 cm (35.4 in) laterally by 53.0 cm (20.9 in) vertically. The maximum rearward extension of the air bag was 74 cm (29 in).

Figure 4: View of the front passenger air bag.

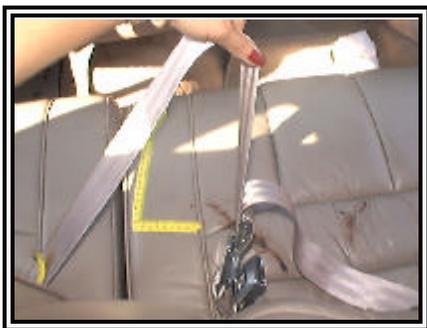
The latch plate of the center lap belt did show some routine usage marks as did the lower end of the restraint webbing (near the anchor), where the webbing comes up through the seat cushion. However, the latch plate was positioned approximately 61 cm (24 in) up the webbing and the webbing exhibited no signs of latch plate movement to that location. Use of the seat belt with the latch plate adjusted in this position, as depicted in Figure 5, would not provide any means of restraint to the child occupant. On the

Figure 5: View of the front center lap belt.

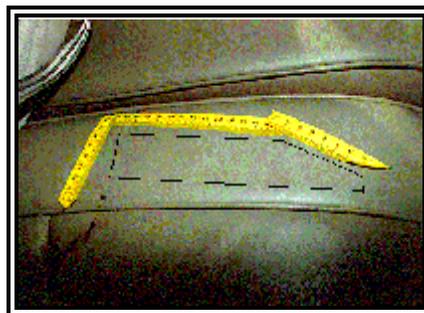
Figure 6: Fabric transfer on the front seat cushion.

surface of the leather seat cushion was a bluish fabric transfer from the child's clothing, denoted by the yellow tape in Figure 6. This transfer was 5.0 cm (2.0 in) wide by 20.0 cm (7.9 in) long, began 18.0 cm

(7.1 in) forward of the seat back and was directed forward and to the right. The presence of this transfer indicates the child's buttocks was sliding forward with respect to the vehicle, in response to the 1 o'clock principle direction of force. The medical records indicated there were no contusions or abrasions on the child's abdomen/pelvis/lower extremities indicative of lap belt usage. The physical evidence determined through the vehicle's inspection and child's kinematic pattern, discussed below, do not support the child as restrained.

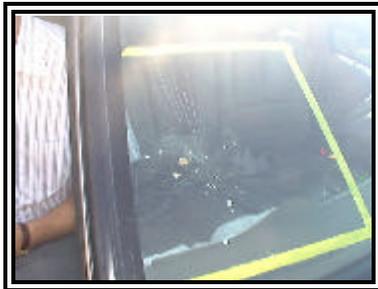
The right side of the vehicle's front interior exhibited signs of interaction with the front passenger air bag. This interaction occurred due to an altered deployment path of the passenger air bag caused by the child's forward position and forward kinematics. There was a windshield fracture with an area of heavy air bag fabric transfers located 9.0 cm (3.5 in) left of the right A-pillar and 16.0 cm (6.3 in) above the instrument panel. A scuff on the top surface of the air bag 24.0 cm (9.4 in) rear of the instrument panel and 20.0 cm (7.9 in) right of the left edge of the air bag corresponded to the windshield fracture. Located 18.0 cm (7.1 in) rearward of the forward edge of the right front door on the lower surface of the arm rest was an air bag transfer 18.0 cm (7.1 in) long. A tan vinyl transfer on the face of the air bag 20.0 - 40.0 cm (7.9 - 15.7 in) down from the top and 23.0 - 31.0 cm (9.1 - 12.2 in) left of the right edge of the air bag corresponded to the door transfers.

Figure 7: Windshield fracture caused by front passenger air bag contact.

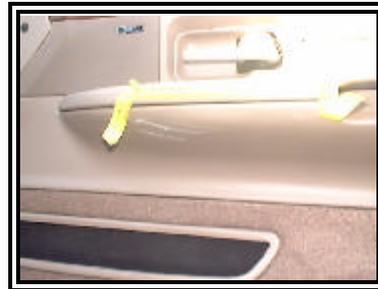
Figure 8: Air bag transfers to the lower surface of the right front door.

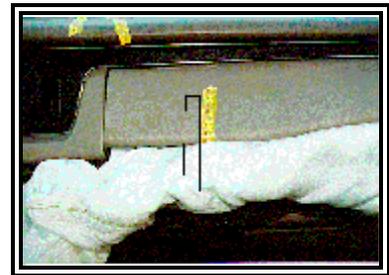
On the top of the passenger side module flap cover was a vertical 5.0 cm ( 2.0 in) pink fabric transfer, 9.5 cm (3.7 in) right of the inboard edge of the flap. Adjacent to this on the bottom surface of the bag was a 9.0 cm (3.5 in) pink fabric transfer which began 13.0 cm (5.1 in) outboard of the instrument panel. These transfers were caused by interaction with the right sleeve of the child's out-stretched arm, early in the deployment sequence. At this time, the child was positioned forward and right of center. Her right arm (arm bracing for impact) was over the top of the module cover flap. The forward body position and trajectory interfered with the deployment path of the air bag deflecting it to the right side of the vehicle.

Figure 9: Fabric transfers on the cover flap and passenger air bag.

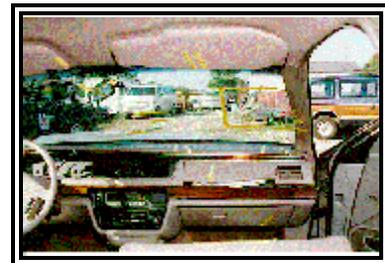
Interior damage of the Ford Crown Victoria was limited to deployment of the Supplemental Restraint System and occupant contact points located primarily on the passenger side of the vehicle. There was no intrusion into the interior space of the vehicle caused by the exterior forces of the crash. Figures 10 and 11 below depict the interior contact evidence.

The right center portion the windshield exhibited 3 separate air bag scuffs. The first scuff was 4.0 cm (1.6 in) in length, located 8.0 cm (3.1 in) above the instrument panel and 72.0 cm (28.3 in) left of the right of the A-pillar. The second scuff was 5.0 cm (2.0 in) long and was located 13.0 cm (5.1 in) above the instrument panel and 86.5 cm (34.1 in) left of the A-pillar. The third scuff was 6.0 cm (2.4 in) long located 14.0 cm (5.5

Figure 10: Interior view of the Ford Crown Victoria.

in) above the instrument panel and 80.0 cm (31.5 in) left of the A-pillar. The right edge of the windshield was scuffed and fractured by the altered deployment path of the passenger air bag. The fracture was located 9.0 cm (3.5 in) left of the right A-pillar and 16.0 cm (6.3 in) above the instrument panel. A 7.0 cm (2.8 in) square area of heavy air bag fabric transfers was located adjacent to the fracture site. The right A-pillar exhibited 2 small air bag scuffs. The first was 4.0 cm (1.6 in) in length located 22.0 cm (8.7 in) from the base of the pillar. The second scuff was a 1.0 cm (0.4 in) square area located 25.0 cm (9.8 in) from the base of the pillar.

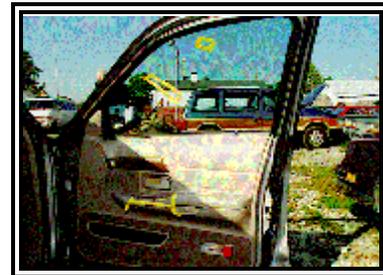
The altered deployment of the front passenger air bag also scuffed the right front door glazing and the lower aspect of the door. A 12.0 cm (4.7 in) scuff was located 46.0 cm (18.1 in) forward of the trailing edge of the glazing and 19 cm (7.5 in) above the glazing's lower edge. A scuffed 2.0 cm x 1.0 cm (0.8 in x 0.4 in) area was located 28.0 cm (11.0 in) forward of the glazing's trailing edge and 36.0 cm (14.2 in) above the lower edge. A 3.0 cm (1.2 in) air bag transfer was located on the upper aspect of the door (near the lock), 7.0 cm (2.8 in) forward of the door's trailing edge. Located 18.0 cm (7.1 in) rearward of the forward edge of the right front door on the lower surface of the arm rest was an air bag transfer 18.0 cm (7.1 in) long. (Refer to Figure 11 at the right.) An air bag fabric transfer 4.0 cm (1.6 in) in length was located on the leading edge of the B-pillar 29.5 cm (11.6 in) above the floor, 66.0 cm (26.0 in) rearward of the instrument panel.

Figure 11: Right front door contacts.

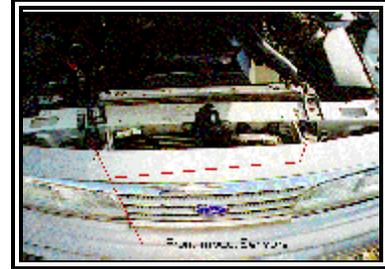
The two front impact sensors were mounted to the upper radiator support immediately behind the front grille and headlamps. The sensors were located in the impact zone for this crash and were undamaged. The left and right sensors were identified by the serial numbers of 5A12941866 and 5A13644869, respectively. During inspection of the Ford, the electrical system was energized in order to read the air bag indicator light in the vehicle's instrument cluster. Upon ignition, the indicator light was off for two seconds, illuminated (steady) for six seconds, turned off for two seconds, and then began a cycle of three flashes and then off for two seconds which then continued to repeat. According to the owner's manual the steady six second indication was normal, as the air bag system conducted its internal diagnostics. However, the repeated flashing sequence was an indicator of a problem with the air bag system and service was required.

Figure 12: Air bag sensor locations.

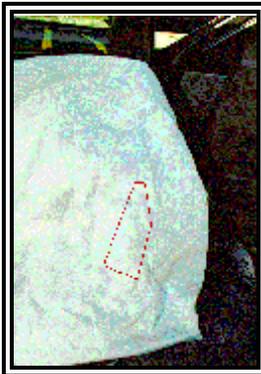
Two tan colored vinyl transfers 20.0 cm (7.9 in) length were located on the face of the air bag. These arc shaped transfers were located approximately 20.0 cm (7.9 in) from the top surface of the air bag and 23.0 cm (9.1 in) and 31.0 cm (12.2 in) left of the outboard (right) edge of the bag. The transfers are depicted in Figure 13. These transfers were matched directly to the scuffs on the lower aspect of the right front door, Figure 14. On the inboard side panel of the air bag, 18.0 cm (7.1 in) forward of the instrument panel and 10.0 cm (3.9 in) from the top surface of the bag, was a blue fabric transfer. Refer to Figure 15. The transfer was 18.0 cm (7.1 in) in length. This transfer was evidence of possible contact with the blue leggings of the child. On the bottom surface of the bag was the aforementioned 9.0 cm (3.5 in) pink fabric transfer which began 13.0 cm (5.1 in) rearward of the instrument panel, Figure 9. This transfer was attributed to the red/pink/white shirt the child was wearing. The location of this transfer of the bottom surface of the air bag indicated that the child occupant was positioned forward in the very early stages of the deployment sequence.

Figure 13: Vinyl transfers to the face of the air bag.

The child's forward kinematic trajectory during the deployment sequence caused the child to load the air bag and alter its deployment path to the right. The altered air bag expansion contacted and fractured the right side of the windshield (Figure 7), and contacted and scuffed the right front window glazing and the lower aspect of the right front door (Figures 11, 13 and 14).

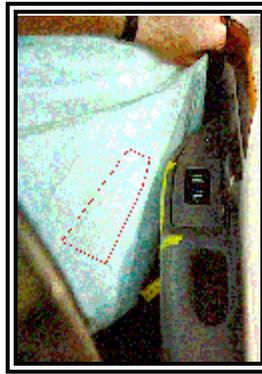
Figure 14: Match-up of the transfer to the right front door.

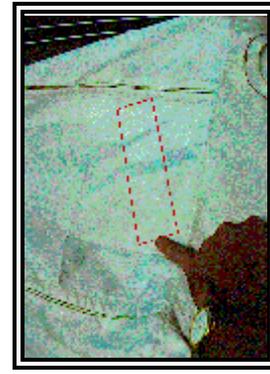
Figure 15: Blue transfer to the air bag inboard side panel.

The child rebounded back into the right front seat where she was found. As the child began to move rearward, it is probable that her leggings contacted the inboard side panel of the deployed air bag causing the aforementioned transfer (Figure 15). Additionally, the child's lower extremities contacted the glove box door resulting in the small contusions to the region. Her rebound trajectory likely caused her left hand/forearm to contact the back (non-mirrored) side of the center mirror. This contact displaced the left side of the mirror into the windshield, causing it to fracture. Her right hand and forearm rotated up and abraded the right sunvisor causing the minor lacerations and contusions to the right hand and fingers. The child came to rest with her buttocks in the right front position and with her head toward the seat's center position. Her head was turned to its right, with the mouth near the small pooling of blood found on the seat cushion.
