## ON-SITE AIR BAG FATALITY INVESTIGATION

CASE NUMBER - IN97-063  
LOCATION - MISSISSIPPI  
VEHICLE - 1994 DODGE CARAVAN  
CRASH DATE - December, 1997

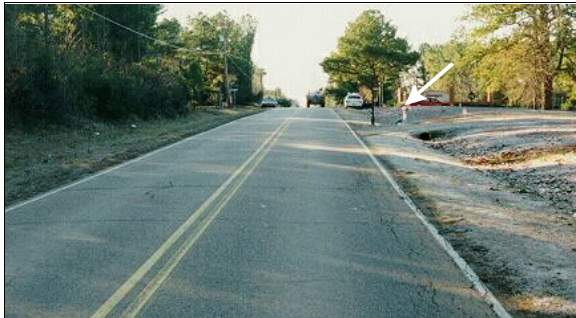
**Figure 1:** Case vehicle's southbound travel path up hill; Note: arrow marks approximate point of impact in southbound lane (case photo #01)

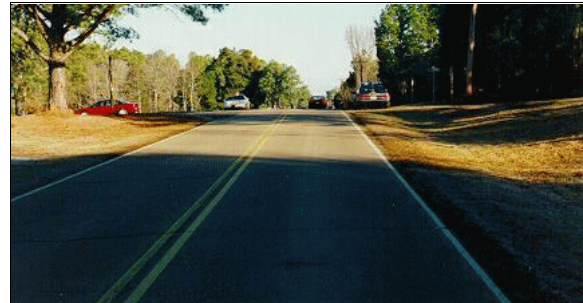
**Figure 2:** Dakota pickup's northward travel path in northbound lane up hill; Note: police vehicles mark location of hill crest (case photo #08)

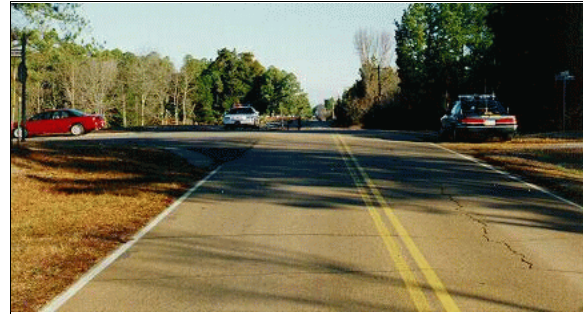
**Figure 3:** Dakota pickup's northward travel path just south of hill crest to in southbound lane after passing noncontact vehicle; Note: police vehicles mark location of hill crest (case photo #09)

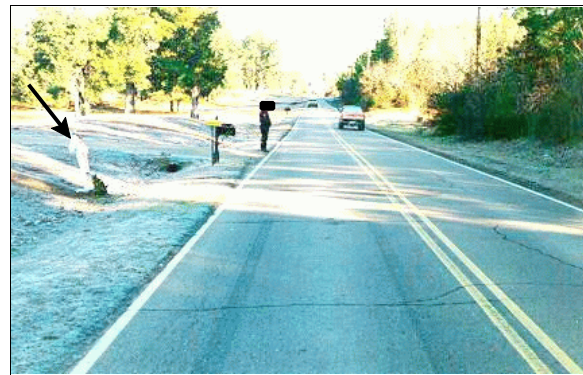
The city roadway was straight and level (i.e., actual slope was 1.7%, positive to the south) at the location of the impact. The roadway was also level (i.e., actual slope was 1.8%, positive to the south) in the case vehicle's southward direction of travel; however, the Dakota pickup had a 3.4% grade positive to the north (i.e., an upgrade in the Dakota's direction of travel) prior to traversing the hill crest, but only a 1.7% grade (i.e., level), negative to the north, after cresting the hill near the area of impact. The pavement was bituminous, but traveled, and the width of the travel lanes for both vehicles was 3.0 meters (9.8 feet). The shoulders were not improved (i.e., grass). Pavement markings consisted of a double solid yellow centerline for both north and southbound traffic. In addition, solid white edge lines were present along the outside of both north and southbound lanes. The estimated coefficient of friction was 0.75, not including the slope. There were no visible traffic controls. The statutory speed limit was 72 km.p.h. (45 m.p.h.). No regulatory speed limit sign was posted near the crash site. At the time of the crash the light condition was dark, but illuminated by overhead street lamps near the area of impact, the atmospheric condition was clear, and the road pavement was dry. Traffic density was light, and the site of the crash was primarily urban residential. In addition, approximately 50 meters (164 feet) south of the crash site, there was a three-leg intersection at the top of the hill crest on the west side of the roadway for an entrance to a subdivision (**Figure 3**), and there was an intersecting residential driveway within a short distance just north of the crash site (**Figure 4**).

**Figure 4:** Dakota pickup's northbound travel path in southbound lane after cresting hill showing skid marks leading to point of impact (i.e., roadside arrow) in southbound lane (case photo #11)

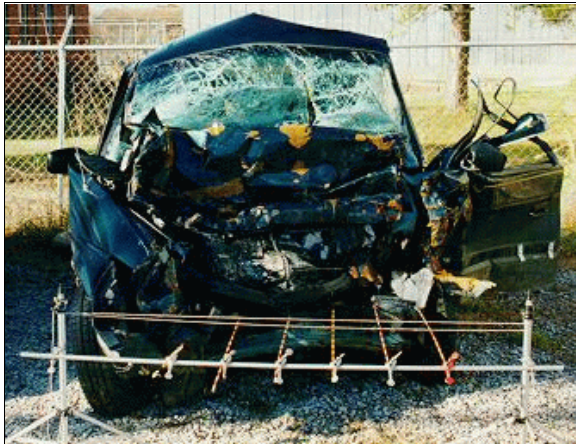
The front of the case vehicle (**Figures 5** and **7** below) was impacted by the front of the Dakota pickup (**Figures 6** and **8** below), causing the case vehicle's driver and front right passenger supplemental restraints (air bags) to deploy. The crash was slightly offset toward the driver's side of each vehicle. The impact was so severe that the case vehicle was driven backwards, off the west side of the roadway, approximately 8.2 meters (27 feet) and rotated approximately 60 degrees counterclockwise. The case vehicle came to rest on the west roadside, heading southeast. Upon maximum engagement, the Dakota pickup rotated approximately 60 degrees counterclockwise off

**Figure 5:** Case vehicle's frontal damage with contour gauge present (case photo #14)

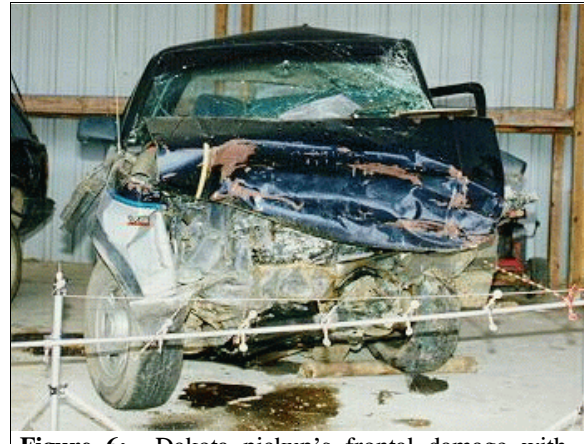
**Figure 6:** Dakota pickup's frontal damage with contour gauge present (case photo #58)

The Dakota pickup's frontal impact with the case vehicle caused the entire front end to be crushed primarily straight back (**Figures 6** and **8** above). Direct damage started at the front left bumper corner and extended to the right 125 centimeters ( 49.2 inches) along the front bumper. Maximum crush was measured at 119 centimeters (46.9 inches) at C<sub>1</sub>. The total field L was measured at 126 centimeters (49.6 inches). The

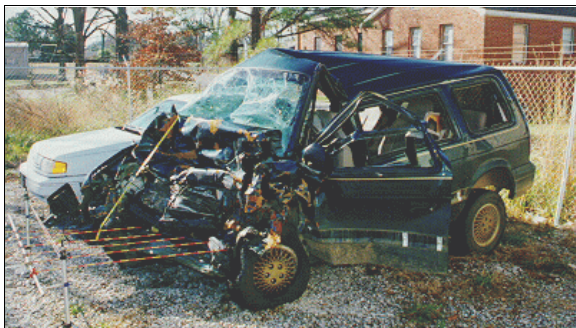
**Figure 7:** Case vehicle's frontal damaged, viewed from left of front, with contour gauge present (case photo #18)

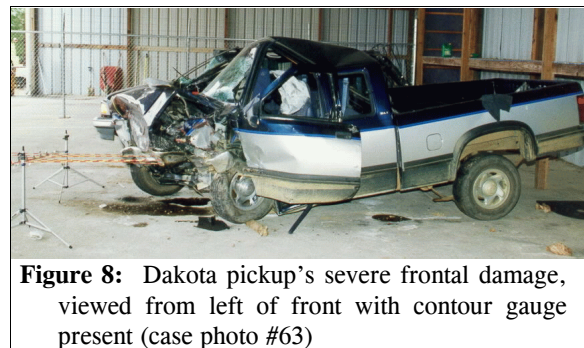
**Figure 8:** Dakota pickup's severe frontal damage, viewed from left of front with contour gauge present (case photo #63)

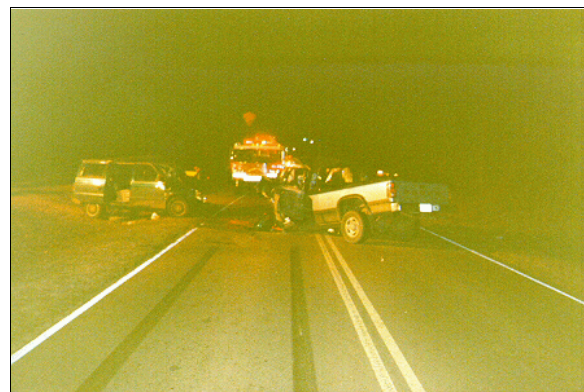
of the case vehicle and came to rest, partially blocking the north and southbound lanes, heading northwest primarily in the northbound lane (**Figure 9**).

**Figure 9:** On-scene northward view of the case vehicle and Dakota pickup at final rest positions; Note: Dakota's pre-crash skid marks and post-impact counterclockwise rotation of both vehicles (case photo #13)

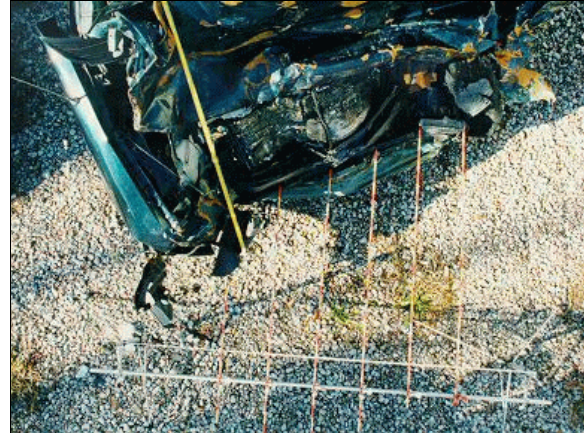
The case vehicle’s contact with the Dakota pickup involved a wide engagement of the entire front surface. Direct damage began 25 centimeters (9.8 inches) inward from the front right bumper corner and extended across the front bumper, a measured distance of 129 centimeters (50.8 inches), to the front left bumper corner. The direct contact damage consisted of both bumper level and override- type damage above the bumper. All six C-measurements were average according to NASS CDS protocol. For example, at C<sub>2</sub> the crush extended backwards 84 centimeters (33.1 inches) at bumper level and 101 centimeters (39.8 inches) above bumper. Maximum crush was measured as 103 centimeters (40.6 inches) above the bumper between C<sub>2</sub> and C<sub>3</sub> (**Figure 10**). The wheelbase on the case vehicle’s left side was shortened 54 centimeters (21.3 inches) while the right side was shortened 10 centimeters (3.9 inches). The case vehicle’s front bumper, bumper fascia, grille, hood, radiator, left fender, and right and left head light and turn signal assemblies were directly damaged and crushed rearward. The case vehicle’s left and right front tires were physically restricted, and the left front of the tire was deflated from the crash. Both the right and left

**Figure 10:** Overhead view of case vehicle’s frontal damage with contour gauge present; Note: offset nature of crush profile (case photo #16)

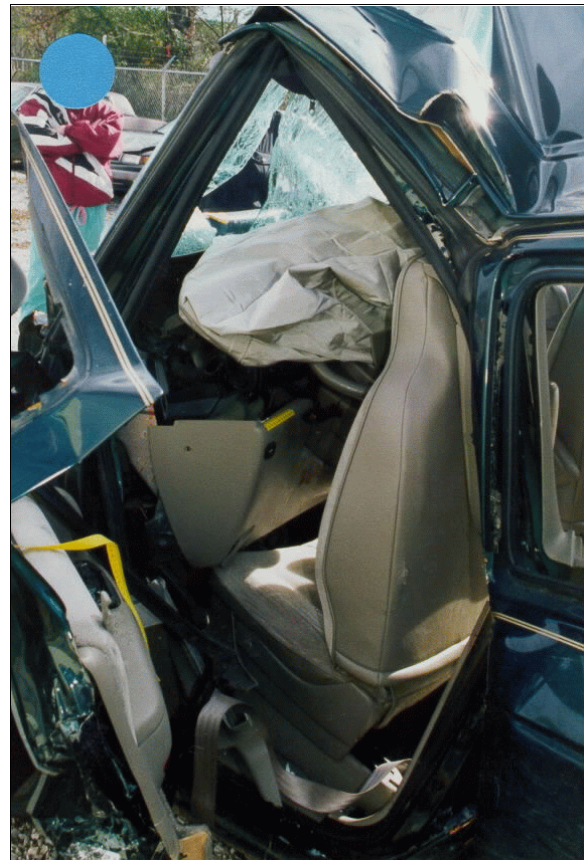
**Figure 11:** Case vehicle’s driver seating area showing massive intrusion; Note: buckled roof and vertical intrusion around left “B”-pillar (case photo #26)

fenders sustained induced damage. Remote buckling and vertical intrusion was also found on the left portion of the roof over the driver's seating area (**Figure 11** above).

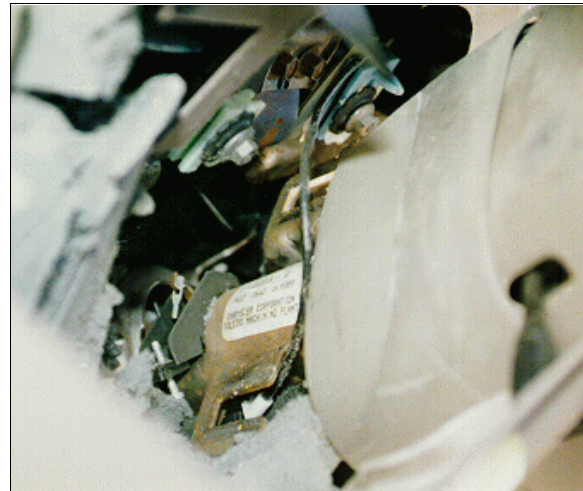
**Figure 12:** Close-up of case vehicle's steering column showing shear capsule separation (case photo #29)

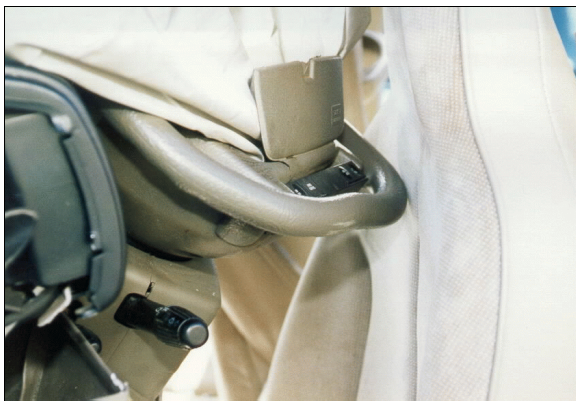
**Figure 13:** Case vehicle's driver seating area viewed from left showing deployed air bag, air bag module's bottom cover flap, and deformed steering wheel rim against seat back (case photo #42)

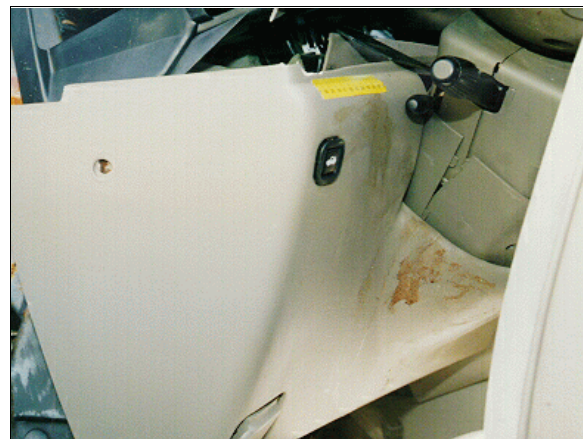
**Figure 14:** Close-up of case vehicle's driver knee bolster showing contact evidence from driver's knee (case photo #27)

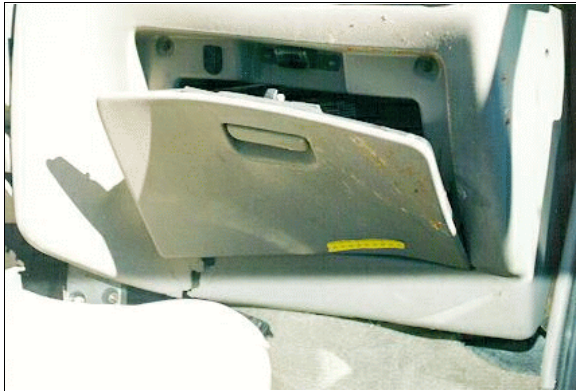
**Figure 15:** Case vehicle's impacted glove box door and front right knee bolster (case photo #38)

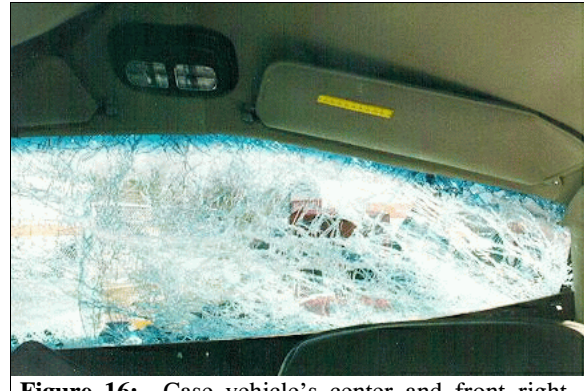
deployment. Also, there was a possible scuff to the right sun visor (**Figure 16**). Finally, the lower portions of both front seat backs shows evidence of occupant contact by the lower extremities of the back left and back right passengers, respectively.

**Figure 16:** Case vehicle's center and front right greenhouse area showing cracked and holed windshield's glazing, displaced rearview mirror, and scuffed front right sun visor (case photo #36)

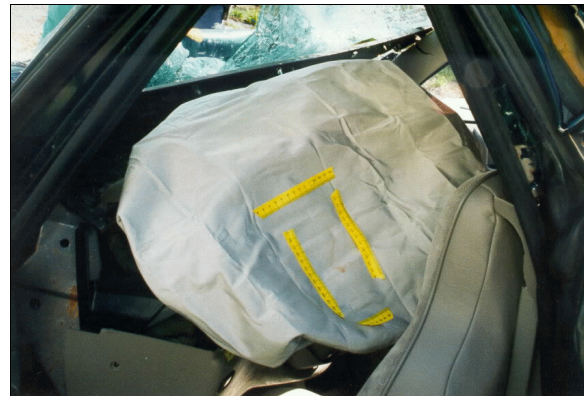
**Figure 17:** Case vehicle's deployed driver air bag showing (i.e., yellow tape) driver's contact area (case photo #40)

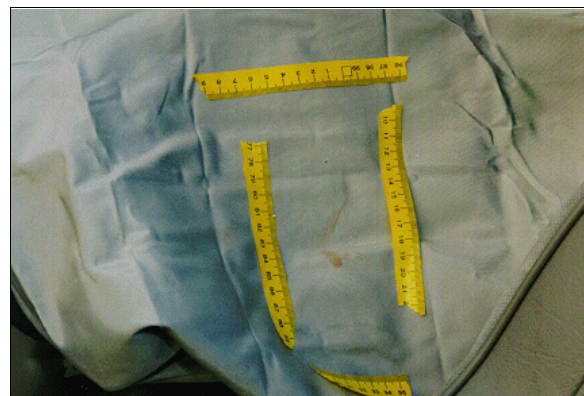
**Figure 18:** Close-up of case vehicle's deployed driver air bag showing skin transfer and blood smear (case photo #41)

apparent on the front surface of the driver's air bag, located just below the center of the air bag toward the 6 o'clock position [i.e., specifically 18 cm (7.1 in) inward from the 9 o'clock position and 6 cm (2.4 in) upward from the 6 o'clock position].

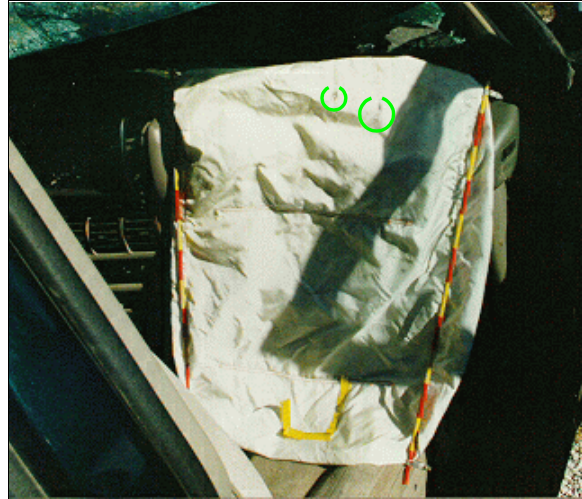
**Figure 19:** Case vehicle's front right passenger air bag showing skin transfer near bottom and windshield punctures (circled) near top (case photo #44)

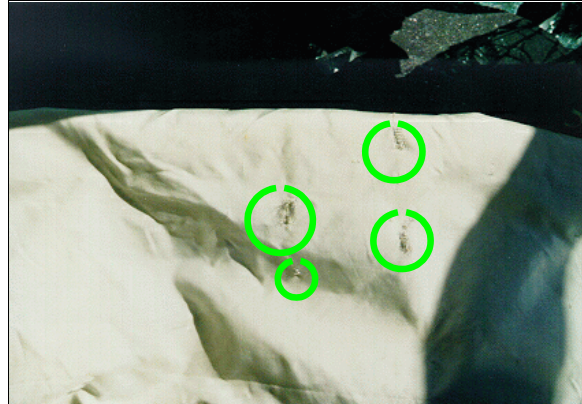
**Figure 20:** Close-up of case vehicle's deployed front right passenger air bag showing (highlighted) punctures near top of front surface from interaction with intruding windshield's glazing (case photo #45)

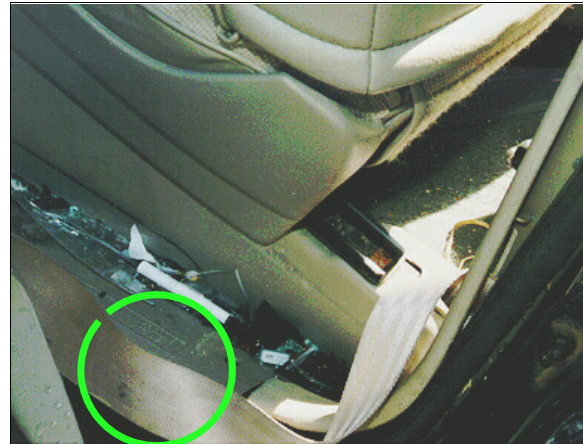
The case vehicle's driver was restrained by her available, active, three-point, lap-and-shoulder, safety belt system. There was no clear evidence of belt pattern bruising and abrasions to the driver's body, but the inspection of the driver's seat belt webbing and "D"-ring showed evidence of loading (i.e., blood on webbing, friction scrubs on the "D"-ring). In addition, it had been cut during the extrication process (**Figure 21**).

**Figure 21:** Case vehicle's driver safety belt showing (highlighted) friction scrub (case photo #31)

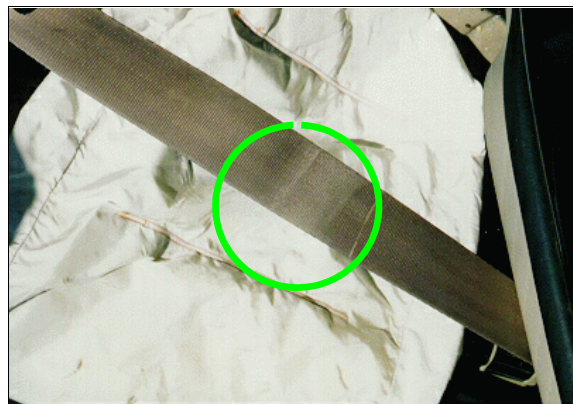
The case vehicle's front right passenger (i.e., driver's mother) was restrained by her available, active, three-point, lap-and-shoulder, safety belt system. Furthermore, there was evidence of belt pattern bruising and abrasions to the passenger's abdomen and chest, and the inspection of the front right passenger's seat belt webbing and "D"-ring showed evidence of loading (i.e., a friction scrub on the "D"-ring and webbing—**Figure 22**).

**Figure 22:** Close-up of case vehicle's front right safety belt showing friction scrub on webbing (case photo #47)

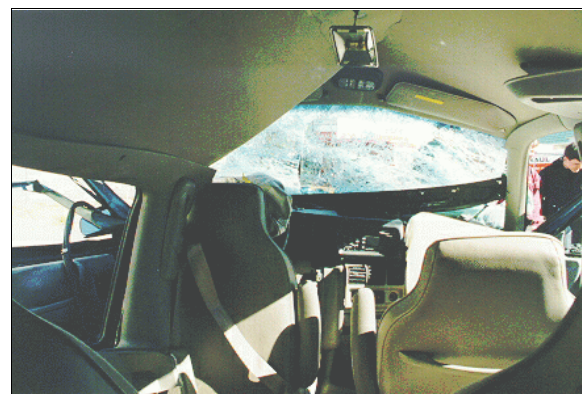
The case vehicle's second seat left passenger was restrained by his available, active, three-point, lap-and-shoulder, safety belt system. Furthermore, there was evidence of belt pattern bruising to the passenger's abdomen and left side of his neck, and an inspection of the passenger's three-point, safety belt system showed evidence of loading (i.e., a friction scrub on the "D"-ring and webbing). There was a significant amount of intrusion to this passenger's seating area (**Figure 23** and **Figure 24** below).

**Figure 23:** Case vehicle's interior viewed from back showing intrusion into seating area occupied by second seat left passenger (case photo #51)

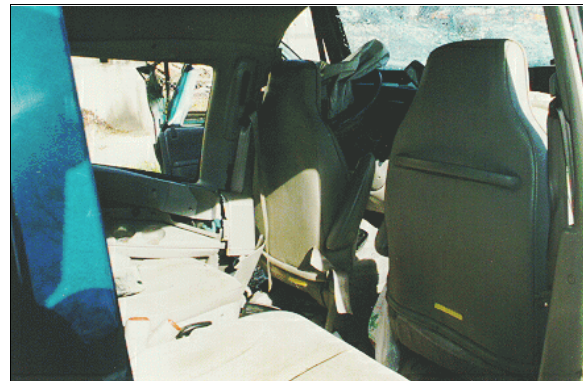
**Figure 24:** Case vehicle's second row seating area; Note: intrusion to left side and contacts to lower portion of front seat backs (case photo #50)

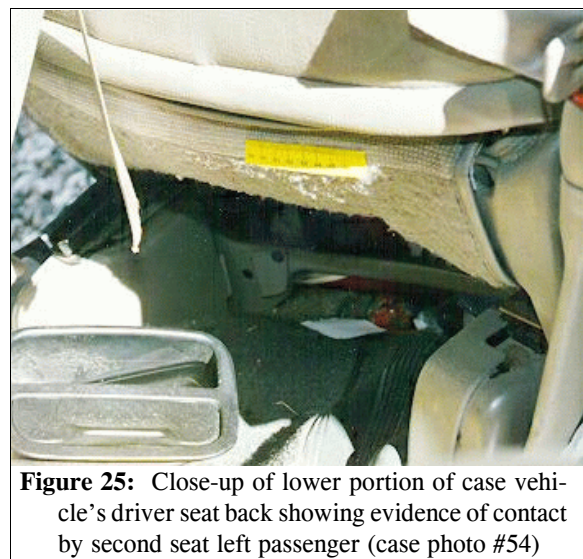
**Figure 25:** Close-up of lower portion of case vehicle's driver seat back showing evidence of contact by second seat left passenger (case photo #54)

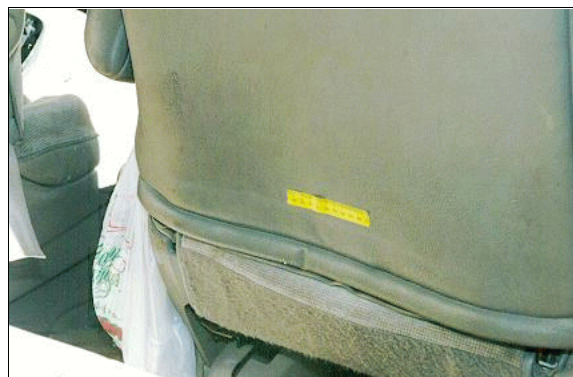
**Figure 26:** Close-up of lower portion of case vehicle's front right seat back showing evidence of contact by second seat right passenger (case photo #56)

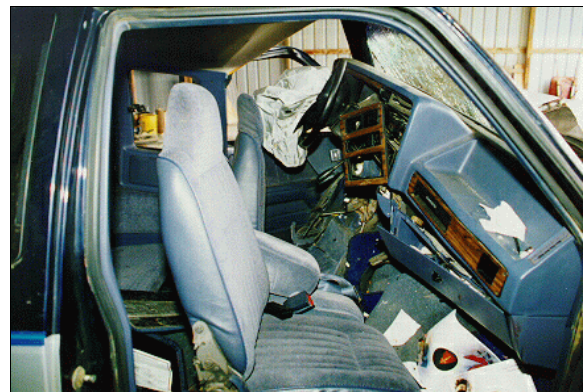
Figure 27: Dakota pickup's front seating area showing massive intrusion into driver's position (case photo #74)

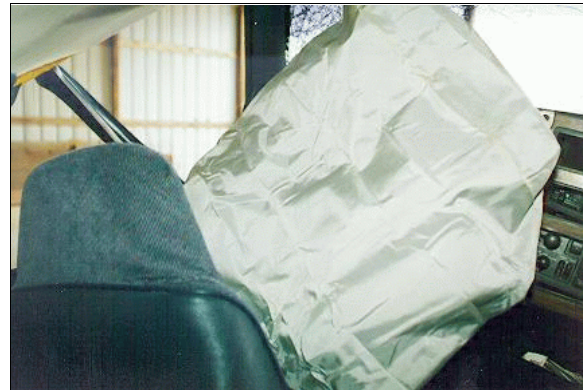
(SRS) that consisted of a frontal air bag for the driver only. The driver's air bag deployed as a result of the Dakota's frontal impact with the case vehicle (**Figure 27** above and **Figure 28**).

**Figure 28:** Dakota pickup's deployed driver air bag showing no residual evidence of contact (case photo #76)
