**REDESIGNED AIR BAG SPECIAL STUDY (RABSS)  
SCI TECHNICAL SUMMARY REPORT**

**NASS CDS CASE NO. 1998-08-124A**

**RABSS VEHICLE - 1998 FORD TAURUS SE**

**CRASH DATE - AUGUST, 1998**

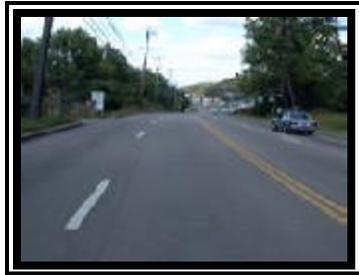
The 24 year old male driver of the 1998 Ford Taurus SE was operating the vehicle northbound (**Figure 1**) in the southbound lanes and negotiating a right curve at a (police reported) speed of 89 km/h (55 mph). The 20 year old male driver of the 1994 Ford Ranger XL was operating the vehicle southbound in the #2 curb lane (**Figure 2**) and negotiating a left curve (police reported speed unknown). Upon recognition of the impending harmful event, the driver braked (approximately 13.0 meters (42.7 ft) of pre-impact skid marks present but not documented by the NASS researcher) in avoidance remaining in the southbound travel lane prior to the collision.

**Figure 1. Northbound approach for the 1998 Ford Taurus SE.**

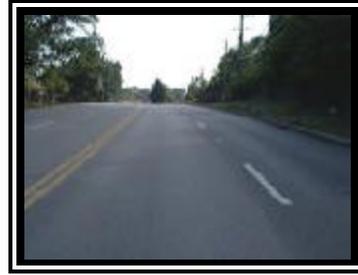
**Figure 2. Southbound approach for the 1994 Ford Ranger XL pickup truck.**

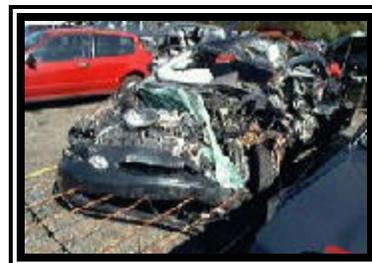
The Ford Taurus sustained severe frontal damage as a result of the impact with the Ford Ranger pickup truck (**Figure 3**). The direct contact damage began at the front left bumper corner and extended 57.0 cm (22.4 in) inboard. The impact deformed the full frontal width resulting in a combined direct and induced damage length (Field L) of 96.0 cm (37.8 in). Six crush measurements were documented at the level of the bumper: C1= 83.0 cm (32.7 in), C2= 72.0 cm (28.3 in), C3= 50.0 cm (19.7 in), C4= 33.0 cm (13.0 in), C5= 18.0 cm (7.1 in), C6= 0 cm. Contact damage continued rearward to the A-pillar which restricted the left front door opening and shattered the side glazing. Additional damage was noted to the hood, A-pillar and windshield header area from the underride (**Figure 4**). Induced buckling was documented to the left rear door and roof area. The windshield was fractured from exterior forces and was removed by rescue personnel during the driver's extrication from the vehicle (roof pillars also cut). The left front wheel/tire was restricted and deflated.

**Figure 3. Frontal damage to the 1998 Ford Taurus SE.**

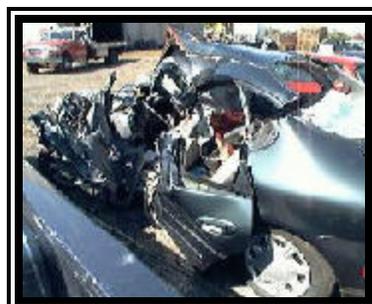
**Figure 4. Left side view of the 1998 Ford Taurus SE.**

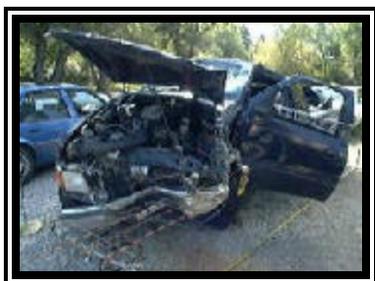
**Figure 5. Frontal damage to the 1994 Ford Ranger XL.**

The Ford Ranger XL supercab 4x4 pickup truck sustained severe frontal damage as a result of the impact with the Ford Taurus (**Figure 5**). The direct contact damage began at the left front corner and extended 74.0 cm (29.1 in) inboard. Damage was noted to the hood which was displaced up and rearward from the impact force. The left front wheel was displaced 93.0 cm (36.6 in) rearward to the fire wall. The left fender was displaced rearward to the A-pillar which restricted the door opening and shattered the side glazing. The A-pillar and roof buckled from induced impact forces. Bed contact to the cab area displaced the rear panel into the passenger compartment area. Rollover damage was noted to the left, right and top areas of the vehicle with 3.0 cm (1.2 in) of maximum crush documented at the left C-pillar. The right rear wheel separated from the axle during the rollover. Post-crash damage was also noted to the left front door from a forced opening.

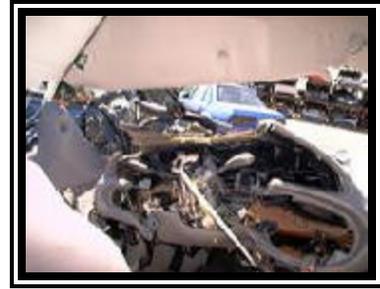
Interior damage to the Ford Taurus identified through the NASS vehicle inspection was severe (**Figure 6**) and was attributed to occupant contact and interior intrusions. Blood spattering and a scuff mark were documented to the lower section of the driver air bag. Several cuts to the air bag material were also identified from rescue efforts post-crash (steering wheel removed). Extensive damage was noted to the steering wheel rim with 10.0 cm (3.9 in) of displacement to the right half of the rim and 8.0 cm (3.1 in) to the left half. The (tilt-unknown position) steering column was displaced upward approximately 18.0 cm (7.1 in) to an almost vertical position. The left knee bolster (rigid plastic type) and instrument panel were fractured and scuffed from extensive loading. Longitudinal intrusions into the driver space included 45.0 cm (17.7 in) of instrument panel intrusion, 37.0 cm (14.6 in) of toepan intrusion, 43.0 cm (16.9 in) of windshield header intrusion, 30.0 cm (11.8 in) of A-pillar/steering assembly intrusion and an estimated opposing vehicle penetration of 30.0 cm (11.8 in). Vertical intrusions into the driver space included 17.0 cm (6.7 in) of roof panel intrusion and 11.0 cm (4.3 in) of roof side rail intrusion. Lateral intrusions into the driver space included 23.0 cm (9.1 in) of B-pillar intrusion, 18.0 cm (7.1 in) of kicker panel intrusion and 28.0 cm (11.0 in) of sill intrusion. Other intrusions included 13.0 cm (5.1 in) of longitudinal toepan/instrument panel intrusion into the front right seating area.

**Figure 6. Interior view of the 1998 Ford Taurus SE.**

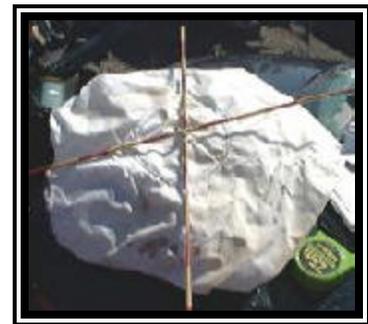
The 1998 Ford Taurus SE was equipped with redesigned frontal air bags for the driver and front right passenger positions. The air bags had deployed as a result of the crash. The driver air bag was housed in the center of the steering wheel with a horizontally oriented flap tear seam (H-configuration). The flaps were rectangular in shape as the upper flap measured 15.0 cm (5.9 in) in width and 7.0 cm (2.8 in) in height as the lower flap measured 13.0 cm (5.1 in) in width and 6.0 cm (2.4 in) in height. Although no contact evidence was identified on the exterior surface of the module cover flaps, blood spattering and a scuff mark were documented to the lower section of the air bag. The air bag was also cut as rescue personnel removed the windshield (and steering wheel) during driver extrication. The NASS researcher measured the diameter of the driver air bag at 50.0 cm (19.7 in) in its deflated state (**Figure 7**). The bag was tethered by two internal straps and vented by two ports located at the 11 o'clock and 1 o'clock sectors on the rear aspect of the air bag.

**Figure 7. 1998 Ford Taurus SE redesigned driver air bag.**

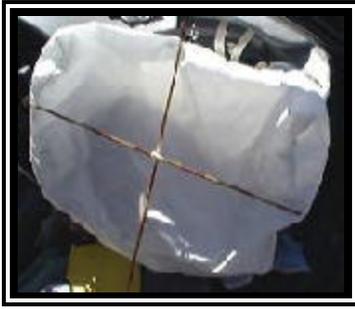
**Figure 8. 1998 Ford Taurus SE redesigned passenger air bag.**

The front right passenger air bag deployed from a top mount module in the right instrument panel with a single cover flap design hinged at the forward aspect. There was no contact evidence on the air bag or module cover flap which opened in an upward direction toward the windshield. The cover flap was asymmetrical in shape and measured 40.0 cm (15.7 in) in width and 27.0 cm (10.6 in) in height along the left edge of the flap and 16.0 cm (6.3 in) along the right edge. The NASS researcher measured the passenger air bag at 60.0 cm (23.6 in) in width and 40.0 cm (15.7 in) in height in its deflated state (**Figure 8**). No internal straps or vent ports were present. No cutoff switch was reported for the front right air bag.

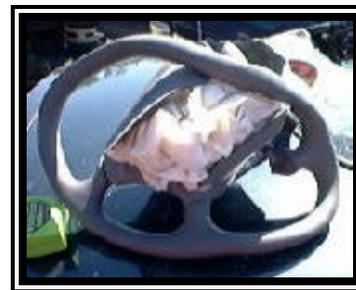
**Figure 9. Steering wheel rim/hub deformation.**

At impact, the driver initiated a forward trajectory in response to the 12 o'clock impact force and bottomed out the deployed redesigned driver air bag, subsequently loading the steering wheel hub/rim resulting in extensive multiple injuries which included fractures of the right 4<sup>th</sup>-6<sup>th</sup> ribs (with hemothorax), a contusion to the right lung, a lacerated liver, thoracic aorta, right atrium and a ruptured pericardium. This mechanism was evidenced by the severe deformation to the steering wheel hub/rim (**Figure 9**) relative to the driver's lack of restraint use. His upper extremities contacted the mid-instrument panel area which resulted in bilateral fractures of the radius/ulna as evidenced by the indentations and displacement of the left instrument panel. His lower extremities loaded the knee bolster and steering column (shifted to an almost vertical position) resulting in bilateral contusions/abrasions and fractures of the left femur and tibia/fibia, evidenced by the scuff marks and displacement documented to these components.

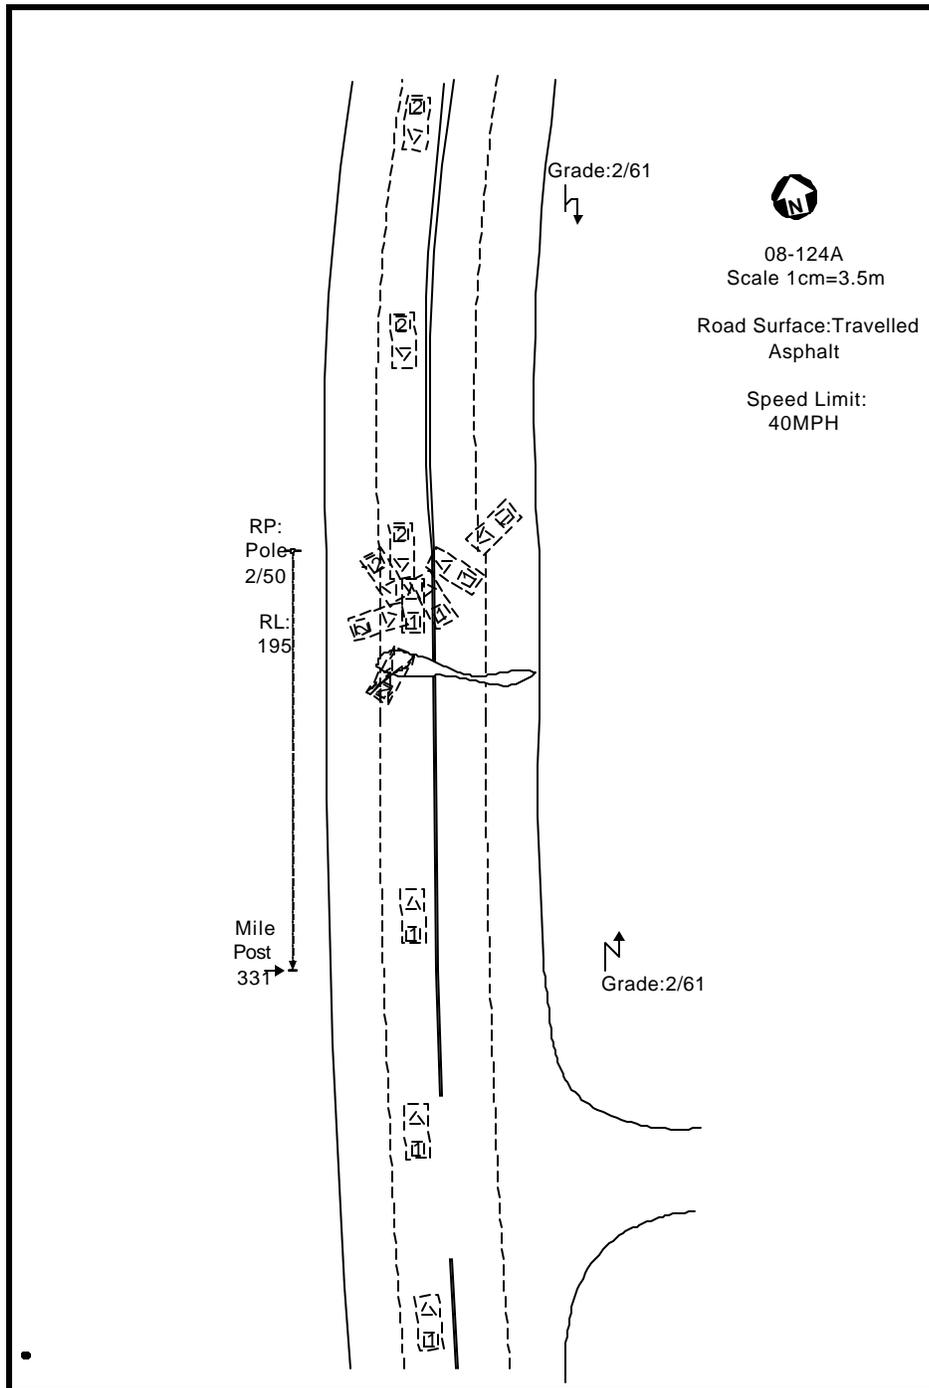
Figure 10. NASS Scene Diagram

This two-vehicle crash occurred during the morning hours of August, 1998. At the time of the crash, it was dark (street lighted) with no adverse conditions as the roads were dry. The crash occurred on a hillcrest in the southbound lanes of a 4-lane north/south asphalt roadway which curved to the right for southbound traffic (see **Figure 10 - page 8**). The speed limit at the crash scene was 64 km/h (40 mph) with no traffic control present.
