**REDESIGNED AIR BAG SPECIAL STUDY (RABSS)  
SCI TECHNICAL SUMMARY REPORT**

**NASS RABSS CASE NO. 1998-12-806E**

**RABSS VEHICLE - 1999 CHEVROLET CORVETTE**

**CRASH DATE - OCTOBER, 1998**

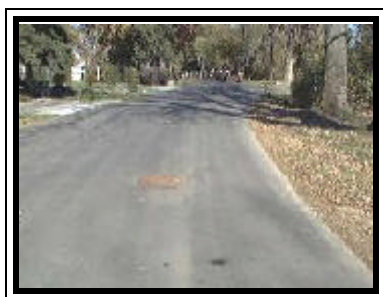
The 54 year old male driver of the 1999 Chevrolet Corvette was operating the vehicle eastbound and negotiating a left curve (**Figure 1**) on wet pavement (direction of travel/collision dynamics identified incorrectly in the NASS case file). The intermittent rain resulted in hazardous conditions as puddles and leaves were collecting about the residential roadway. As the vehicle reached the apex of the curve, it encountered a puddle and hydroplaned initiating a slight counterclockwise rotation. Upon recognition of the impending harmful event, the driver steered left and braked in avoidance, subsequently exiting the left (north) pavement edge.

**Figure 1. Overview of crash site looking west (struck tree to the right in image).**

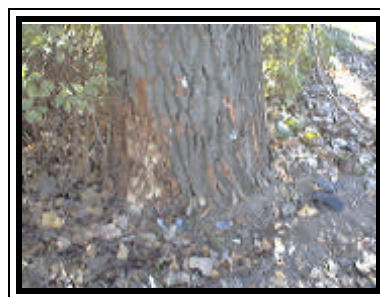
**Figure 2. East view of struck tree.**

As the Chevrolet Corvette exited the north pavement edge of the rural two lane roadway, the front right area struck a large diameter tree (**Figure 2**) resulting in moderately severe damage. Initial contact involved the extreme front right corner area which displaced the bumper and leading edge of the right fender. The continued forward motion of the vehicle resulted in engagement of the right front wheel/tire against the tree. This was the first significant structural contact, therefore, the air bag system probably deployed at this time, late in the crash sequence. The impact induced deceleration was sufficient to deploy the Chevrolet's redesigned frontal air bag system. The damage algorithm of the WinSMASH program computed a (barrier equivalent) velocity change of 35.6 km/h (22.1 mph). The specific longitudinal component was -33.5 km/h (-20.8 mph). The Collision Deformation Classification (CDC) for this initial impact to the Chevrolet Corvette was 01-FREE-3. At this point, the Corvette rotated clockwise approximately 40 degrees as the front left area impacted a bush (adjacent to the tree) resulting in superficial damage. The CDC for this second and final impact to the Corvette was 11-FYEW-1. The Chevrolet Corvette came to rest off the north pavement edge facing southeast.

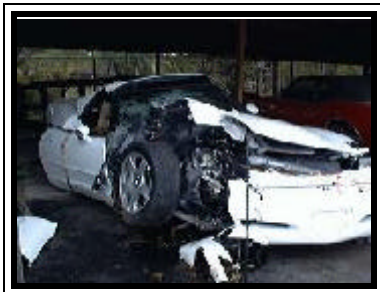
The 1999 Chevrolet Corvette sustained moderately severe frontal damage as a result of the impact with the tree (**Figures 3 & 4**). The direct contact damage began at the front right bumper corner and extended 36.0 cm (14.2 in) inboard. The impact deformed the full frontal width resulting in a combined direct and induced damage length (Field L) of 95.0 cm (37.4 in). Six crush measurements were documented at the level of the bumper: C1= 13.0 cm (5.1 in), C2= 18.0 cm (7.1 in), C3= 26.0 cm (10.2 in), C4= 35.0 cm (13.8 in), C5= 41.0 cm(16.1 in), C6= 54.0 cm (21.3 in). The contact damage extended rearward down the right side surface which deformed the fender and deflated/restricted the right front wheel/tire. Lateral displacement of the hood was noted from engagement against the tree. Superficial scratches were documented along the remainder of the bumper fascia from the bush impact. Reduction in the right side wheelbase measured 37.0 cm (14.6 in). Reduction in the left side wheelbase measured 4.0 cm (1.6 in). The windshield fractured at the right A-pillar from exterior impact forces and center mid-windshield area from (interior) occupant contact.

**Figure 3. Frontal damage to the 1999 Chevrolet Corvette.**

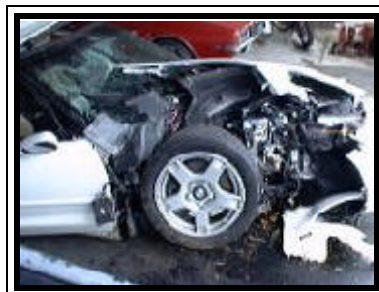
**Figure 4. Right side view.**

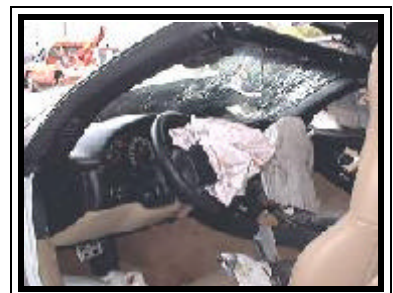
Interior damage to the Corvette identified through the NASS vehicle inspection was moderate and was attributed to occupant contact (**Figure 5**). A scuff mark was noted to the left knee bolster (padded type) along with an indentation to the glove compartment door. The upper portion of the steering wheel rim was deformed 6.0 cm (2.4 in). A spider-web type fracture was documented to the center windshield area with rear view mirror separation (unknown if

**Figure 5. Interior view.**

damaged). Indentations were found along the center instrument trim panels with the vents and radio out of place. The right front glazing was found adjacent to the vehicle (intact) with hair strands attached. A door failure was identified at the right latch/stryker assembly. Longitudinal intrusions into the front right passenger space included 17.0 cm (6.7 in) of toepan intrusion and 11.0 cm (4.3 in) of windshield header intrusion.

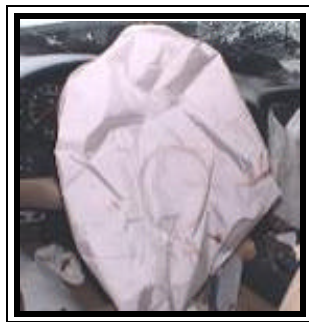
The 1999 Chevrolet Corvette was equipped with redesigned frontal air bags for the driver and front right passenger positions. The air bags had deployed as a result of the crash. The driver air bag was housed in the center of the steering wheel with a vertically oriented flap tear seam (I-configuration). The flaps were symmetrical in shape and measured 8.0 cm (3.1 in) in width and 13.0 cm (5.1 in) in height. Although no contact evidence was identified on the exterior surface of the module cover flaps, blood spattering was documented to the (front/back) lower section of the air bag. The NASS researcher measured the diameter of the driver air bag at 56.0 cm (22.0 in) in its deflated state (**Figure 6**). The bag was tethered by two internal straps and vented by two ports located at the 11 o'clock and 1 o'clock sectors on the rear aspect of the air bag.

**Figure 6. 1999 Chevrolet Corvette redesigned driver air bag.**

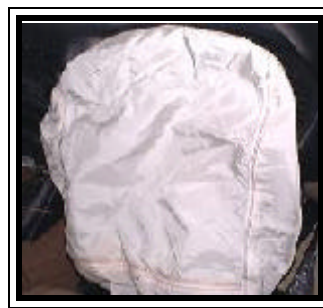
The front right passenger air bag deployed from the right top instrument panel area with a single cover flap design hinged at the forward aspect. The cover flap was rectangular in shape and measured 27.0 cm (10.6 in) in width and 18.0 cm (7.1 in) in height. Although no contact evidence was identified on the exterior surface of the module cover flap, blood spattering was documented to the lower right quadrant of the air bag. The NASS researcher measured the passenger air bag at 38.0 cm (15.0 in) in width and 50.0 cm (19.7 in) in height in its deflated state (**Figure 7**). No internal tether straps or vent ports were present. No cutoff switch was reported for the front right redesigned passenger air bag.

**Figure 7. 1999 Chevrolet Corvette redesigned passenger air bag.**

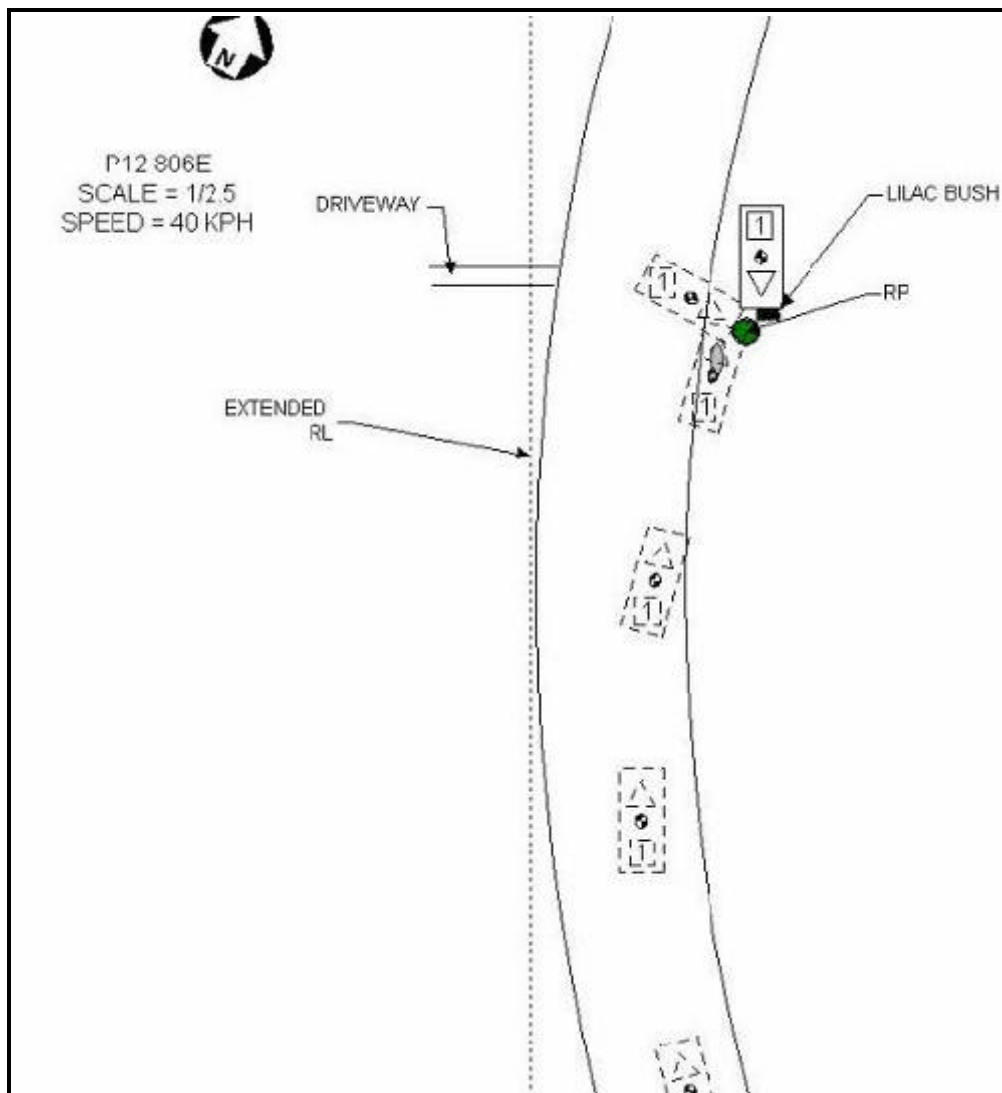
This single vehicle crash occurred during the late evening hours of October, 1998. At the time of the crash, it was dark (street not lighted) with intermittent rain conditions as the roads were wet. The crash occurred off the north pavement edge of a level two lane east/west asphalt roadway (**see Figure 8 - page 8**) which curved left for eastbound traffic. No traffic control was present at the scene which had a posted speed limit of 40 km/h (25 mph). The roadside environment featured various trees and shrubbery, residential driveways and mailboxes.

Figure 8. NASS Scene Diagram (direction of travel identified incorrectly).
