Remote, Redesigned Air Bag Special Study

Dynamic Science, Inc., Case Number (1998-049-804E)

1998 Dodge Durango

Summary

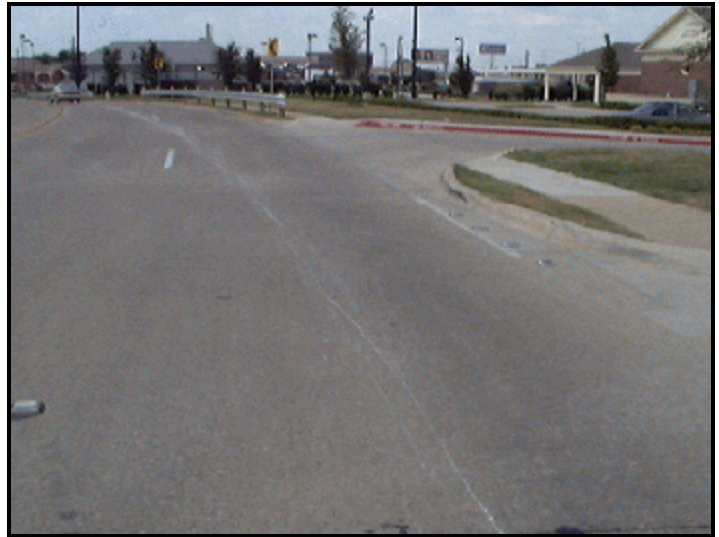
Figure 2. Approach to guardrail impact

The non-contact vehicle attempted to change lanes from the left lane into the right lane. To avoid striking the second vehicle, the driver of Vehicle 1 applied the brakes (unknown lockup) and steered to the right. This steering input caused Vehicle 1 to depart the right road side, climb the concrete curb, and strike the end of a guardrail (event 1) with the front plane of the vehicle (12FDEW2).

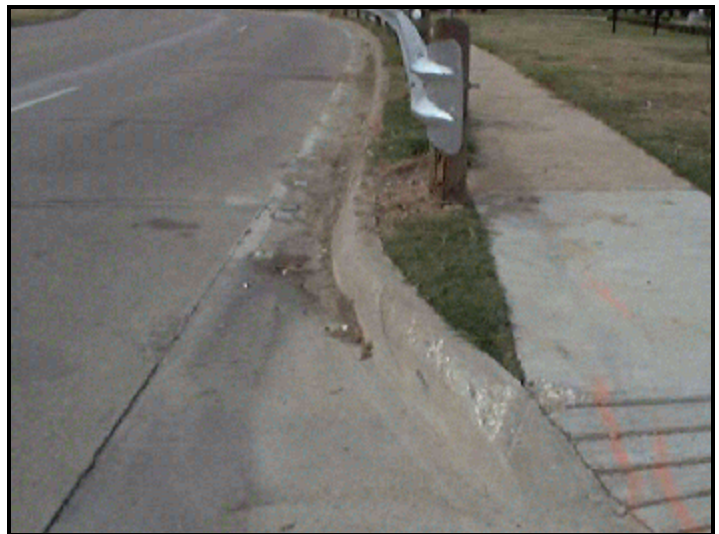
Figure 3. Impact with guardrail

A Delta V could not be calculated for this impact due to the guardrail being an energy absorbing (yielding) object. A barrier speed was calculated for this impact, utilizing WinSMASH, as 26 km/h (16 mph).

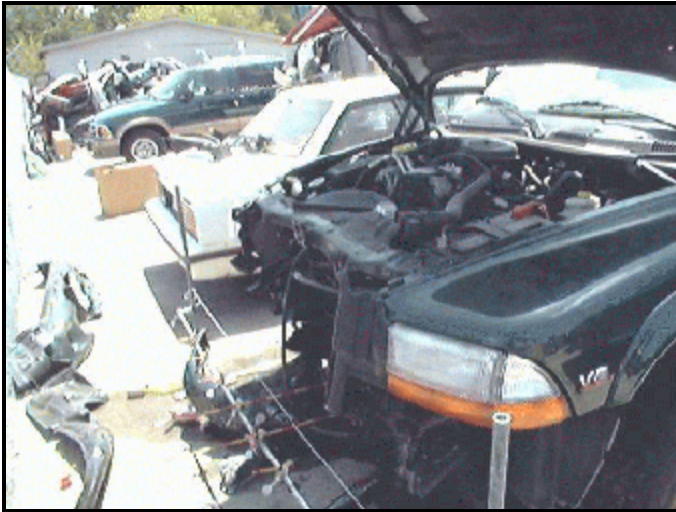
Figure 4. Exterior, Vehicle 1 (1998 Dodge Durango)

Plane of Impact	Field L cm/in.	C1 cm/in.	C2 cm/in.	C3 cm/in.	C4 cm/in.	C5 cm/in.	C6 cm/in.
Bumper	96	0	39	30	10	0	0
	37.8	0	15.4	11.8	3.9	0	0

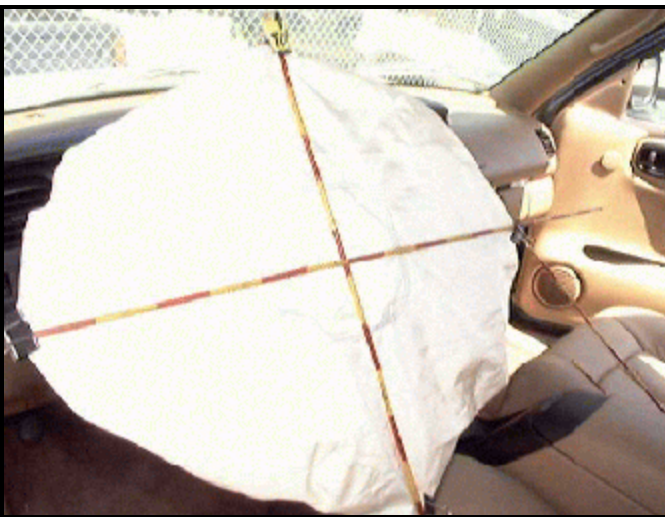
The front left air bag was housed in the steering wheel hub and was concealed by rectangular, asymmetrical H-configuration cover flaps. The circular air bag was equipped with two tether straps and no vent ports. A small scuff was found on the top right quadrant of the front of the bag from contact with the driver's face.

Figure 6. Interior, case vehicle. Driver's side air bag.

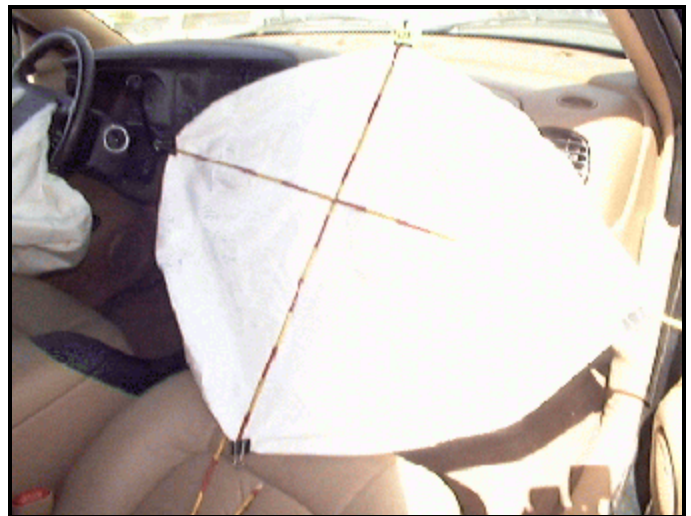
The front right air bag was housed in the mid-instrument panel position. The single air bag cover flap was in the shape of an inverted "D". The oval shaped air bag was not equipped with either tethers or vent ports. There were no indications of damage or contact to either the air bag or the module cover.

Figure 7. Interior, case vehicle. Passenger's side air bag.

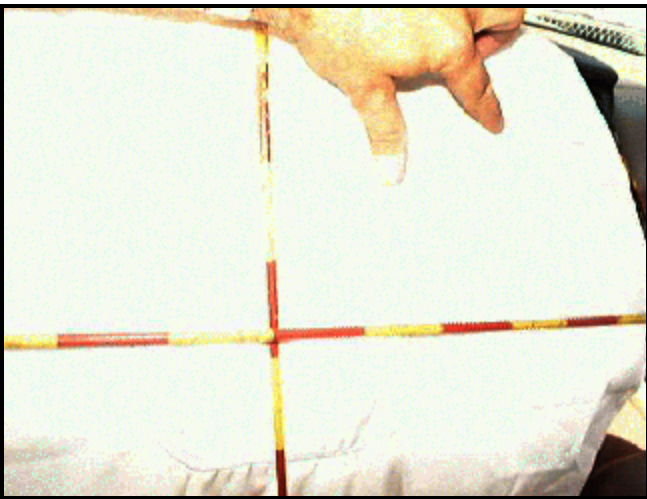
At impact, the driver reacted to the 0 degree principal direction of force by moving sharply forward, again loading the locked lap/shoulder restraint-causing the chest skin contusion. The driver also engaged the deploying air bag-causing the neck abrasion. A small scuff was found on the bag from the contact. Three scuffs were also found on the front left door panel from contact with the driver's left flank. No injuries were sustained from these contacts.

Figure 8. Interior, case vehicle. Air bag contact.
