Remote, Redesigned Air Bag Special Study
Dynamic Science, Inc., Case Number (1998-075-804F)
1998 Ford Explorer
Colorado
October/1998

Summary

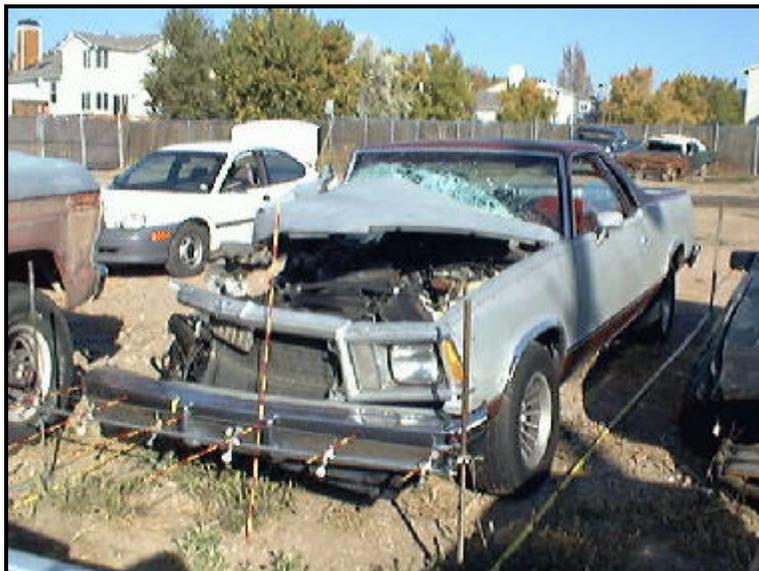
Figure 1. Exterior, Vehicle 1 (Chevrolet El Camino)

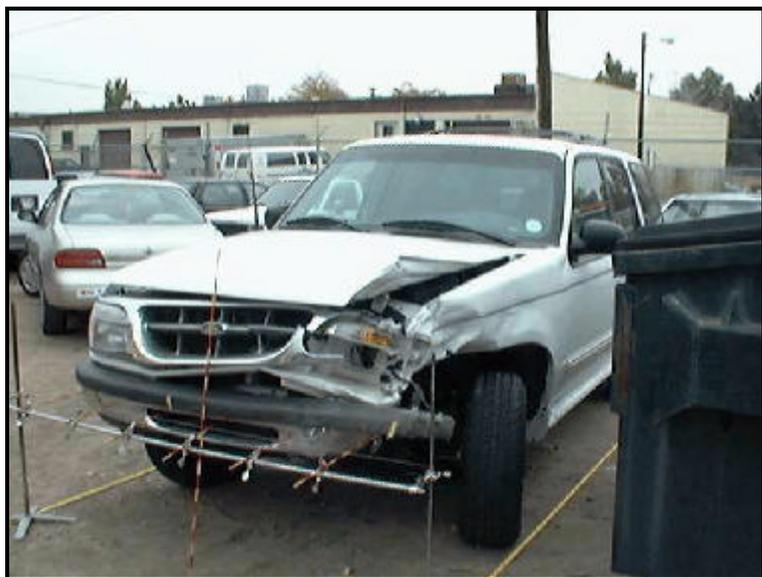
Figure 2. Exterior, Vehicle 2 (Ford Explorer)

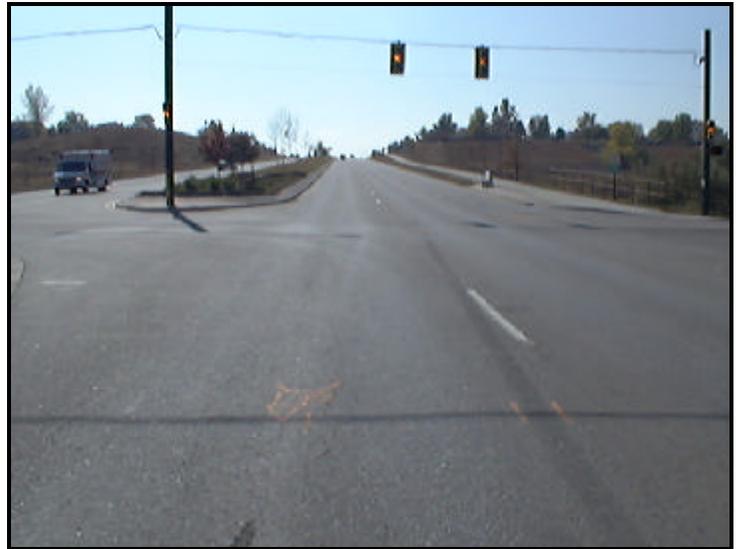
Figure 3. Crash scene, Vehicle 1 approach path.

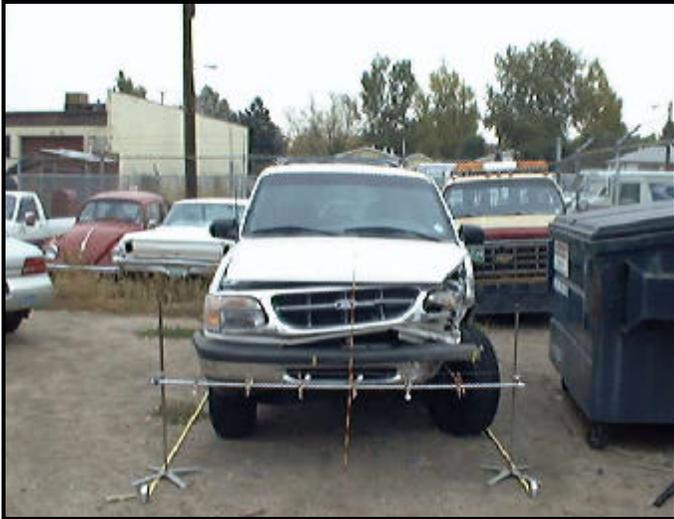
Figure 4. Exterior, Vehicle 2 (1998 Ford Explorer)

Plane of Impact	Field L cm/in.	C1 cm/in.	C2 cm/in.	C3 cm/in.	C4 cm/in.	C5 cm/in.	C6 cm/in.
Bumper	139	12	2	2	1	1	0
	54.7	4.7	0.8	0.8	0.4	0.4	0

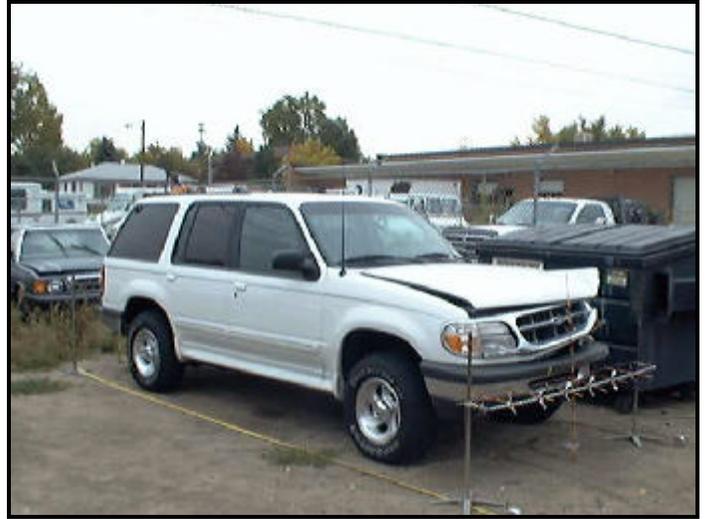
Figure 5. Exterior, Vehicle 2 (1998 Ford Explorer)

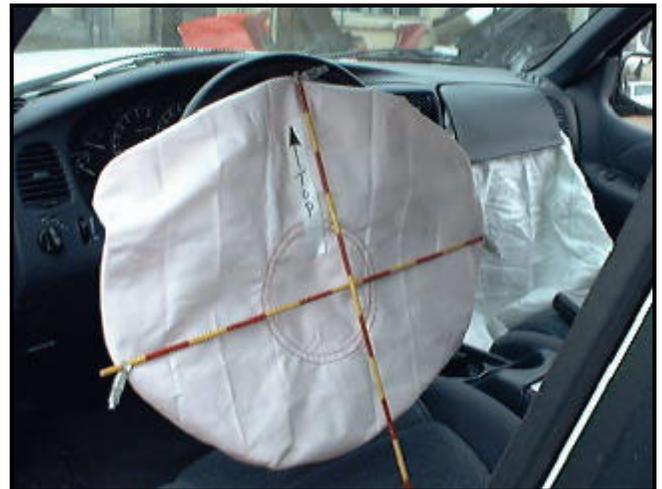
The front left air bag was housed in the steering wheel hub and was concealed by asymmetrical H-configuration cover flaps which were not damaged in the crash. The circular air bag was equipped with two tether straps and two vent ports. No contact evidence was found on the air bag and the bag was not damaged.

Figure 6. Interior, case vehicle. Driver's side air bag.

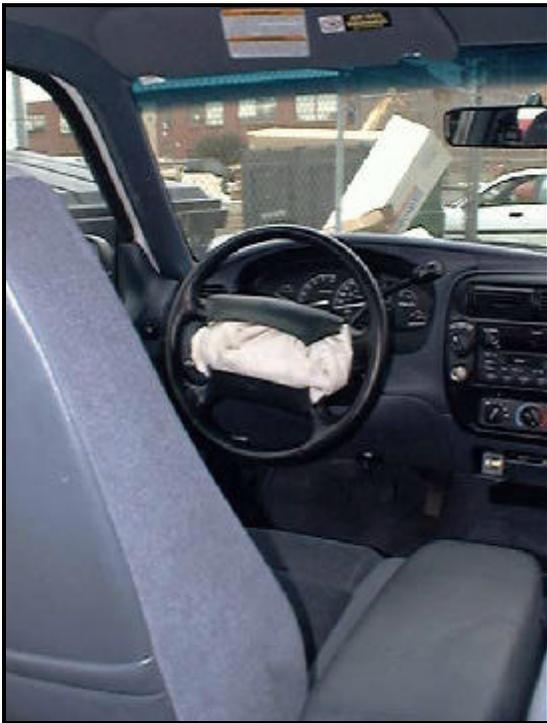
Figure 7. Interior, case vehicle

The interior of the Ford Explorer sustained no damage from occupant contact. There were no areas of intrusion into the passenger compartment. No occupant contact evidence was found in the vehicle.
