Remote, Redesigned Air Bag Special Study

Dynamic Science, Inc., Case Number (1998-081-803F)

1998 Ford Taurus 4-door sedan

November/1998

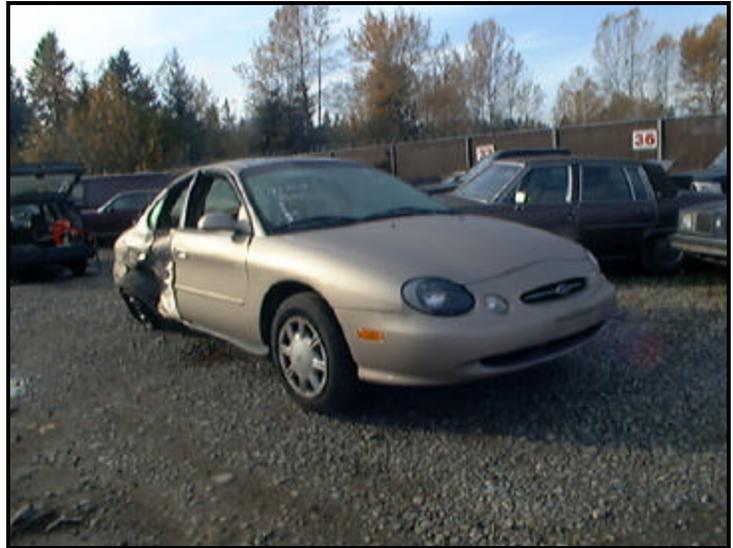
Figure 1. Exterior, Vehicle 1 (Ford Taurus)

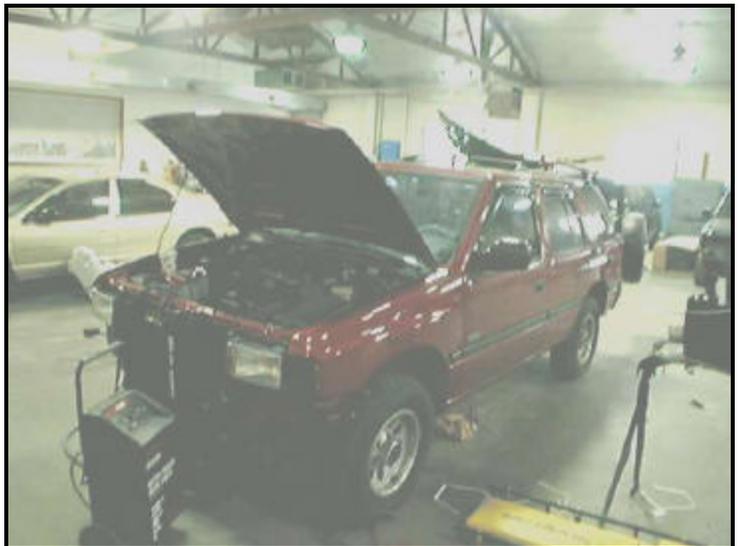
Figure 2. Exterior, Vehicle 2 (Isuzu Rodeo)

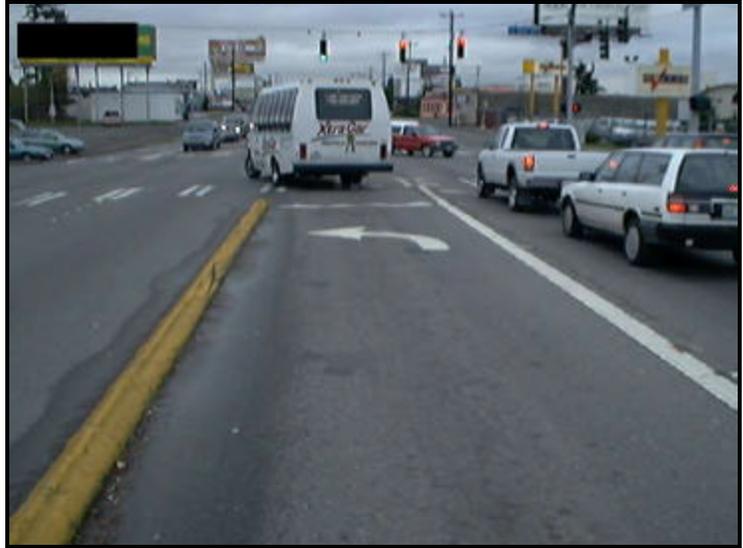
The driver of Vehicle 1 failed to yield to opposing traffic and initiated the left turn in the path of Vehicle 2. The front plane of Vehicle 2 (unknown CDC) struck the right plane of Vehicle 1 (01RZEW3) in the intersection. Vehicle 1 rotated clockwise after impact and came to rest on the north side of the intersection facing north. Vehicle 2 rotated clockwise after impact and came to rest in the original travel lane facing southwest.

Figure 3. Crash scene. Vehicle 1 approach to impact.

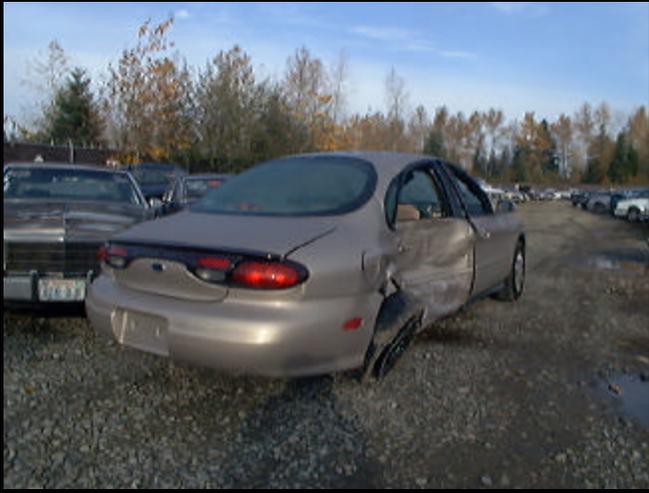
<p>Figure 4. Exterior, Vehicle 1 (1998 Ford Taurus)</p> </div> <div style="text-align: center;">

Plane of Impact	Field L cm/in.	C1 cm/in.	C2 cm/in.	C3 cm/in.	C4 cm/in.	C5 cm/in.	C6 cm/in.
Mid-door	141	3	18	30	32	24	13
	55.5	1.2	7.1	11.8	12.6	9.4	5.1

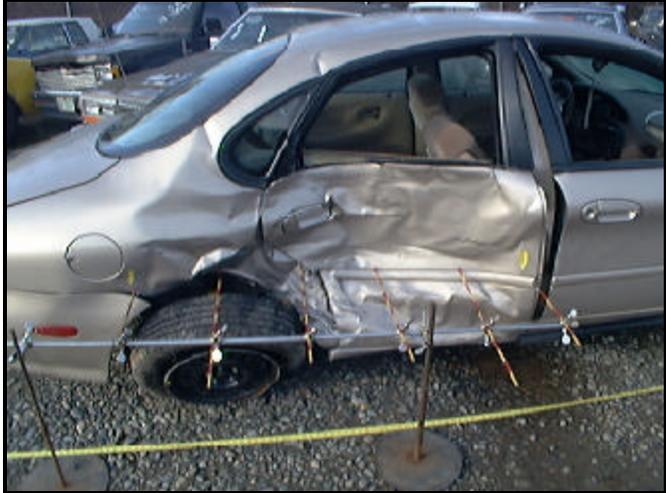
<p>Figure 5. Exterior, Vehicle 1 (1998 Ford Taurus)</p> </div> </div>	
VIN	1FAFP52U0WG
CDC	01RZEW3

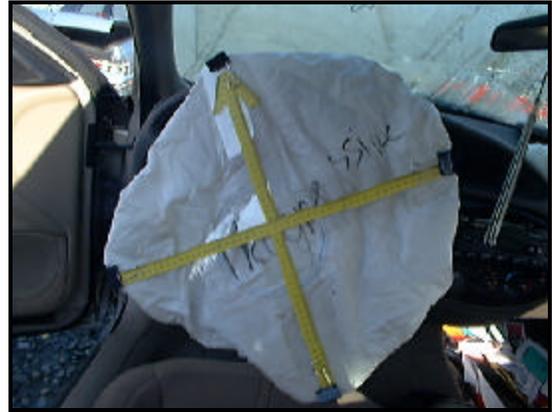
The front left air bag was housed in the steering wheel hub and was concealed by two asymmetrical H-configuration cover flaps which were not damaged in the crash. The circular air bag was equipped with two tether straps and two vent ports. Contact evidence consisting of several small blood spots was found on the front of the air bag. The bag was not damaged.

Figure 6. Interior, Vehicle 1. Driver's air bag.

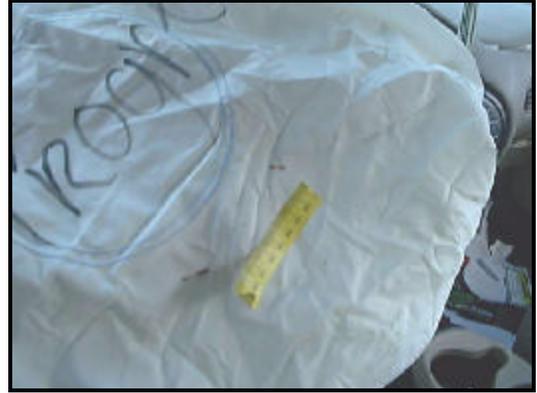
At impact, the case occupants reacted to the 30 degree principle direction of force by moving forward and to the right, loading the lap/shoulder restraints. As the restraints locked, further movement of the occupants was prevented. It appears that the driver came into contact with the deploying driver's frontal air bag-causing the cervical strain. The driver's chest loaded the shoulder belt webbing-causing the left chest skin contusion. The driver was transported from the scene to a hospital where he was treated and released for non-incapacitating injuries. Case occupant 02 did not sustain any injuries and did not appear to have come into contact with any component of the vehicle's interior. He did not receive any medical attention.

Figure 7. Interior, Vehicle 1. Air bag contact.
