ON-SITE REDESIGNED AIR BAG INVESTIGATION

CASE NUMBER - IN98-003
LOCATION - MISSOURI
VEHICLE - 1998 DODGE DURANGO SLT
CRASH DATE - December, 1997

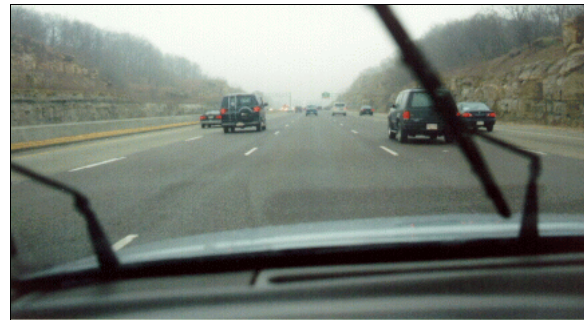
Figure 1: Southeastward travel path viewed from center through lane of five-lane southeastbound roadway; Note: case vehicle and Ford F700 were both traveling southeastward in the adjacent right-hand lane (case photo #02)

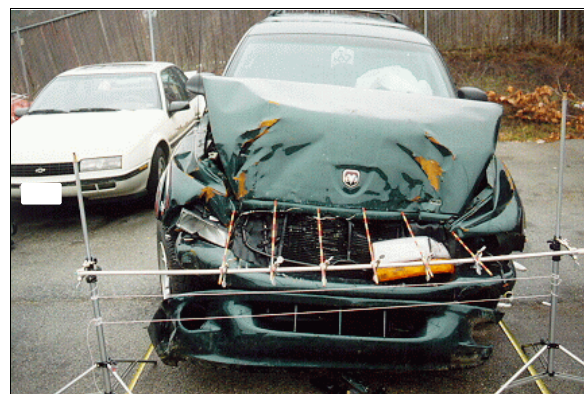
The front (**Figure 2**) of the case vehicle impacted the rear of the flat bed trailer (**Figure 3** below) towed by the Ford, causing the case

Figure 2: Case vehicle's frontal damage with contour gauge present and positioned to show above bumper crush (case photo #04)

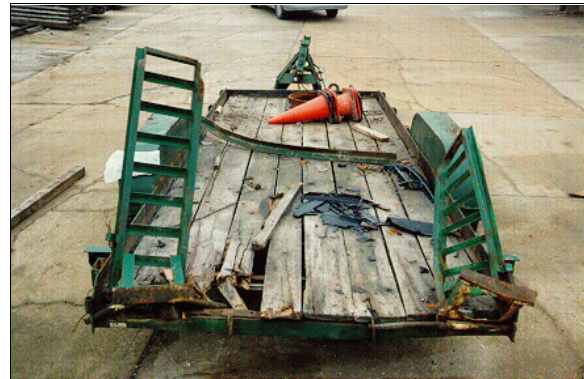
Figure 3: Flatbed trailer towed by Ford showing damaged ramps and wooden floor planks to back of trailer (case photo #72)

(**Figure 23**), torqued rear ramps (i.e., both), bent rear frame member, and splintering to four of the eight wooden floor planks (**Figure 3** above). The Ford truck was towed due to disabling damage; specifically, the Police Crash Report indicates that the Ford's transmission was damaged. The Ford truck and its trailer were outside the scope of WinSMASH.

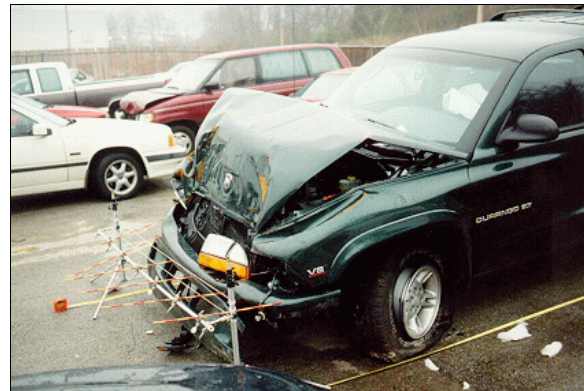
The case vehicle's contact with the Ford truck and trailer involved the entire front of the vehicle. Direct damage began at the left bumper corner and extended across the entire front bumper and hood (**Figure 4**). Maximum crush at the bumper was measured as 22 centimeters (8.7 inches) at C₆. Maximum crush above the bumper was measured as 29 centimeters (11.4 inches) at C₅ (**Figure 5**). The wheelbase on the case vehicle's left side was shortened 19 centimeters (7.5 inches) while the right side was extended 16 centimeters (6.3 inches). The case vehicle's front splash guard, front bumper, right and left headlamp and turn signal assemblies, grille, hood, and both fenders were directly damaged and crushed rearward. As a result of the crash, the case vehicle's left and right front tires were physically restricted and the left front tire was deflated (**Figures 6 and 7** below).

Figure 4: Case vehicle's frontal damage with contour gauge present at bumper level viewed from left of front (case photo #08)

Based on the vehicle inspection the CDC for the case vehicle was determined to be: **12-FDEW-2 (350)**. The WinSMASH reconstruction program, barrier algorithm, was used on the case vehicle's highest severity impact. The Total, Longitudinal, and Lateral Delta Vs are, respectively: 23.4 km.p.h. (14.5 m.p.h.), -23.0 km.p.h. (-14.3 m.p.h.), and +4.1 km.p.h. (+2.5

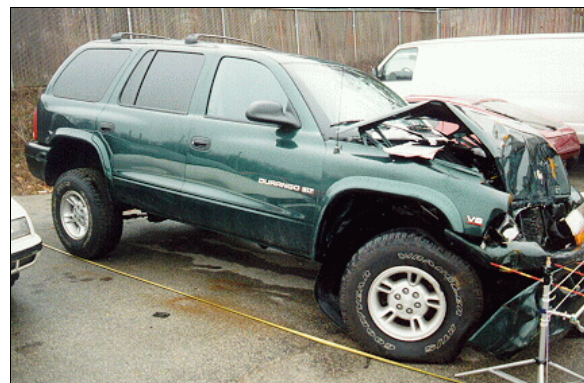
Figure 5: Case vehicle's frontal damage, viewed from right of front, with contour gauge showing bumper level crush (case photo #15)

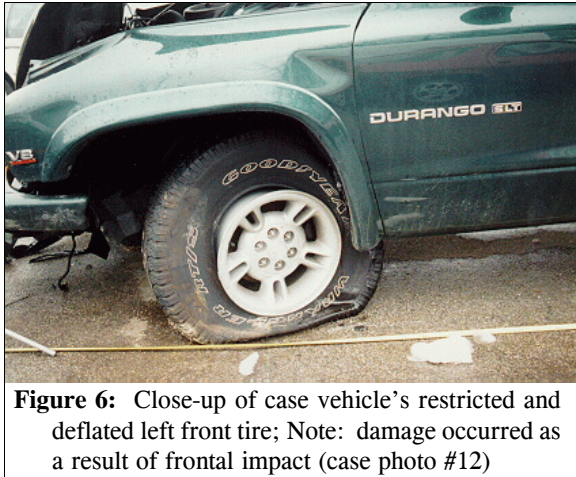
Figure 6: Close-up of case vehicle's restricted and deflated left front tire; Note: damage occurred as a result of frontal impact (case photo #12)

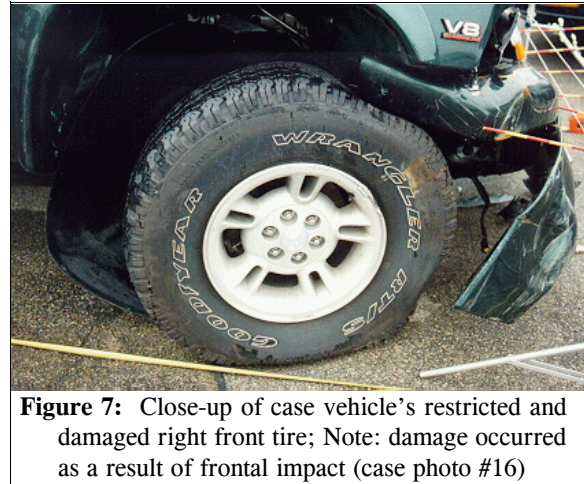
Figure 7: Close-up of case vehicle's restricted and damaged right front tire; Note: damage occurred as a result of frontal impact (case photo #16)

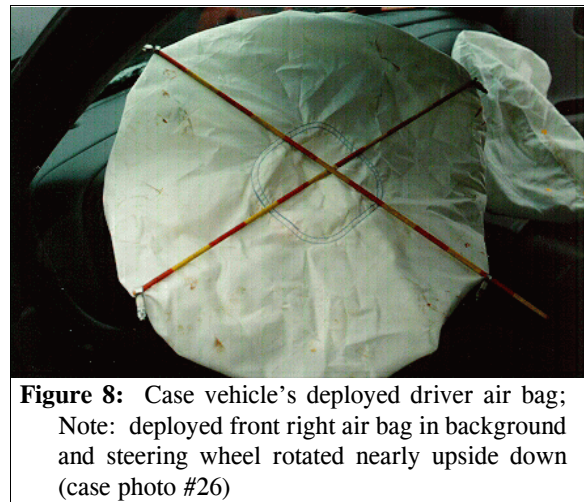
The case vehicle's driver air bag was located in the steering wheel hub. The module cover consisted of asymmetrical "H"-configuration cover flaps made of thick vinyl with overall dimensions of 15 centimeters (5.9 inches) at the horizontal seam and 11 centimeters (4.3 inches) vertically for the upper flap and 2 centimeters (0.8 inches) vertically for the lower flap. An inspection of the air bag module's cover flaps and air bag fabric revealed that the cover flaps opened at the designated tear points, and there was no evidence of damage during the deployment to the air bag or the cover flaps. The driver's air bag was designed with one tether, 6 centimeters (2.4 inches) wide. The driver's air bag had no vent ports. The deployed driver's air bag was elliptical with a height of approximately 52 centimeters (20.5 inches) and a width of approximately 63 centimeters (24.8 inches). An inspection of the driver's air bag revealed blood splashes and smears around the periphery of the bag's frontal surface, with other blood transfers to the top portion of the back surface (**Figure 8**).

Figure 8: Case vehicle's deployed driver air bag; Note: deployed front right air bag in background and steering wheel rotated nearly upside down (case photo #26)

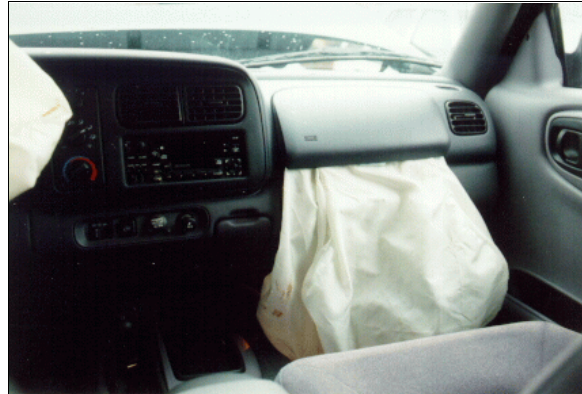
The front right passenger's air bag was located in the middle of the instrument panel (**Figure 9** below). There was a single, essentially rectangular, modular cover flap. The cover flap was made of a thick vinyl over a thick cardboard type frame. The flap's dimensions were 33 centimeters (13.0 inches) at the lower horizontal seam and 23 centimeters (9.1 inches) along both vertical seams. The profile of the case vehicle's instrument panel resulted in a 4 centimeter (1.6

inch) setback of the leading edge of the cover flap relative to the protruding right instrument panel. An inspection of the front right air bag module's cover flap and air bag fabric revealed that the cover flap opened at the designated tear points, and there was no evidence of damage during the deployment to the air bag or the cover flap. The front right passenger's air bag was designed without any tethers, it had no vent ports. The deployed front right air bag was rectangular with a height of approximately 60 centimeters (23.6 inches) and a width of approximately 52 centimeters (20.5 inches). There were scattered blood spots on the front surface and right and left side surfaces of the deployed front right air bag.

Figure 9: Case vehicle's front right seating area showing front right passenger air bag, which deployed from middle-mounted module, and module's undamaged cover flap (case photo #45)

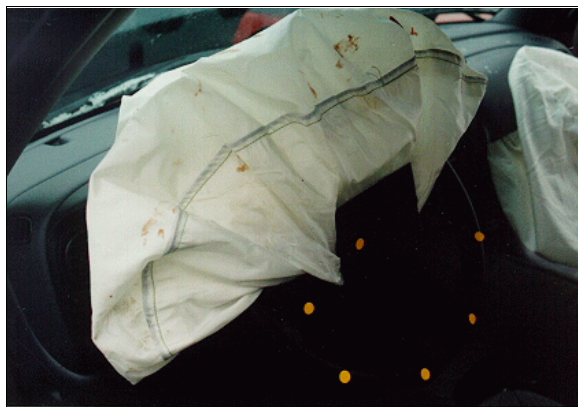
Figure 10: Case vehicle's inverted steering wheel (rotated 180 degrees) showing blood and unidentified splatter evidence (orange dots) on steering wheel's rim and hub and blood evidence on lower front surface of driver's air bag (case photo #27)

An inspection of the case vehicle's interior revealed blood spots around the steering wheel's rim (**Figure 10**), on the interior surface of the driver's door (**Figure 11**), and on the front portion of the driver's seat (**Figure 12**). There was contact evidence (i.e., scrape) on the driver's knee bolster, just to the right of the steering column (**Figure 13** below), and a scrape on the center instrument panel (**Figure 14** below). In addition, hair and skin transfers were detected on the case vehicle's windshield near the driver's side windshield header (**Figure 15** below) and on the header itself; this evidence is contraindicative of the use of the available, lap-and-shoulder, safety belts.

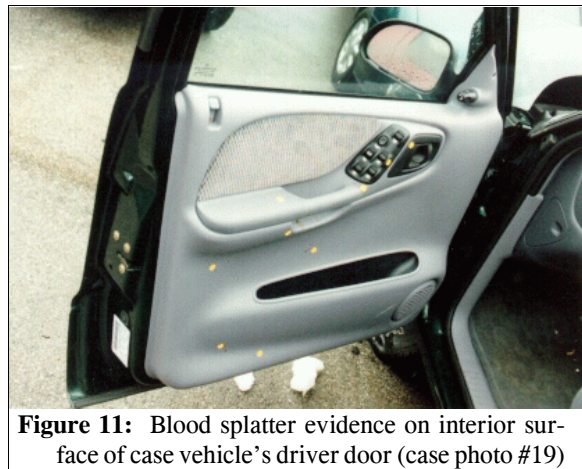
Figure 11: Blood splatter evidence on interior surface of case vehicle's driver door (case photo #19)

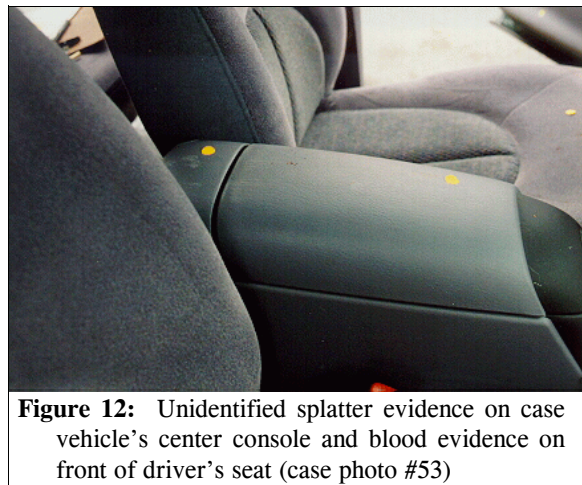
Figure 12: Unidentified splatter evidence on case vehicle's center console and blood evidence on front of driver's seat (case photo #53)

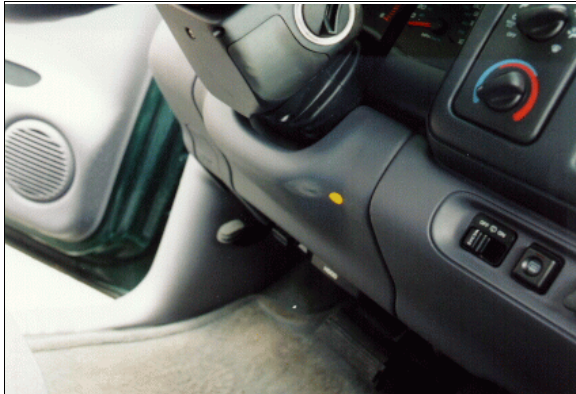
Figure 13: Contact evidence on right side of case vehicle's driver knee bolster (case photo #36)

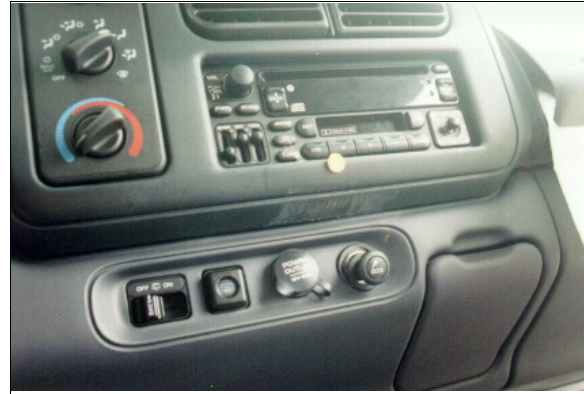
Figure 14: Contact evidence on case vehicle's center instrument panel area (case photo #44)

back seat's seat back (i.e., the seat back was down at the time of the crash—**Figure 19**). In this contractor's opinion, it is possible that the jack rotated off the second seat left's seat back and continued forward contacting the center instrument panel (**Figure 14** above) prior to rebounding backwards into the back seating area as the case vehicle continued to final rest.

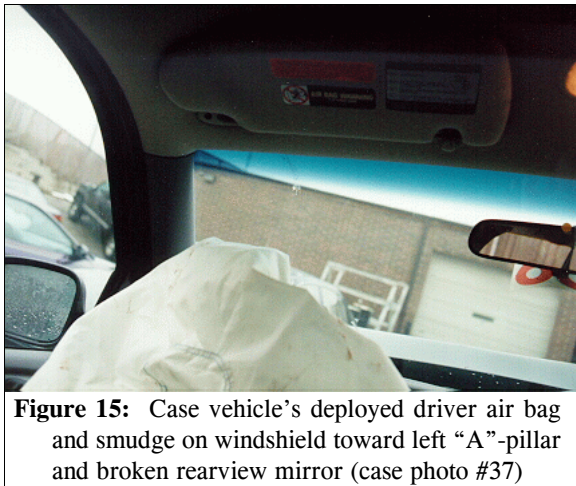
Figure 15: Case vehicle's deployed driver air bag and smudge on windshield toward left "A"-pillar and broken rearview mirror (case photo #37)

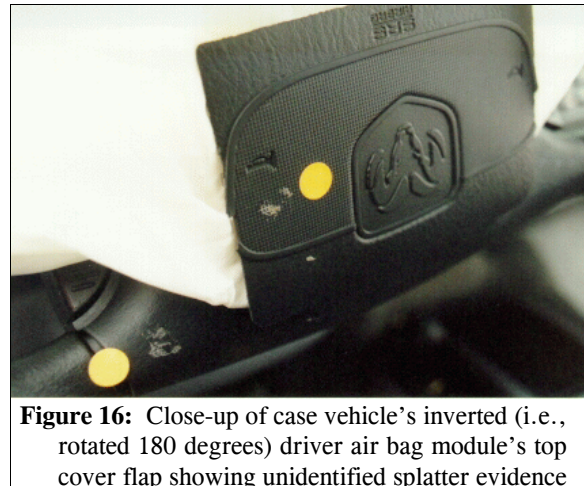
Figure 16: Close-up of case vehicle's inverted (i.e., rotated 180 degrees) driver air bag module's top cover flap showing unidentified splatter evidence on cover flap and upper right rim area (case photo #33)

There were also unidentified splatter marks on the steering wheel's rim and spokes (**Figure 10** above) and to the driver air bag module's top cover flap (**Figure 16**). Furthermore, these unidentified splatter marks were noted on the center console (**Figure 12** above), the center and right instrument panel areas, and on the front right air bag module's cover flap. Finally, there was a scrape on the back surface of the front right seat back from contact by the second seated right passenger (**Figure 17**).

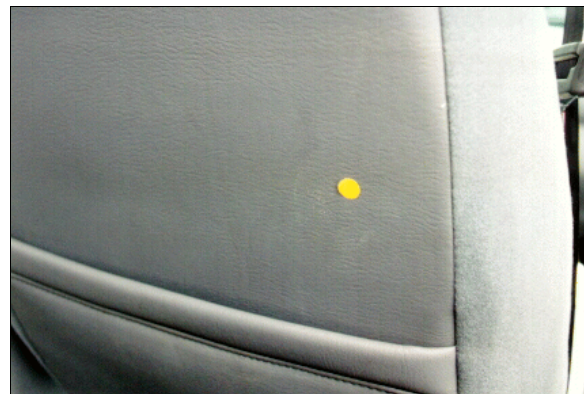
Figure 17: Contact evidence on back surface of case vehicle's front right seat back from contact by second seated right passenger (case photo #57)

The second seated right passenger was transported by ambulance to the hospital. She sustained evident, but not disabling, injuries and was treated and released. The specific injuries sustained by the case vehicle's second seated right passenger are unknown. However, the vehicle inspection indicates that this occupant most likely contacted the back of the front right seat back.

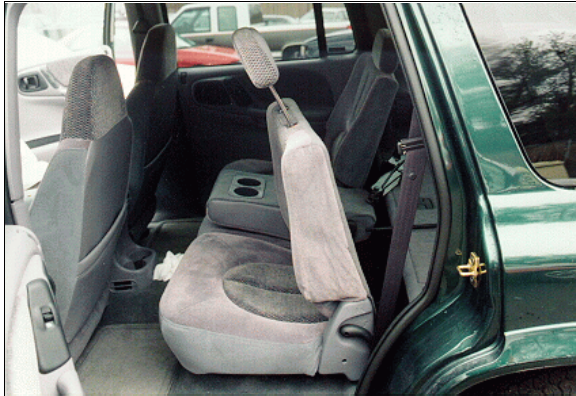
Of interest is the fact that the case vehicle's back (third) seat was folded down prior to the crash. The seat being down enabled the vehicle's tire jack and the jack's crank handle to fly forward during the collision. The jack struck the case vehicle's second seat left's seat back with sufficient force that it bent the seat back forward while rotating it counterclockwise (**Figure 18** below). There was also a scrape on the back surface the

Figure 18: Case vehicle's second seating area showing deformed seat back of second left seat and undeformed seating area where second seat right passenger was seated (case photo #55)

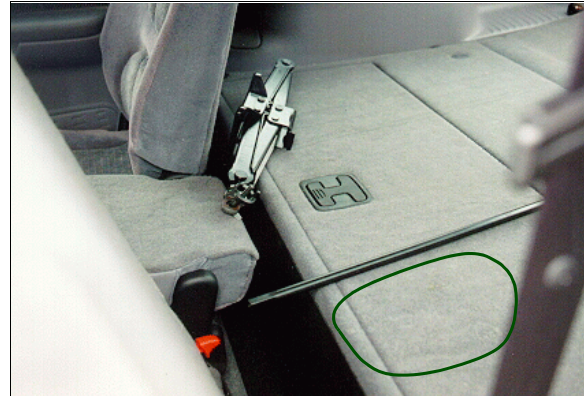
Figure 19: Case vehicle's folded down back seat and base of tire jack that deformed the second seat left's seat back and scraped the folded down area (highlighted) of the back seat (case photo #60)

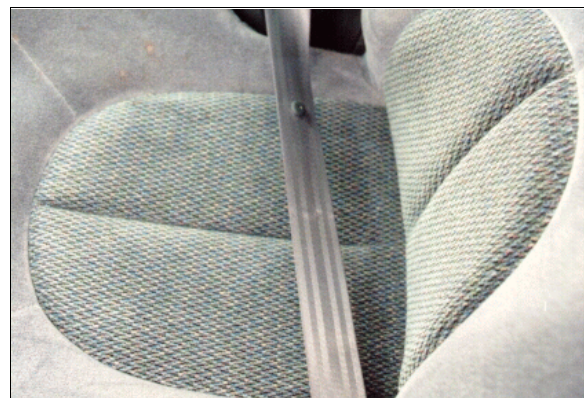
Based on the interior contact evidence, the case vehicle's driver was most likely not using his available, active, three-point, lap-and-shoulder, safety belt system. Although there were indications of frequent belt system use, inspection of the seat belt webbing, "D"-ring, and latch plate showed inconclusive evidence of loading (i.e., a lateral marking on the lap portion of the belt webbing near the midpoint of the driver's seat—**Figure 20**, and a slight "waffling" of the webbing near the left shoulder area of the shoulder portion of the three-point belt).

Figure 20: Case vehicle's driver safety belt showing loading evidence on webbing (case photo #39)

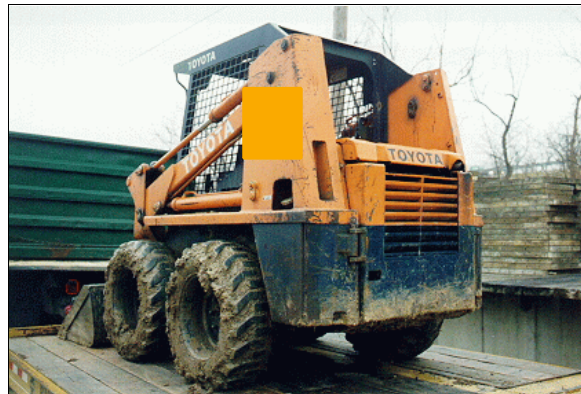
Figure 21: Small Toyota construction vehicle that was on trailer being towed by Ford; Note: vehicle's back was contacted by case vehicle's front (case photo #79)

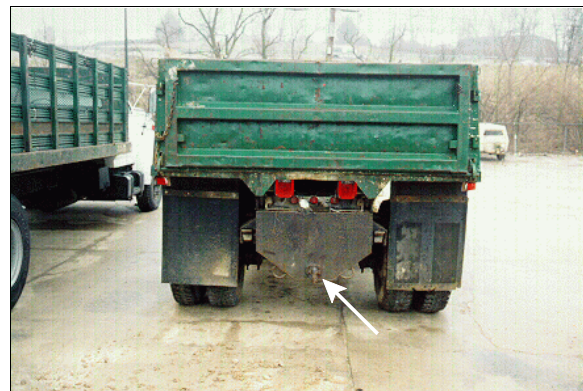
The 1985 Ford F-700 was a rear wheel drive, two-door, incomplete chassis-cab vehicle fitted with a dump truck body (VIN: 1FDNF70H2FV-----). The Ford truck was towing a 6 x 16 foot flatbed trailer upon which was a small construction vehicle (**Figure 21** above). The Ford's damage was limited to the hitch assembly and a steel backing plate (**Figure 22**). Its trailer damage included: a broken hitch connector, crumpled front connector frames

Figure 22: Ford's back showing steel protective plate and repaired hitch assembly (case photo #63)

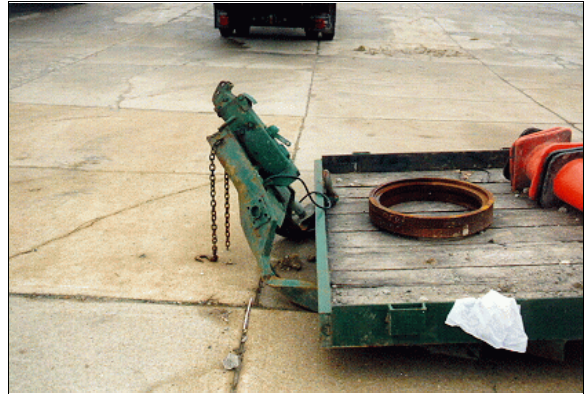
Figure 23: Deformed tongue of flat bed trailer towed by Ford; Note: trailer's tongue was bent upwards when trailer was jammed into back of Ford following trailer's impact by case vehicle's front (case photo #70)
