## ON-SITE AIR BAG INVESTIGATION

CASE NUMBER - IN98-021  
LOCATION - TEXAS  
VEHICLE - 1991 FORD TAURUS GL  
CRASH DATE - August, 1997

1. <i>Report No.</i> IN98-021	2. <i>Government Accession No.</i>	3. <i>Recipient's Catalog No.</i>	
4. <i>Title and Subtitle</i> On-Site Air Bag Fatality Investigation Vehicle - 1991 Ford Taurus GL Location - Texas		5. <i>Report Date:</i> December 4, 2002

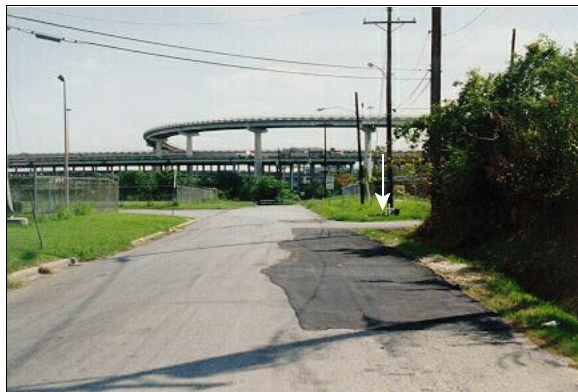
**Figure 1:** Case vehicle's southward travel path in southbound lane; Note: arrow indicates location of impact with culvert (case photo #01)

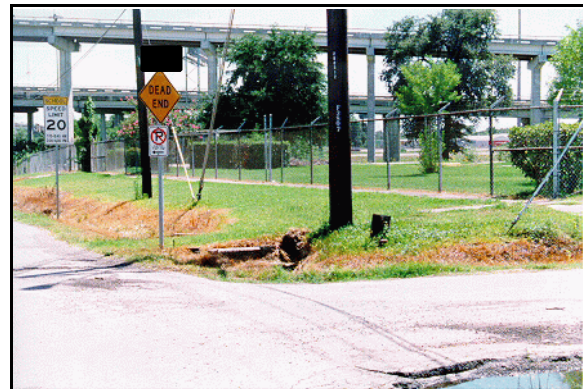
**Figure 2:** South-southwest view from southbound lane showing case vehicle's path of travel to impact with culvert on southwest corner of "Tee" intersection; Note: front right tire track in mud (case photo #03)

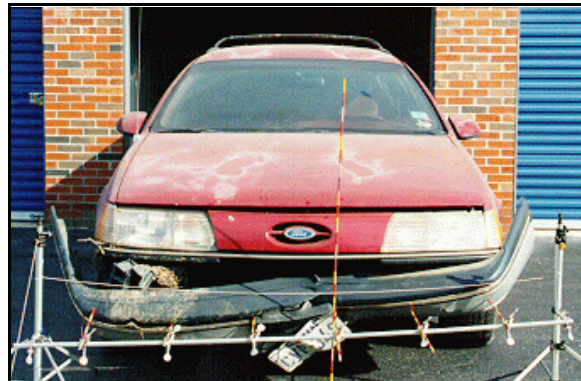
The front bumper (**Figure 3**) and front undercarriage (**Figure 4**) of the case vehicle impacted the concrete culvert, causing the case vehicle's driver supplemental restraint (air bag) to deploy. The case vehicle came to rest at impact.

**Figure 3:** Case vehicle's frontal damage at bumper level and below with contour gauge present; Note: front edge of bumper has been rotated downward and the right side of bumper has been pushed down relative to the left side (case photo #07)

The case vehicle's contact with the culvert involved the front end. Direct damage began at the front right bumper corner and extended laterally across the entire front end, a distance of 147 centimeters (57.9 inches), and vertically involved the bumper and undercarriage only (**Figure 3** above and **Figure 5**). Residual maximum crush was 19 centimeters (7.5 inches) between C<sub>2</sub> and C<sub>3</sub>. The case vehicle's wheelbase was unaltered from the crash. The vehicle's impact with the concrete culvert crushed the bumper and bumper fascia rearward and downward (**Figure 6**). The downward movement was minimal compared to the rearward deformation. The left frame rail was deformed upwards 7.6 centimeters (3 inches—**Figure 4** above). None of the case vehicle's tires were damaged, deflated, or physically restricted. Both the right and left fenders sustained induced damage as well.

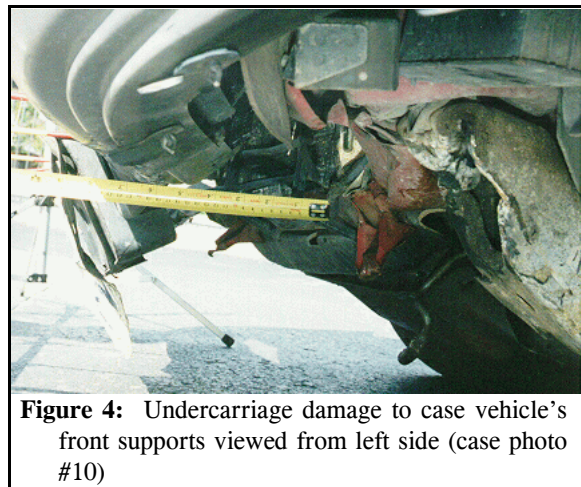
**Figure 4:** Undercarriage damage to case vehicle's front supports viewed from left side (case photo #10)

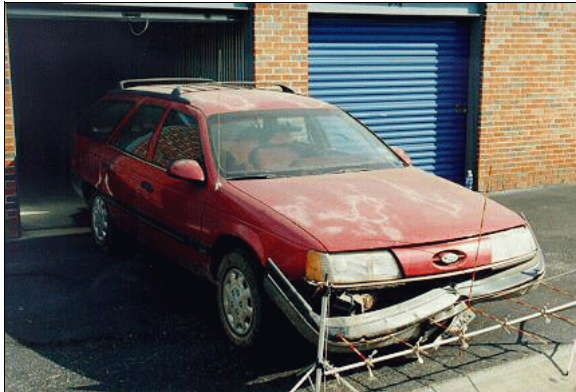
**Figure 5:** Damage to case vehicle's front bumper and undercarriage from culvert impact viewed from right of front (case photo #13)

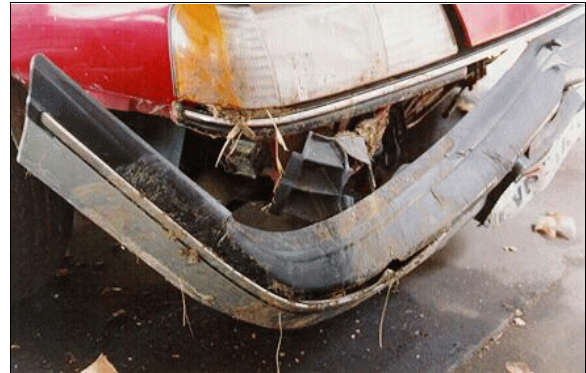
**Figure 6:** Close-up of damage to case vehicle's front right bumper and undercarriage area from impact with culvert (case photo #14)

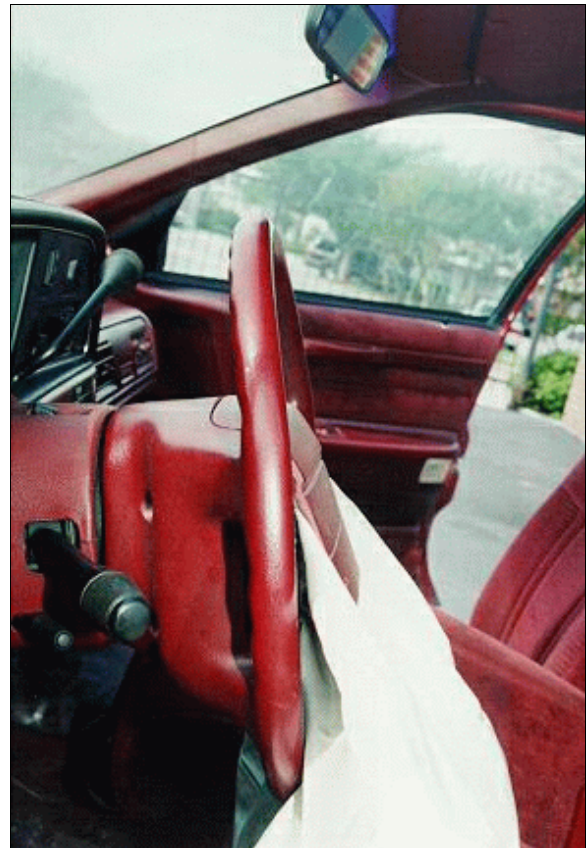
**Figure 7:** Case vehicle's steering wheel rim viewed from left showing slight deformation to rim (case photo #22)

An examination of the case vehicle's interior revealed very little contact evidence. The attorney would not allow the contractor to take apart the driver's knee bolster; therefore, movement of the energy absorbing steering column could not be assessed. There was a rectangular piece of plastic that appeared to be broken off immediately below the steering column but still not enough room for an assessment. The upper half of the steering wheel rim was bent toward the left instrument panel, 1.5 centimeters (0.6 inches), as a result of the driver loading the air bag, momentarily blocking the air bag's forward expansion, and causing the air bag to expand against and bend the steering wheel rim (**Figure 7**). There were

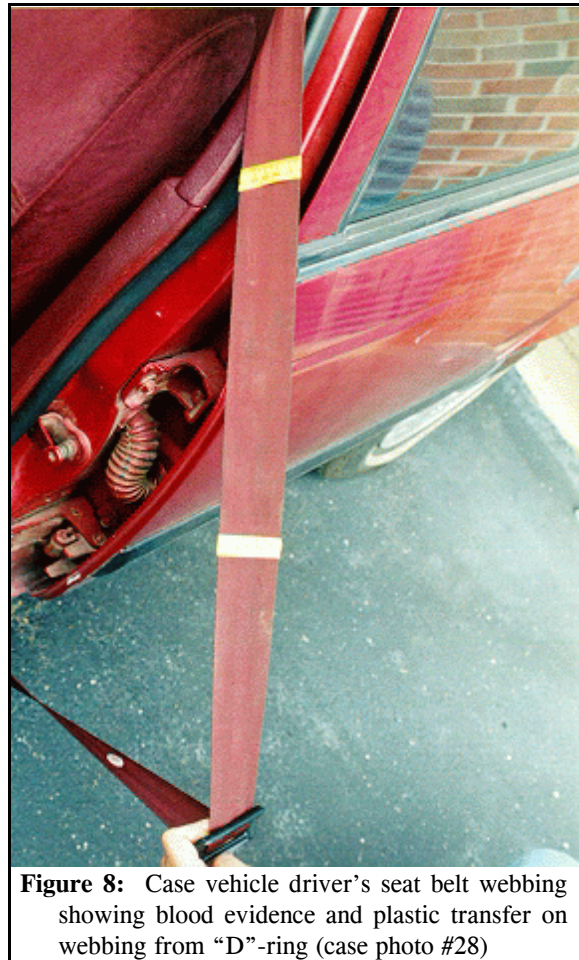
blood smears to the driver's seat belt webbing (**Figure 8**), air bag, as well as to the door sill on the front right passenger side. The toe pan in driver and front right passenger foot wells showed no evidence of intrusion.

**Figure 8:** Case vehicle driver's seat belt webbing showing blood evidence and plastic transfer on webbing from "D"-ring (case photo #28)

The case vehicle's driver [18-year-old, White (Hispanic) female; 157 centimeters and 56 kilograms (62 inches, 123 pounds)] was restrained by her available, active, three-point, lap-and-shoulder, safety belt system. In addition, there was mention of belt pattern bruising and/or abrasions to the driver's chest on the autopsy. The inspection of the driver's seat belt webbing, "D"-ring, and latch plate showed evidence of loading (i.e., heat abrasion to latch plate, dried blood on webbing, and plastic transfer to webbing from "D"-ring-**Figure 8** above).

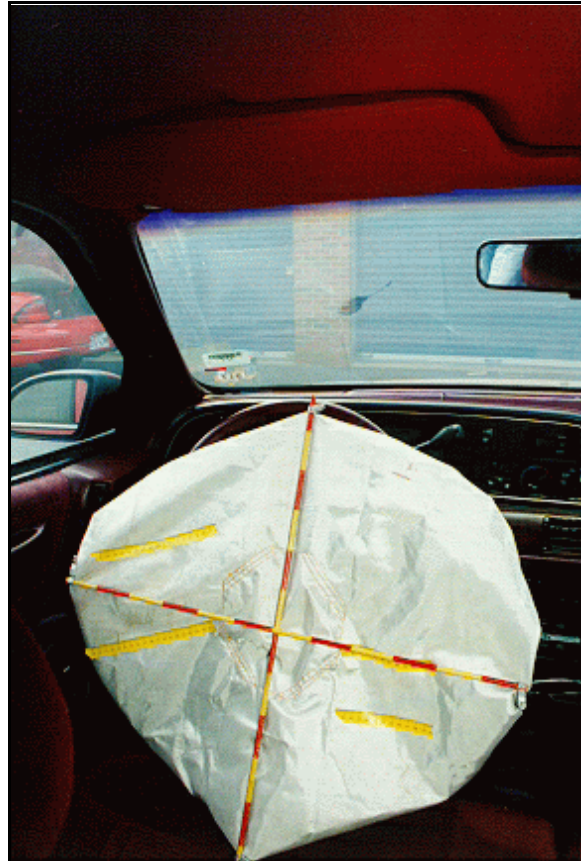
**Figure 9:** Vertical view of case vehicle's driver seating area showing deployed air bag and greenhouse area; Note: tape indicates skin transfers (case photo #21)

bag. The air bag contacted the driver on the chin and left side of her face (Figures 9 and 10 above) lifting her upwards and to the left. The driver’s inertia sensitive seat belt system locked up preventing the driver from contacting the left roof, the left roof side rail, the left “A”-pillar, and/or the windshield’s glazing. Although no direct contact evidence was found, based on occupant kinematics principles and injury information, the driver most likely contacted the left front window frame. The driver rebounded back down and to the right into her seat, coming to rest in her seat slumped forward still restrained by her seat belt.

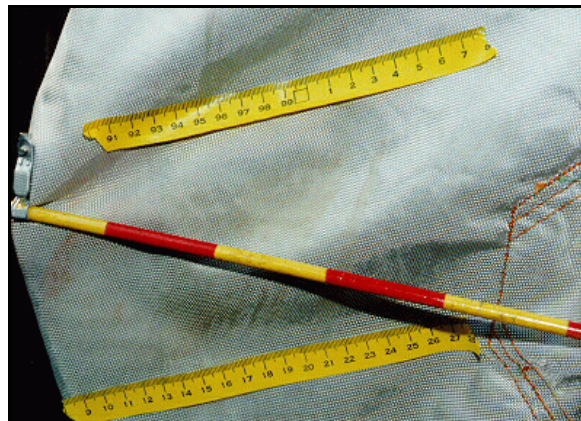
**Figure 10:** Close-up of case vehicle's driver air bag showing skin transfer on left side (case photo #24)
