TRANSPORTATION RESEARCH CENTER

ON-SITE CHILD AIR BAG-RELATED SERIOUS INJURY INVESTIGATION

CASE NUMBER - IN98-031
LOCATION - IOWA
VEHICLE - 1997 DODGE CARAVAN
CRASH DATE - November, 1998

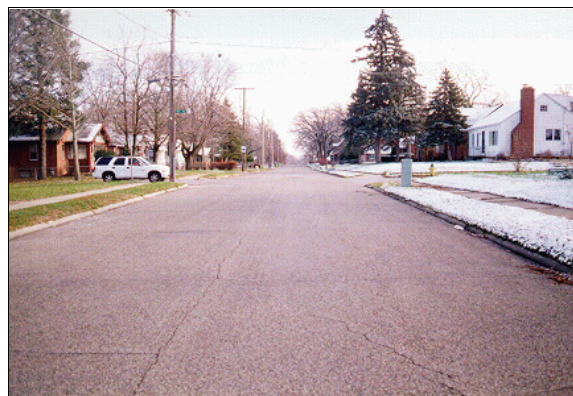
The case vehicle was traveling east in the eastbound lane (**Figure 1**) of a two-lane, undivided, city roadway and intended to continue in its easterly travel path after passing through an approaching four-leg intersection. The Intrepid had been traveling south in the southbound lane of an intersecting, two-lane, undivided, city roadway, and had stopped and waited while a northbound vehicle made a left-hand turn and traveled westbound at the four-leg intersection. The Intrepid accelerated southward, intending to continue its southerly travel path through the intersection. The case vehicle's driver did not have time to make any avoidance maneuvers prior to the crash. The crash occurred within the four-leg intersection of the two roadways; see **CRASH DIAGRAM** below.

Figure 1: Case vehicle's eastbound path of travel; Note: white vehicle at left shows Intrepid's southbound path of travel (case photo #01)

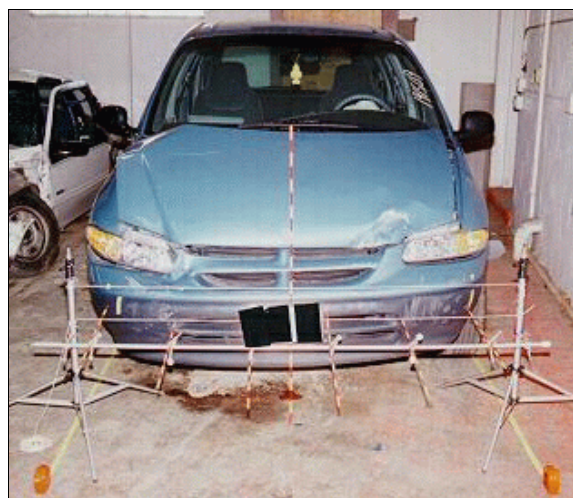
Figure 2: Case vehicle's frontal damage from impact with Intrepid; Note: contour gauge present at bumper level (case photo #12)

The case vehicle's contact with the Intrepid involved its entire front (**Figure 2** above and **Figure 5**). Direct damage began at the front left

bumper corner and extended, a measured distance of 146 centimeters (57.5 inches), along the bumper stopping 6 centimeters (2.4 inches) leftward of the front right bumper corner. Residual maximum crush was 8 centimeters (3.1 inches) at C₁. The case vehicle's wheelbase was unaltered from the crash. The case vehicle's front bumper fascia, grille, hood, and right headlight assembly were directly damaged and crushed rearward. None of the case vehicle's tires were damaged, deflated, or physically restricted. Both the right and left headlight and turn signal assemblies sustained induced damage as well as both the left and right fenders and the right front door's forward seam.

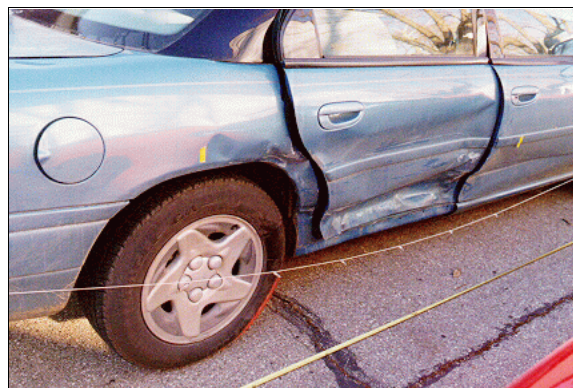
Figure 3: Intrepid's right-side damage; Note: yellow tape indicates width of direct damage (case photo #59)

Direct damage to the Intrepid began at the rear edge of the right front door–near the right rocker panel, and extended rearward to the mid-point of the right rear wheel well. There was direct contact damage to the right rear wheel and tire (**Figure 3** above). The Intrepid’s right front

and right rear door panels, right rear wheel well, right rear wheel, right rear tire, and the right side rocker panel were directly damaged and crushed inward.

Based on the vehicle inspection, the CDC for the Intrepid was determined to be: **03-RZEW-2 (80)** [residual maximum crush was 7 centimeters (2.8 inches) at C₄]. The WinSMASH reconstruction program, damage only algorithm, was used on the Intrepid's highest severity impact. The Total, Longitudinal, and Lateral Delta Vs are, respectively: 14.0 km.p.h. (8.7 m.p.h.), -2.4 km.p.h. (-1.5 m.p.h.), and -13.8 km.p.h. (-8.6 m.p.h.). The Intrepid was driven from the scene.

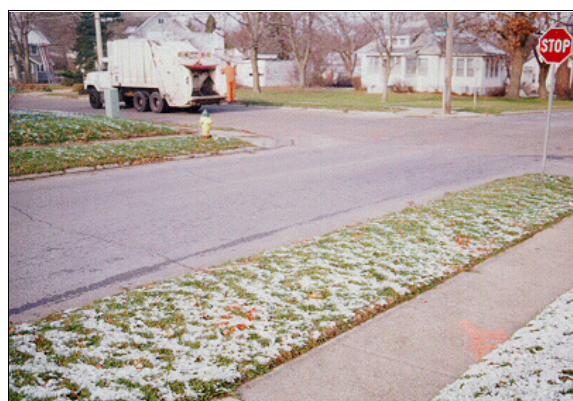
Figure 4: Northwest view from beyond Intrepid's final rest position on east roadside of four-leg intersection's south leg (case photo #10)

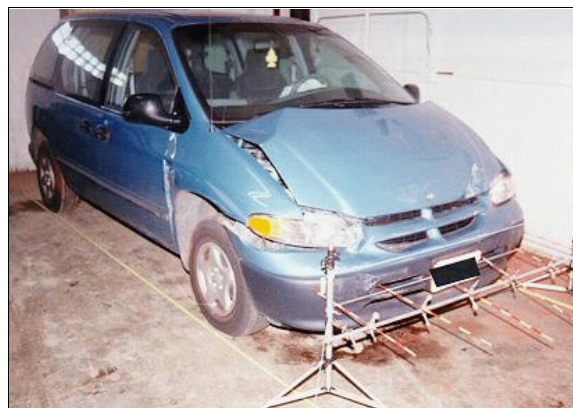
Figure 5: Case vehicle's frontal damage and slight rightward shift viewed from right of front (case photo #25)

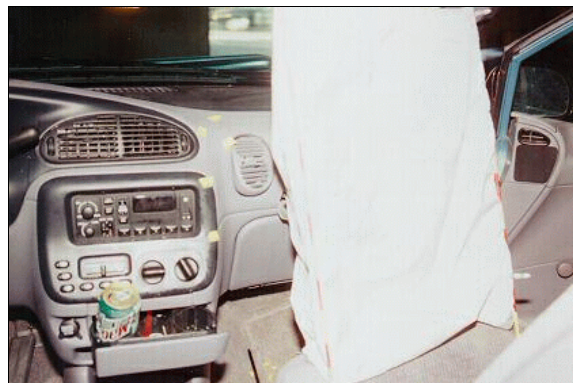
Inspection of the case vehicle's interior revealed that there was evidence of occupant contact to the right portion of the center instrument panel (**Figure 6**). This instrument panel contact occurred after the "out-of-position" front passenger was redirected leftward and forward, after she impacted the deploying front right passenger air bag, as the case vehicle was rotating clockwise as a result of maximum engagement. In addition, there were some scratches/nicks noted to the steering wheel rim, but it is unclear if these were contact related. Furthermore, there were scuffs noted to the back surface of the second seat's seat back from contact by the back right passenger. There was

Figure 6: Case vehicle's deployed front passenger air bag showing no obvious occupant contact evidence on air bag's front surface; Note: occupant contacts to center instrument panel (case photo #39)

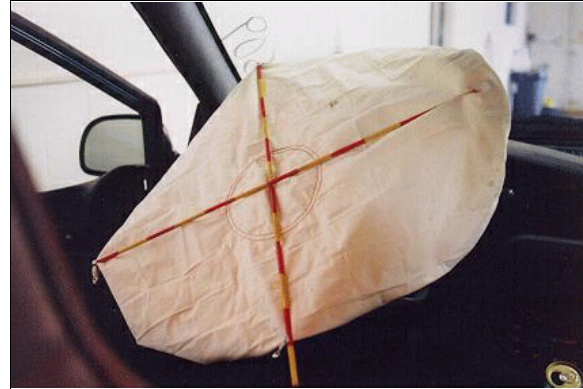
inspection of the air bag module's cover flaps and air bag revealed that the cover flaps opened at the designated tear points, and there was no evidence of damage during the deployment to the air bag or the cover flaps. The driver's air bag was designed with two tethers, each approximately 8 centimeters (3.1 inches) in width. The driver's air bag had no vent ports. The deployed driver's air bag was elliptical, with a height of 55 centimeters (21.7 inches) and a width of 65 centimeters (25.6 inches). An inspection of the driver's air bag fabric revealed faint black marks, smears, and smudges on the air bag's fabric (**Figure 7**), primarily along the right half.

Figure 7: Case vehicle's deployed driver air bag showing only faint marks, smears, and smudges, indicative of only possible occupant contact (case photo #35)

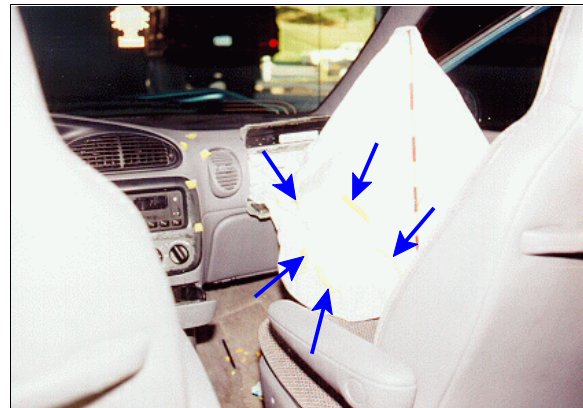
The front right passenger's air bag was located in the middle of the instrument panel. There were two, symmetrical, "H"-configuration, modular cover flap. The cover flap was made of a thick vinyl over a sheet metal frame/liner which acted as the hinge point for the deploying flaps. The flap's dimensions were: 28 centimeters (11.0 inches) at the forward horizontal seam, 28 centimeters (11.0 inches) at the rear (i.e., toward the windshield) horizontal seam, 7 centimeters (2.8 inches) vertically for the upper flap and 7 centimeters (2.8 inches) vertically for the lower flap. The profile of the case vehicle's instrument panel was flush with the leading edge of the cover flap. An inspection of the front right air bag module's cover flaps and air bag revealed that the cover flaps opened at the designated tear points, and there was no evidence of damage during the deployment to the air bag or the cover flaps. The front right passenger's air bag was designed without any tethers or vent port. The deployed front right air bag was rectangular with a height of approximately 60 centimeters (23.6 inches) and a width of approximately 46 centimeters (18.1 inches). An inspection of the front right passenger's air bag fabric revealed several clear, body fluid stains and one light pink stain on the left side surface of the air bag's fabric from occupant contact (**Figures 8 and 9**). In addition,

Figure 8: Case vehicle's deployed front right passenger air bag showing "out-of-position" passenger's contacts to air bag's fabric and center instrument panel; Note: tape and arrows outline area contacted on air bag's fabric and tape marks contact with center instrument panel (case photo #41)

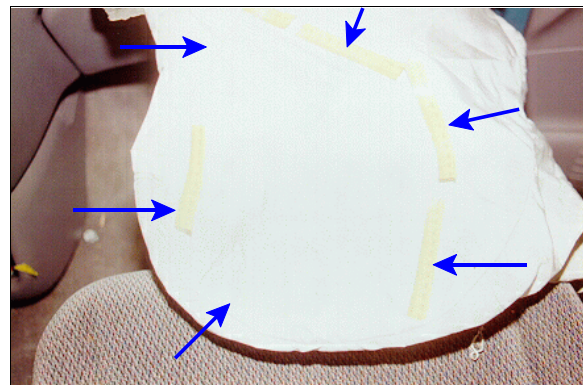
Figure 9: Close-up of the case vehicle's deployed front right passenger air bag showing unseated occupant's contact with left surface of air bag's fabric; Note: yellow tape and arrows outline perimeter of contact area (case photo #42)

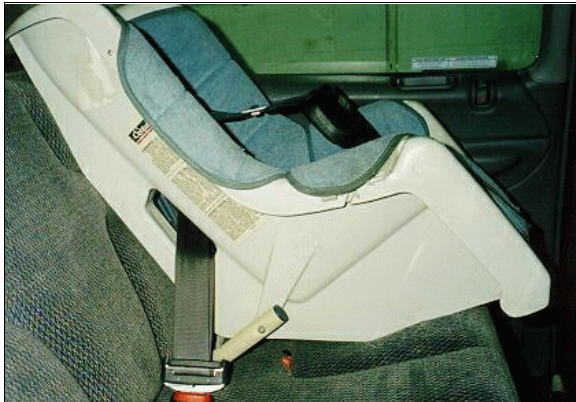
Figure 11: State specialist's photo of case vehicle's convertible child safety seat that was used to restrain second seat left passenger in case vehicle forward facing configuration (case photo #47)

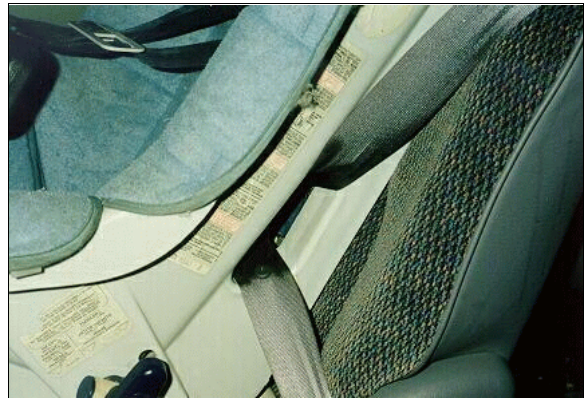
Figure 10: State specialist's photo of case vehicle's convertible child safety seat showing how second seated left passenger in child seat was secured by safety belts (case photo #46)

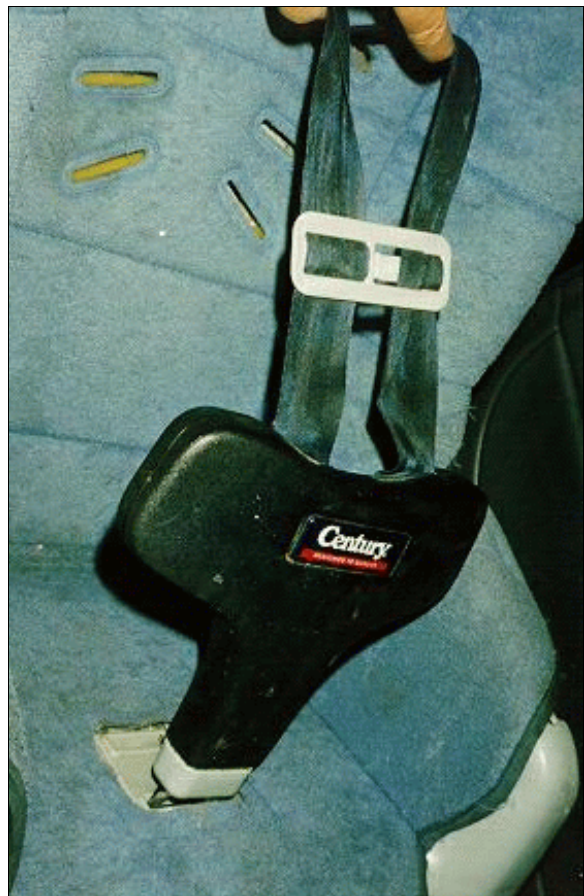
The Convertible Child Safety Seat (CCSS) used by the case vehicle's Second Seat Left Passenger was in the forward facing position at the time of the crash. The seat was manufactured by Century and was identified by Model name "2000 STE". The child safety seat had been removed from the case vehicle prior to this contractor's vehicle inspection. Although the child safety seat had been removed, an inspection of the seat by an Iowa occupant protection specialist revealed that the convertible seat was designed with a three-point harness connected to a pullover shield which buckled between the child's legs. The seat was also equipped with a three-position pullover "T"-shield. Furthermore, the inspection reveal that the child safety seat was properly attached to the vehicle by the safety belts inserted through the seat's side slots (Figure 10), and its adjustable seat angle was in the semi-reclined position (Figure 11), an approved angle for toddlers weighing 9 to 18 kilograms (20 to 40 pounds). Inspection of the child safety seat's webbing and shield by the Iowa specialist reportedly showed no evidence of loading; however, the child safety seat occupant's father indicated the shield's latch plate had been bent and he had repaired it (Figure 12).

Figure 12: State specialist's photo of case vehicle's convertible child seat used to restrain second seat left passenger in forward facing configuration; Note: chest clip's location reflects how it was worn at time of crash (case photo #48)

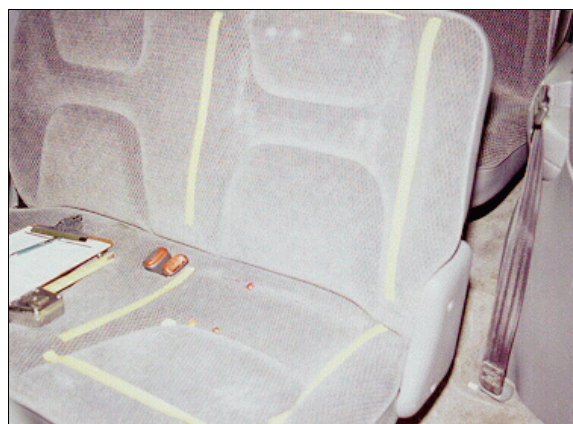
Figure 13: Imprint of child safety seat on fabric of case vehicle's second seat left; Note: child safety seat was not present during vehicle inspection (case photo #45)

vehicle's second seat (**Figure 13** above) and the absence of occupant contact to the back of the driver's bucket seat, indicates that this child seat was secured to the vehicle, and the child was restrained by the seat's harness. Thus, the second seat left passenger had his back against the safety seat and was restrained by the available child seat's harness with harness retainer clip and "T"-shield. The second row bench seat had non-adjustable seat tracks and the seat backs.
