VERIDIAN ENGINEERING CASE NO. CA98-036

**ON-SITE FATAL AIR BAG DEPLOYMENT INVESTIGATION
1997 PLYMOUTH VOYAGER MINIVAN**

**REDESIGNED AIR BAG DEPLOYMENT
1998 DODGE NEON**

FINAL CASE REPORT
VERIDIAN ENGINEERING CASE NO. CA98-036
1997 PLYMOUTH VOYAGER MINIVAN
AIR BAG DEPLOYMENT/OCCUPANT FATALITY
1998 DODGE NEON
REDESIGNED AIR BAG DEPLOYMENT
STATE OF CONNECTICUT
JUNE, 1998

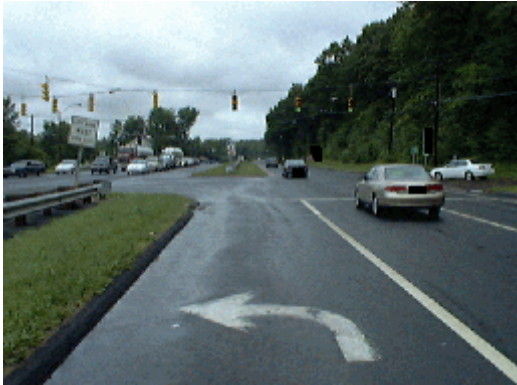
Prior to the crash, the Plymouth which was traveling northbound had stopped at a traffic light in the designated left turning lane (**Figure 1**). The driver of the Dodge, a 21 year old male, traveling southbound in the left through lane of a four lane, divided, 2.6 percent positive slope (southbound), dry asphalt, straight arterial roadway with a posted speed limit of 89 km/h (55 mph) reportedly observed the Plymouth stopped at the intersection (**Figure 2**). As he approached the intersection, the driver indicated that the Plymouth suddenly

Figure 1 - Trajectory of the Plymouth

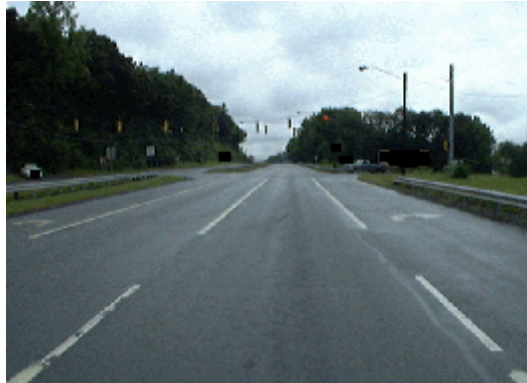
proceeded into the intersection. From scene physical evidence, the driver of the Dodge steered to the right and applied full brakes skidding 15.3 m (50.2') prior to the point of impact (POI).

The front of the Dodge struck the right side of the Plymouth which resulted in the deployment of the frontal air bag systems in both vehicles. The Dodge then rotated 45 degrees clockwise and came to the final rest position (FRP) within the intersection boundary in the right through lane. The Plymouth rotated counterclockwise and traveled 16.0 m (52.5') in a southeasterly direction and struck a W-beam strong post guardrail system located adjacent to the intersection roadway edge with the front right bumper of the vehicle (**Figure 5 - Scene Schematic**). The vehicle remained in contact with the guardrail at the FRP facing south.

Figure 2 - Trajectory of the Dodge

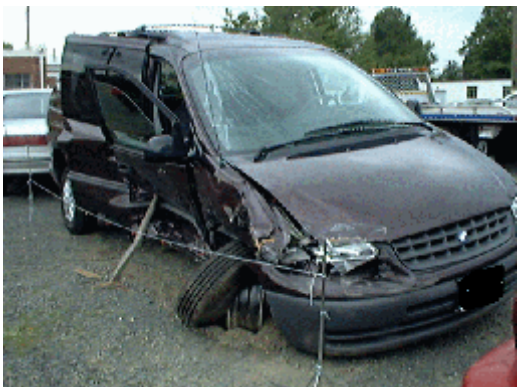
The impact to the side plane of the Plymouth resulted in a Collision Deformation Classification (CDC) code of 02-RYEW-3 while the related damage to the Dodge was classified 11-FDEW-2 (**Figures 3 & 4**). The impact with the guardrail resulted in a CDC of 12-FREW-1.

Figure 3
View of the right side impact damage and the right front bumper corner damage to the 1997 Plymouth Voyager

The 1997 Plymouth Voyager minivan was equipped with a dual front Supplemental Restraint System (SRS) which deployed as the result of the impact with the Dodge. Exterior damage to the Plymouth involved the right front tire and wheel, right front fender, right front door, right rear sliding door, the right sill, the roof, the A-pillar, B-pillar, the front bumper, the hood, and the windshield. The right front wheel was displaced rearward 13.5 cm (5.3"). The maximum crush of 34.3 cm (13.5") was located 178.4 cm (70.25") forward of the right rear axle and 12.7 cm (5.0") below the door rub strip. Crush values are listed in the following table:

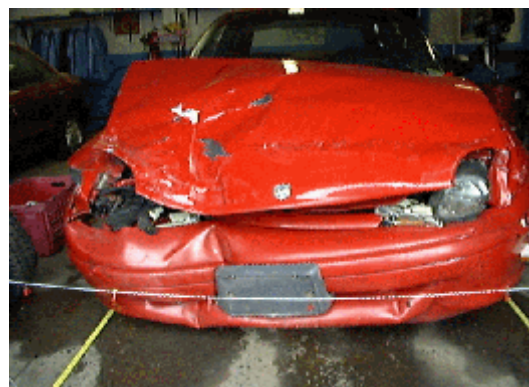
Figure 4
View showing contact damage to the frontal plane of the 1998 Dodge Neon

The 1998 Dodge Neon was equipped with a redesigned dual front Supplemental Restraint System (SRS) which deployed as the result of the impact with the Dodge. Exterior damage to the Dodge involved the front bumper, grille, both front fenders, right headlight, and the windshield. The right front wheel was displaced rearward 6.4 cm (2.5"). Maximum crush of 41.3 cm (16.25") was located 17.8 cm (7.0") right of the vehicle centerline. Crush values are listed in the following table:

The Collision Deformation Classification (CDC) for the Dodge was: 11-FDEW-2.

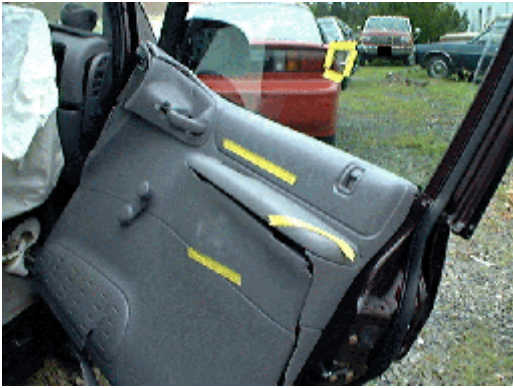
There were a series of white transfer marks noted on the interior surface of the right front door which were attribute to contact by the front right occupant during the first impact sequence with the Dodge (**Figure 6**). The highest mark was located on the right front side glazing which measured 1.3 cm (0.5") in diameter and located 55.9 cm (22.0") rearward from the base of the upper A-pillar and 17.8 cm (7.0") above the belt line. The next highest mark was located 44.5 cm (17.5") rearward from the instrument panel along the belt line and measured 17.1 cm (6.75") in length and 5.1 cm (2.0") in height. This was attributed to contact by the occupant's upper torso.

Figure 6
View of occupant contacts to the right front door surface of the Plymouth

The next white transfer mark which was 8.9 cm (3.5") long was located on the rear most portion of the door armrest. This was attributed to contact by the occupant's hip area. The lowest white transfer mark on the door surface was located at the bottom portion of the armrest in-line with the seat cushion surface. This mark measured 16.5 cm (6.5") in length and 9.5 cm (3.75") in height and was located 49.5 cm (19.5") rearward from the instrument panel.

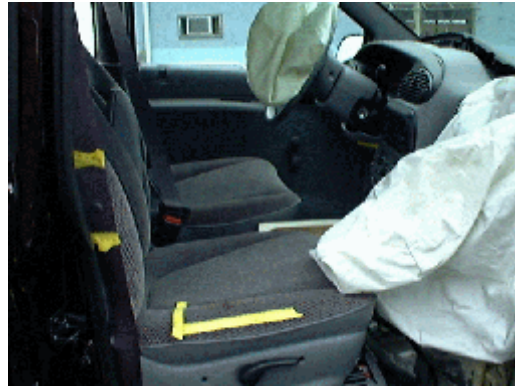
Figure 7
Lateral view of the front right seat in the Plymouth

The front right occupant seat was locked by damage, but appeared to be in the full rear adjusted position (**Figure 7**). It was displaced laterally with the in-board armrest in contact with the inboard armrest of the driver's seat. The leading edge of the seat cushion was located 29.2 cm (11.5") rearward from vertical plane of the instrument panel, 76.2 cm (30.0") from the toe pan, and 34.3 cm (13.5") above the floor pan. The seat cushion was inclined 13 degrees and measured 45.7 cm (18.0") longitudinally and 55.9 cm (22.0") laterally. There was a bodily fluid deposit on the outboard mid aspect of the seat cushion which was attribute to the position of the front right occupant's head at final rest.

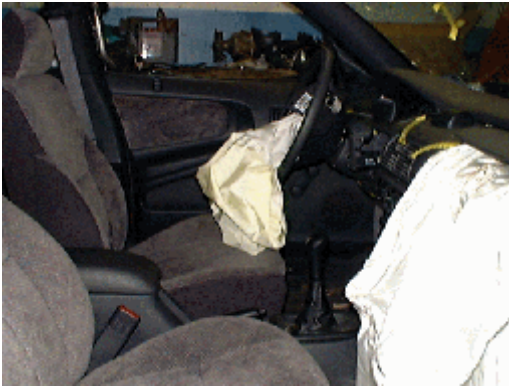
The front right occupant seat was locked by damage, but appeared to be in the full rear adjusted position (**Figure 8**). The leading edge of the seat cushion was located 17.8 cm (7.0") rearward from vertical plane of the instrument panel, 63.5 cm (25.0") from the toe pan, and 24.1 cm (9.5") above the floor pan. The

Figure 8
Lateral view of the front seat area in the Dodge

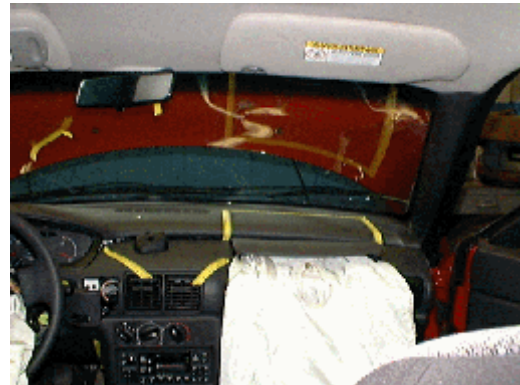
The front right air bag module cover flap opened upward and contacted the top surface of the instrument panel as noted by the outline transfer pattern on the vinyl surface. There was no contact evidence noted on the surface of the flap (**Figure 9**).

Figure 9
View of the instrument panel of the Dodge

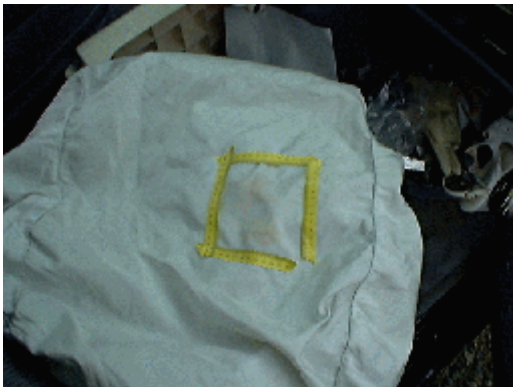
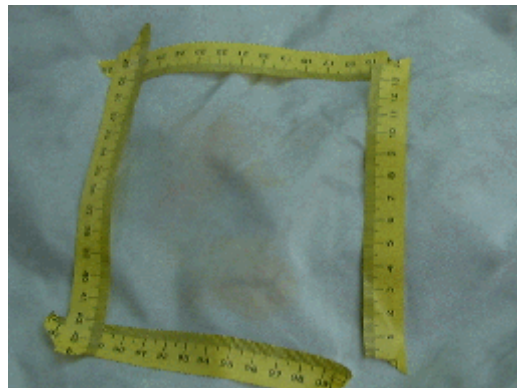
An oblong circular prominent peach color cosmetic transfer pattern (**Figures 10 & 11**) was present on the vertical face of the air bag which was attributed to contact by the front right occupant's facial area. The pattern measured 10.2 cm (4.0") vertically and 8.9 cm(3.5") laterally. It was located 26.7 cm (10.5") below the top of the vertical face of the air bag and 10.2 cm (4.0") left of the right vertical seam edge line.

Figure 10
View of the cosmetic transfer on the front right air bag in the Plymouth

Figure 11
Close-up view of the cosmetic transfer on the front right air bag surface in the Plymouth

The concentration of the cosmetic transfer indicated that the air bag was fully inflated by the time the occupant made contact. This was an important factor in determining the occupant's position at the time of SRS

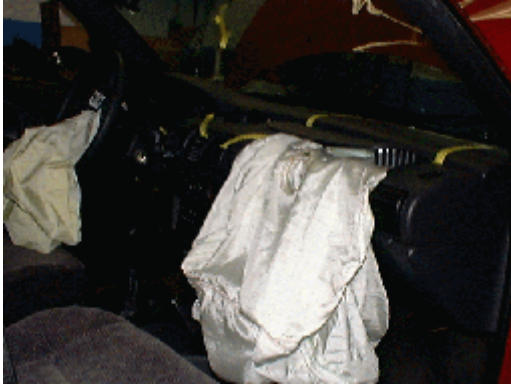
The front right air bag module cover flap opened upward and contacted the top surface of the instrument panel as noted by the outline transfer pattern on the vinyl surface. The air bag module cover measured 34.3 cm (13.5") laterally and 15.2 cm (6.0") longitudinally. The left side of the module was located 16.5 cm (6.5") right of the vehicle centerline. The leading edge of the flap was recessed 19.1 mm forward of the leading vertical plane of the instrument panel. The hinged edge of the module cover was located 39.2 cm (14.254") rearward from the base of the windshield (**Figure 12**). There was no contact evidence noted on the surface of the flap.

Figure 12
Angular view of the dual front air bags in the Dodge

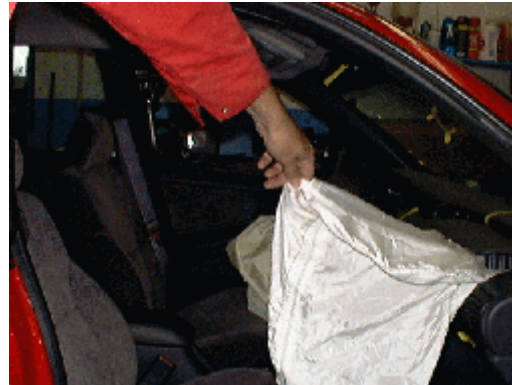
Figure 13
View showing the excursion of the front right air bag in the Dodge

The tethered front right air bag had a post crash rearward excursion which measured 44.5 cm (17.5") from the inflator unit (**Figure 13**). The vertical height of the front surface measured 50.8 cm (20.0") and the width measured 48.3 cm (19.0"). There were four tethers attached to the face of the air bag which were 7.6 cm (3.0") wide and 50.8 cm (20.0") in length. The top two tethers were attached by a red double stitch row to the front of the air bag near the respective perimeter sides and located 48.3 cm (19.0") from the inflator unit. The bottom tethers were also attached adjacent to the respective side seams and located 91.4 cm (36.0") from the inflator unit.
