**VERIDIAN ON-SITE AIR BAG RELATED CHILD PASSENGER
FATALITY INVESTIGATION
VERIDIAN CASE NO. CA98-049
VEHICLE: 1997 FORD EXPLORER
LOCATION: VIRGINIA
CRASH DATE: SEPTEMBER 1998**

Contract No.
DTNH22-94-D-07058

<p>14. <i>Sponsoring Agency Code</i></p>	
<p>15. <i>Supplementary Notes</i> On-site investigation of a front-to-rear crash that resulted in frontal air bag deployment and the death of a 5 year old male front right child passenger.</p>			
<p>16. <i>Abstract</i> This on-site investigation focused on the injury mechanisms and cause of death of a 5 year old male front right passenger of a 1997 Ford Explorer. The Explorer was equipped with frontal air bags for the driver and front right passenger positions that deployed as a result of an off-set, front-to-rear crash with a 1988 Dodge Caravan. The 31 year old female driver of the Ford Explorer was distracted to her right as she approached the slower moving Dodge Caravan. As she redirected her attention forward, the driver detected the Caravan and braked in an attempt to avoid the crash. The front left area of the Explorer impacted the back right area of the Caravan resulting in moderate damage to both vehicles. The unrestrained chi

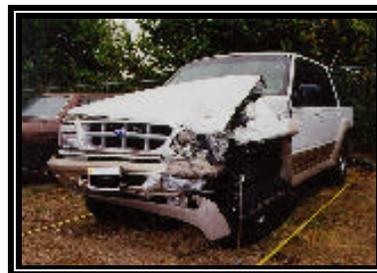
Figure 1. Front left view of the damage to the Ford Explorer.

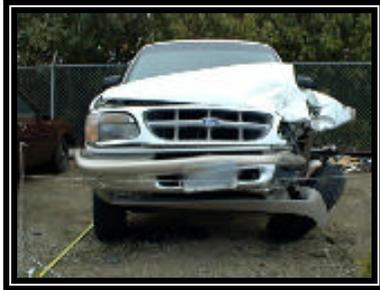
The Ford Explorer sustained moderate severity frontal damage from its impact sequence with the rear of the Dodge Caravan. Maximum crush was 35.6 cm (14.0") located at the left corner of the front bumper. The direct contact damage began at the front left corner and extended 44.4 cm (17.5") inboard (**Figure 3**). The damage deformed the full frontal width of the bumper profile resulting in a combined direct and induced damage length of 136.5 cm (53.75"). The crush profile at bumper level (**Figure 4**) was as follows:

Figure 3. Frontal view of the Ford Explorer.

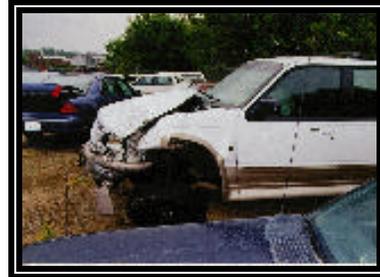
C1 = 35.6 cm (14.0"), C2 = 8.9 cm (3.5"), C3 = 5.1 cm (2.0"), C4 = 2.5 cm (1.0"), C5 = 0.6 cm (0.25"), C6 = 0 cm.

The damage extended rearward into the leading edge of the left front fender, the left front suspension, and the left front tire and wheel assembly. The crash forces transmitted into the left front suspension fractured the steering spindle. The components damaged by the impact included the front bumper, left headlamp assembly, grille, hood, radiator support, left front fender, and the left front suspension. The Collision Deformation Classification (CDC) for this impact was 12-FLEW-2.

Figure 4. Profile view of the damage pattern to the Ford Explorer.

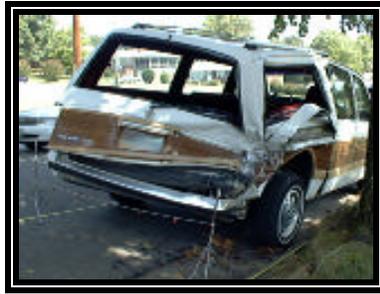
The right rear of the Dodge Caravan sustained moderate damage with a maximum crush value of 36.8 cm (14.5") located at the right bumper corner (**Figure 5**). The direct contact damage began at the corner and extended 55.9 cm (22.0") inboard. The combined direct and induced damage was 157.4 cm (62.0") that included the full width of the rear plane. The crush profile at bumper level (**Figure 6**) was as follows: C1 = 0 cm, C2 = 0 cm, C3 = 5.1 cm (2.0"), C4 = 16.5 cm (6.5"), C5 = 26.0 cm (10.75"), C6 = 36.8 cm (14.5"). The CDC for this impact was 06-BREW-3.

The front left corner of the Explorer crushed the bumper, liftgate, right D-pillar, and the right quarter panel. The damage also shattered the backlight and the right quarter window glazing.

Figure 5. Right rear view of the Caravan's damage.

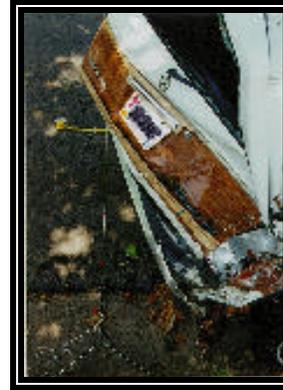
Figure 6. Overhead view of the Caravan's crush profile.

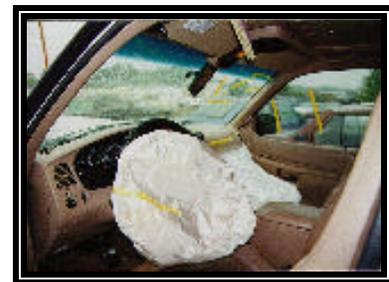
The 1997 Ford Explorer was equipped with a frontal air bag system for the driver and right passenger positions. The system consisted of two crash sensors mounted to the upper radiator support panel, a safing sensor that was located in the front left kick panel, a control/diagnostic module located in the center instrument panel, a steering wheel mounted driver air bag module, and the front right passenger air bag module located in the right mid instrument panel. The system deployed (**Figure 7**) as a result of the impact sequence with the rear of the Dodge Caravan.

Figure 7. Deployed frontal air bag system.

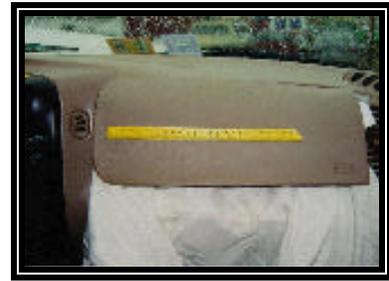
The front right child passenger was displaced forward by the pre-crash braking and was in a close proximity to the front right air bag module cover at deployment. The cover flap initially contacted the child as evidenced by a two closely spaced subtle, semi-circular scuff marks along the leading edge of the flap. The scuff marks began at the lower left corner of the flap and extended 22.9 cm (9.0") laterally to the right, extending 2.5 cm (1.0") vertically onto the face of the flap.

The front right air bag deployed from a single cover flap (**Figure 8**) that was 16.5 cm (6.5") in height and 37.1 cm (14.625") in width. The flap was hinged at the top surface, therefore it opened in an upward direction. The front right air bag membrane was a non-tethered design that measured 55.9 cm (22.0") in height and approximately 81.3 cm (32.0") in width. The bag was vented by two 5.1 cm (2.0") diameter ports located at the lateral aspects of the bag.

Figure 8. Front right air bag cover flap.

The forward positioned child passenger contacted the cover flap at deployment and was subsequently contacted by the expanding air bag membrane. As a result of the later contact sequence, the child altered the deployment path of the bag. The bag expanded against the windshield and the mid instrument panel, below the location of the module cover. Air bag fabric transfers identified the expansion points.

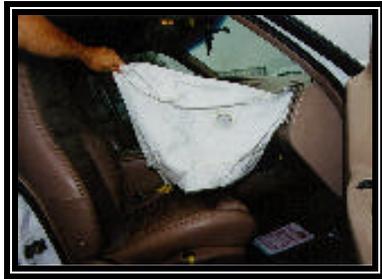
The front right child passenger of the Ford Explorer was in a presumed upright seated position with the seat adjusted to a mid track position. The seat back was adjusted to an angle of 19 degrees aft of vertical. The seat cushion sloped rearward at an angle of 19 degrees of horizontal. With the seat adjusted to this position, the horizontal distance between the seat back support and the vertical profile of the mid mount passenger air bag module cover (**Figure 10**) was 74.9 cm (29.5"). The leather seat covering probably resulted in a reduced friction coefficient between the child's clothing and the cushion as compared to a fabric seat covering. The child was not restrained by the manual belt system.

Figure 10. Excursion of the passenger air bag and adjusted position of the seat.

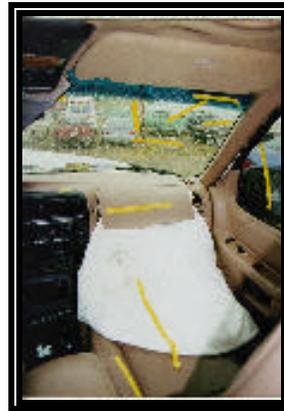
Figure 11. Child passenger trajectory and air bag contact points.

The child initiated a forward trajectory in response to the 12 o'clock impact force as the air bag membrane expanded from the module (**Figure 11**). The air bag membrane expanded against his lower lip, anterior chin, neck, and right face resulting in a heavy tissue abrasions. The expanding air bag subsequently contacted his anterior right shoulder and upper arm which resulted in a continuous abrasion pattern of the

The combination of module cover flap contact and air bag expansion under the child passenger's chin and anterior neck, hyperextended his head and displaced him in an upward and rearward direction. The child sustained an unspecified cervical fracture. It was unknown if cord damage occurred.
