SCI/NASS COMBINATION CASE REPORT

CASE NUMBER - NASS-99-09-071J

VEHICLE - 1998 TOYOTA CAMRY

CRASH DATE - June, 1999

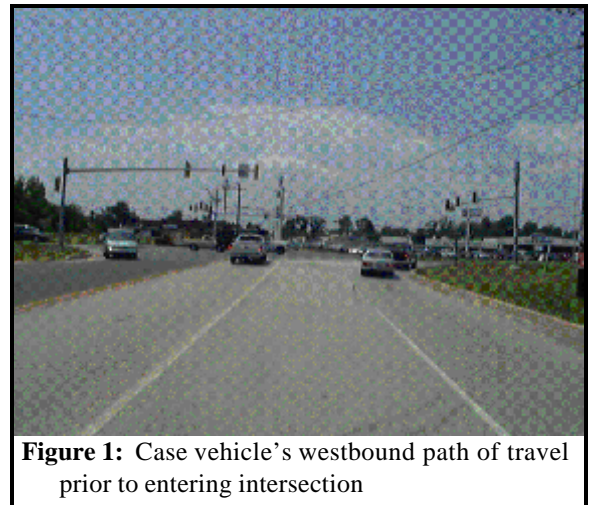
The bituminous roadway for the case vehicle was straight with a negative slope of over 2% heading into the point of the crash. The bituminous roadway for vehicle #2 was straight and level at the point of the crash. It was daylight at the time of the crash with the roadways being dry and without defects. The posted speed limit is 89 km.p.h. (55 m.p.h.) for both roadways. Both roadways were controlled by a cycled automatic on-colors signal with turn arrow. The case vehicle's east/west roadway was divided by a double white line, with a solid white line dividing the left and right turn lanes and bordered with solid white

fog and raised curbs (**Figure 1**, above). Vehicle #2's north/south trafficway was divided by a raised grassy median, with a painted solid white line on the outside and inside of the left and right turn lanes respectively and a painted dashed white line dividing the two through lanes. The northbound lanes were bordered by a painted solid yellow line along the median and a painted solid white fog line and raised curb along the west edge of the roadway.

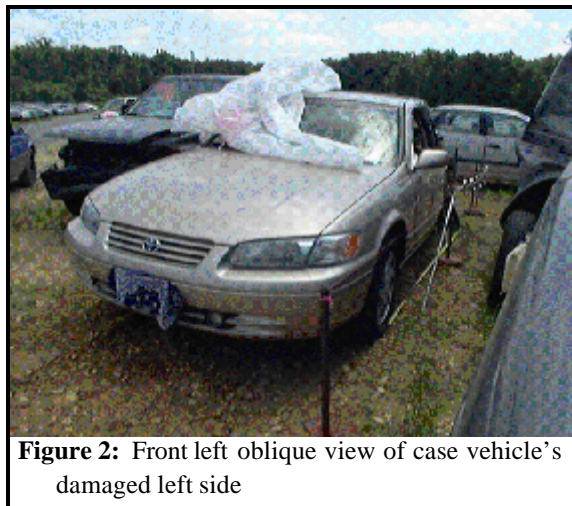
The case vehicle's initial contact with vehicle #2 involved the left side from just behind the left B-pillar (**Figures 2-3**). Field L began 156 centimeters (61.4 inches) behind the left front axle and extended rearward 224 centimeters (88.2 inches). Direct damage from the case vehicle's initial impact extended from 178 centimeters (70.1 inches) behind the left front axle and extended rearward 203 centimeters (79.9 inches). The maximum crush to the case vehicle's left side was a measured 53 centimeters (20.1 inches) and was located between C2 and C3 (**Figure 4**). The

Figure 2: Front left oblique view of case vehicle's damaged left side

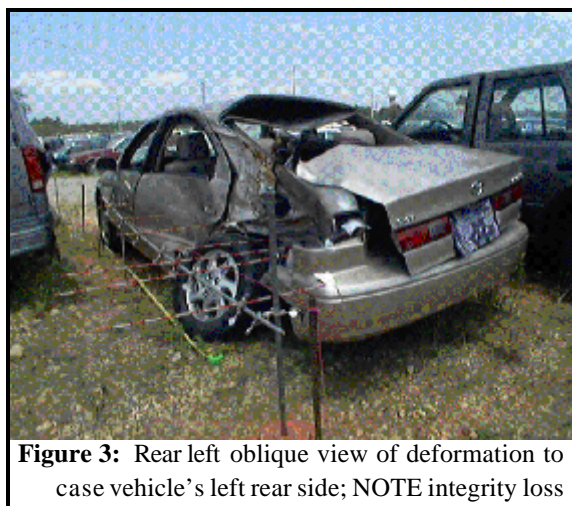
Figure 3: Rear left oblique view of deformation to case vehicle's left rear side; NOTE integrity loss

wheelbase on the left side was lengthened 6 centimeters (2.4 inches) with the right side being shortened 6 centimeters (2.4 inches). All of the case vehicle's doors remained closed with the left rear being jammed and inoperable. The glazing was disintegrated to the case vehicle's back light and left rear door. There was 12 centimeters (4.7 inches) of intrusion to the case vehicle's left C-pillar and 9 centimeters (3.5 inches) to the left rear door panel.

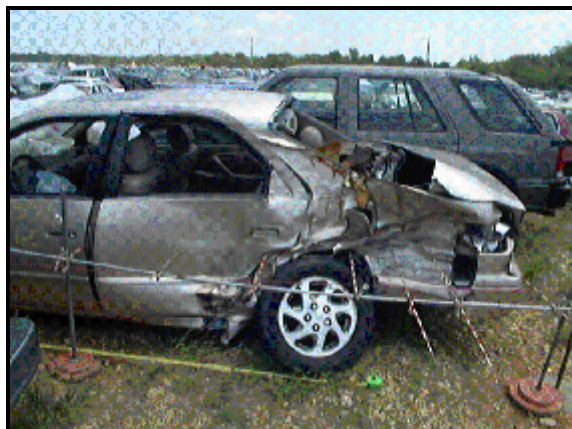
The CDC was determined to be: **10-LZAW-4 (-70)** for the case vehicle (maximum crush was 53 centimeters [20.1 inches] on the left side). No reconstruction program was used on the case vehicle's left side impact due to one of the collision conditions (i.e., vehicle #2 is a heavy truck) being beyond the scope of the WinSMASH reconstruction program; however, this contractor's visually estimated total Delta V for the left side impact is between 27 km.p.h. (17 m.p.h.) and 34 km.p.h. (21 m.p.h.).

Figure 4: Straight on view of deformation to case vehicle's left side with contour gauge set up; NOTE: integrity loss to back light and door window

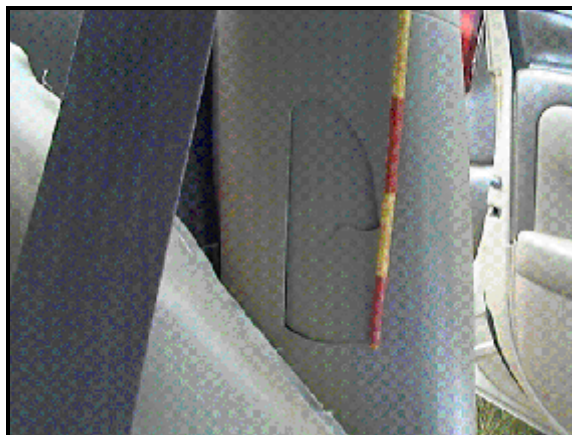
An examination of the case vehicle's interior showed evidence of contact to the case vehicle's left front door panel including the armrest, front left door window sill, driver's front air bag and the driver's left side air bag. Suspected damage from the deploying case vehicle driver's side air bag was found to the left B-pillar (**Figure 5**). Movement of the case vehicle's energy absorbing steering column was not measured for compression. The case vehicle driver's knee bolster showed evidence of scuffing.

Figure 5: View of suspect damage to case vehicle's left B-pillar from side air bag deployment

The driver's seat back-mounted side air bag deployed as a result of the case vehicle's left side impact from vehicle #2. The driver's side air bag deployed through a seam on the outboard side of the driver's seat back. The seam along the seat back side was 23 centimeters (9.1 inches) vertically. The side air bag was 31 centimeters (12.2 inches) longitudinally and 30 centimeters (11.81 inches) vertically (**Figure 9**). The driver's side air bag had no vent ports and was not tethered. Suspected damage due to the deploying case vehicle driver's side air bag was found to the left B-pillar (**Figure 5**, above).

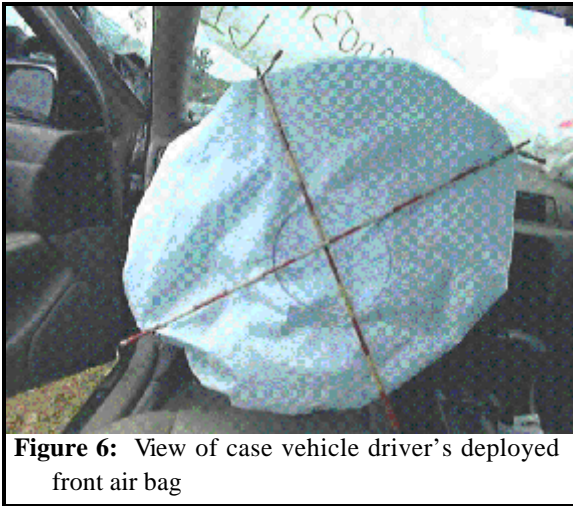
Figure 6: View of case vehicle driver's deployed front air bag

An inspection of the case vehicle's driver air bag revealed no visible evidence of contact by the case vehicle driver (**Figure 6**). There was, however, an area on the lower half of the air bag that was stained red with translucent flakes which the investigator thought was food since it was also on the front right passenger's air bag cover flaps. An inspection of the driver air bag module's cover flaps showed no visible evidence of direct contact from the driver.

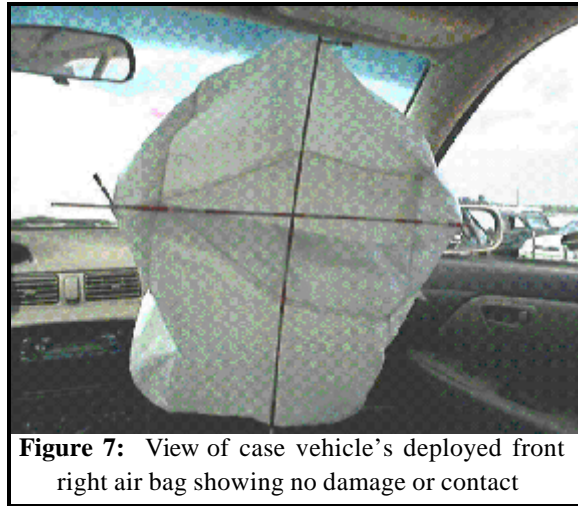
Figure 7: View of case vehicle's deployed front right air bag showing no damage or contact

The front right passenger air bag module's cover flaps opened properly along the tear points. Inspection of the cover flap revealed no damage other than a red stain with translucent flakes which the investigator thought was food since it was also on the driver's air bag. Examination of the front right passenger air bag showed no evidence of damage or contact (**Figure 7**).

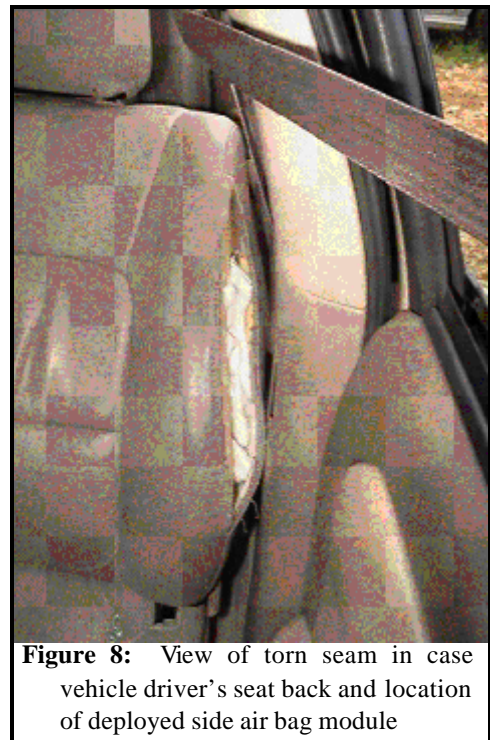
Figure 8: View of torn seam in case vehicle driver's seat back and location of deployed side air bag module

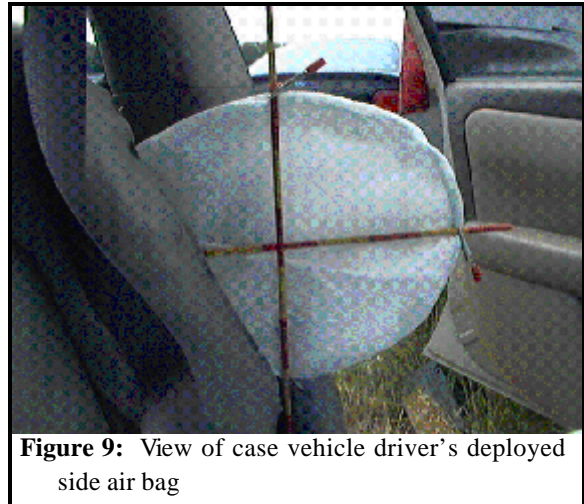
Figure 9: View of case vehicle driver's deployed side air bag

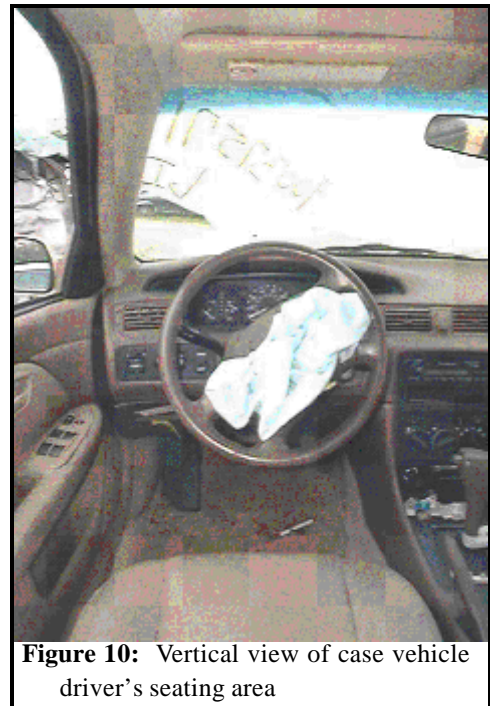
The case vehicle's driver made no avoidance maneuvers; subsequently her pre-impact posture remained unchanged prior to impact. The case vehicle's impact with vehicle #2 resulted in the case vehicle's driver continuing slightly forward but primarily leftward, contacting the left knee bolster with her left knee, the steering column with her right knee, the side arm rest and door panel with her abdomen and upper torso as the case vehicle rotated counterclockwise. The driver's seat belt usage kept her in her seat during the approximately 170 degree rotation. At final rest the driver remained conscious and in her seat (**Figure 10**).

Figure 10: Vertical view of case vehicle driver's seating area
