**REDESIGNED AIR BAG SPECIAL STUDY (RABSS)
SCI TECHNICAL SUMMARY REPORT**

NASS RABSS CASE NO. 1999-43-801C

RABSS VEHICLE - 1999 FORD CROWN VICTORIA

CRASH DATE - MAY, 1999

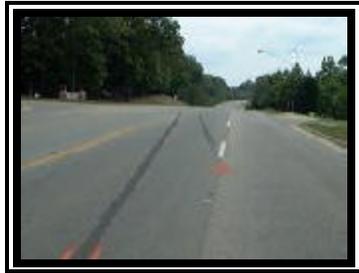
The 24 year old male driver of the 1999 Ford Crown Victoria was operating the police vehicle eastbound (**Figure 1**) responding to a call at a computed speed of 89 km/h (55 mph) and proceeding straight when he observed the Buick Century turn left (west) across his lane of travel.

Figure 1. Eastbound approach for the 1999 Ford Crown Victoria.

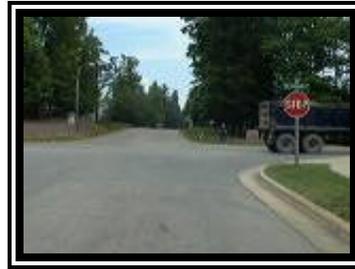
pre-impact skid marks documented at the crash site) in avoidance remaining in the eastbound travel lanes prior to the collision. The 1995 Buick Century was driven by a 24 year old male who was operating the vehicle northbound (**Figure 2**) when he failed to detect the stop sign or Ford as he turned left (west) at a police reported speed of 8 km/h (5 mph).

Figure 2. Northbound approach for the 1995 Buick Century.

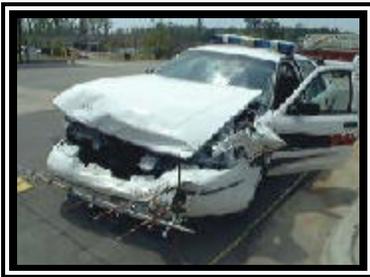
The Ford Crown Victoria sustained moderate frontal damage as a result of the impact with the Buick Century (**Figure 3**). The direct contact damage encompassed the full frontal width resulting in a combined direct and induced damage length (Field L) of 136.0 cm (53.5 in). Six crush measurements were documented at the level of the bumper: C1= 48.0 cm (18.9 in), C2= 43.0 cm (16.9 in), C3= 33.0 cm (13.0 in), C4= 26.0 cm (10.2 in), C5= 18.0 cm (7.1 in), C6= 13.0 cm (5.1 in). Damage was noted to the hood which was displaced up and rearward from engagement against the side surface of the Buick. A rubber transfer was documented to the front bumper from the left front wheel/tire of the Buick. The left fender was displaced rearward which restricted the left front wheel/tire (not deflated). The windshield was fractured from exterior forces (only). Post-crash damage was also noted to the left front door from a forced opening. Direct damage was documented to the right front door from the secondary (sideslap) impact (**Figure 4**). The direct contact damage began 57.0 cm (22.4 in) rearward of the right front axle and extended 37.0 cm (14.6 in) rearward. The impact resulted in a combined direct and induced damage length (Field L) of 56.0 cm (22.0 in). Six crush measurements were documented at the level of the sill: C1= 1.0 cm (0.4 in), C2= 3.0 cm (1.2 in), C3= 5.0 cm (2.0 in), C4= 5.0 cm (2.0 in), C5= 4.0 cm (1.6 in), C6= 2.0 cm (0.8 in).

Figure 3. Frontal damage to the 1999 Ford Crown Victoria.

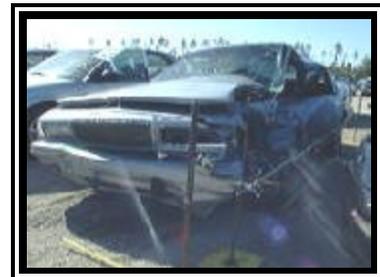
Figure 5. Left side damage to the 1995 Buick Century.

The Buick Century sustained moderate left side damage as a result of the impact with the Ford Crown Victoria (**Figure 5**). The direct contact damage began 45.0 cm (17.7 in) forward of the left rear axle and extended 240.0 cm (94.5 in) forward. The impact resulted in a combined direct and induced damage length (Field L) of 292.0 cm (115.0 in). Direct contact damage was noted to the left fender along with the left front

and rear doors, which restricted both doors and shattered the side glazing. The A-pillar was displaced rearward from the longitudinal element of the impact force. The roof and side rails were displaced laterally from the lateral element of the impact force. The left front wheel was displaced laterally to the right which restricted its movement (not deflated). Direct damage was also documented to the left quarter panel from the secondary (sideslap) impact. The direct contact damage began 43.0 cm (16.9 in) rearward of the left rear axle and extended 43.0 cm (16.9 in) rearward.

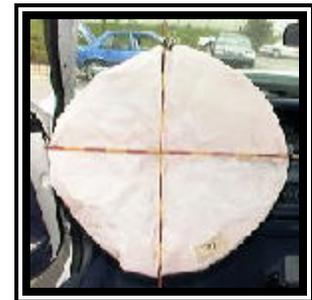
The 1999 Ford Crown Victoria was equipped with redesigned frontal air bags for the driver and front right passenger positions. The air bags had deployed as a result of the crash. The driver air bag was housed in the center of the steering wheel with a single cover flap design hinged at the top aspect. The flap measured 14.5 cm (5.7 in) in width and 11.0 cm (4.3 in) in height. Although no contact evidence was identified on the exterior surface of the module cover flap, blood spattering was identified at the lower left quadrant of the air bag attributed to the driver's forearm injury. The NASS researcher measured the diameter of the driver air bag at 58.0 cm (22.8 in) in its deflated state (**Figure 6**). The bag was tethered by two internal straps and vented by two ports located at the 11 o'clock and 1 o'clock sectors on the rear aspect of the air bag.

Figure 6. 1999 Ford Crown Victoria redesigned driver air bag.

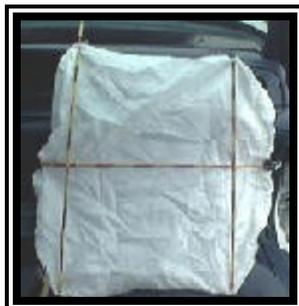
Figure 7. 1999 Ford Crown Victoria redesigned passenger air bag.

The front right passenger air bag deployed from a mid-mount module in the right instrument panel with a single cover flap design hinged at the top aspect. No contact evidence was identified on the air bag or exterior surface of the module cover flap. The cover flap was rectangular in shape which opened in an upward direction toward the windshield and measured 39.5 cm (15.6 in) in width and 16.0 cm (6.3 in) in height. The NASS researcher measured the passenger air bag at 60.0 cm (23.6 in) in width and 65.0 cm (25.6 in) in height in its deflated state (**Figure 7**). No tether straps were present. The bag was vented by one port located at the 9 o'clock sector on the side aspect of the air bag. No cutoff switch was reported for the front right air bag.

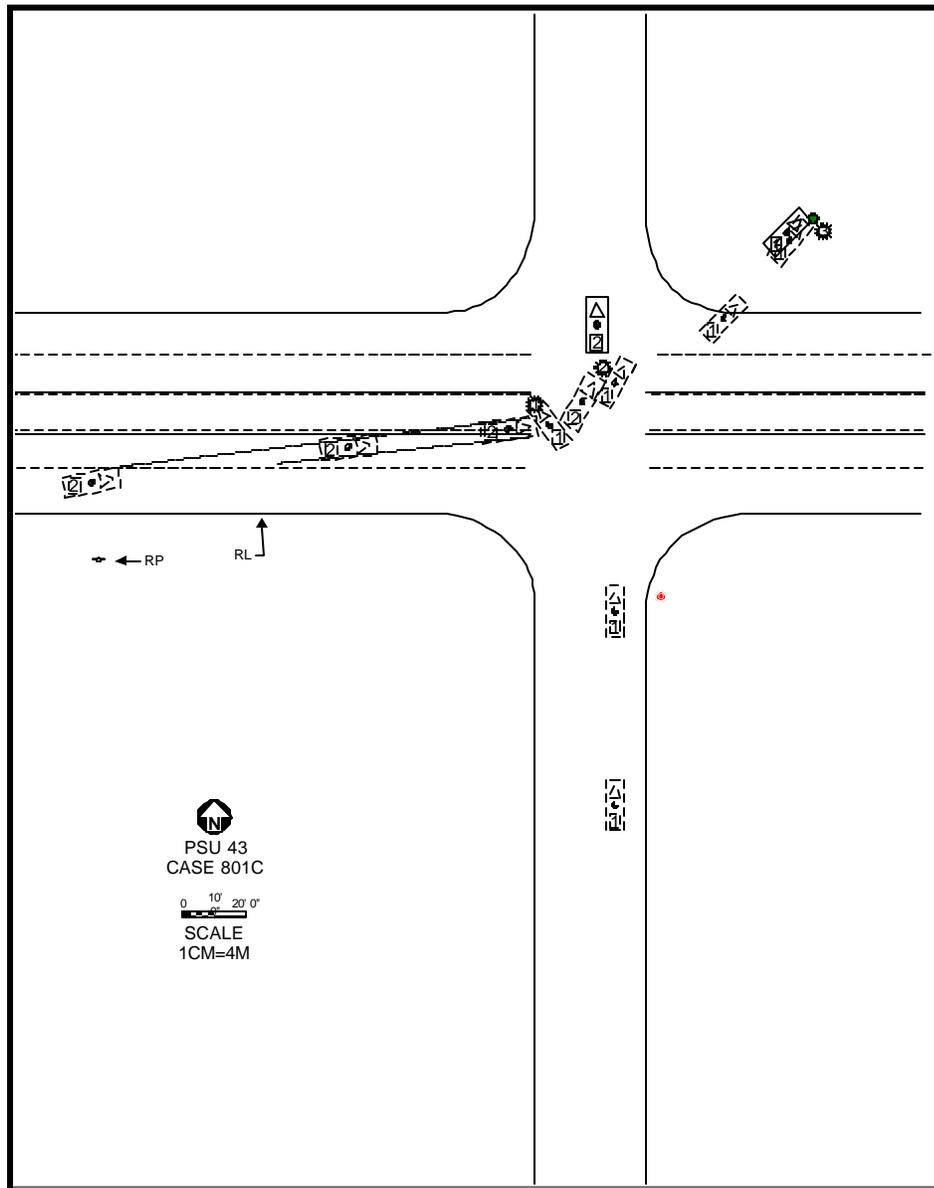
Figure 8. NASS Scene Diagram

This two-vehicle crash occurred during the early morning hours of May, 1999. At the time of the crash, it was dark (street lighted) with no adverse conditions as the roads were dry. The crash occurred in the eastbound lanes of an 5-lane east/west undivided asphalt roadway (see **Figure 8 - page 6**). Traffic control at the scene included stop signs for north/southbound traffic. The speed limit at the crash scene was 72 km/h (45 mph).
