Remote, Redesigned Air Bag Special Study

Dynamic Science, Inc., Case Number (1999-049-110K)

1999 Ford Contour

**Technical Report Documentation Page**

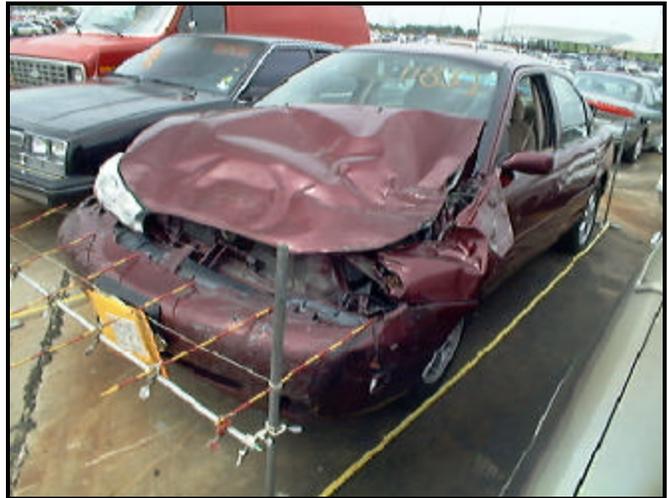
**Figure 1.** Exterior, Vehicle 1 (1999 Ford Contour)

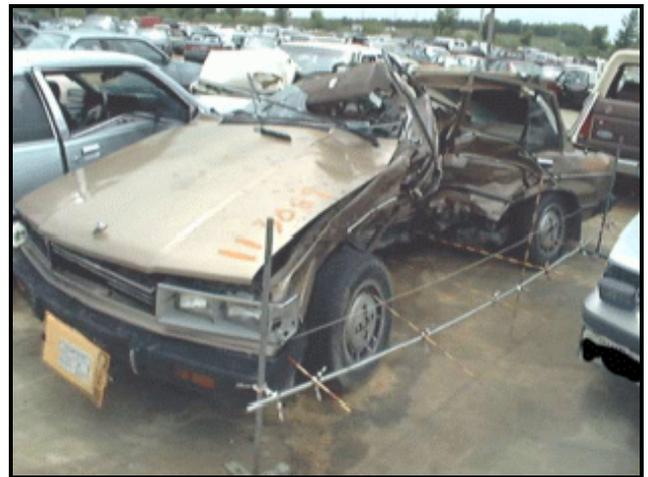
**Figure 2.** Exterior, Vehicle 2 (1982 Nissan Maxima)

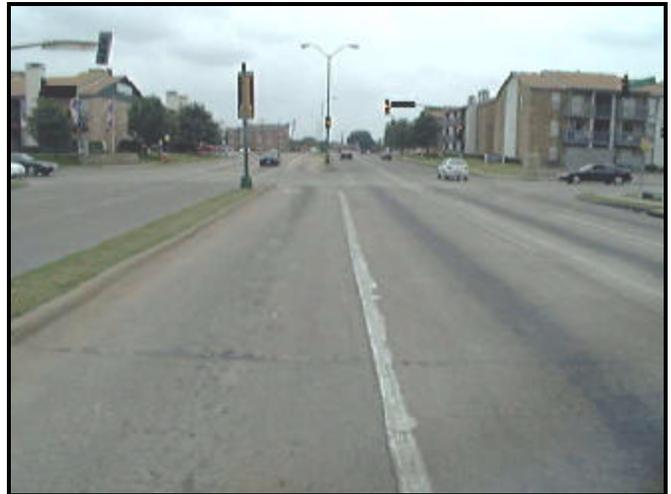
**Figure 3.** Crash scene. Vehicle 1 approach path.

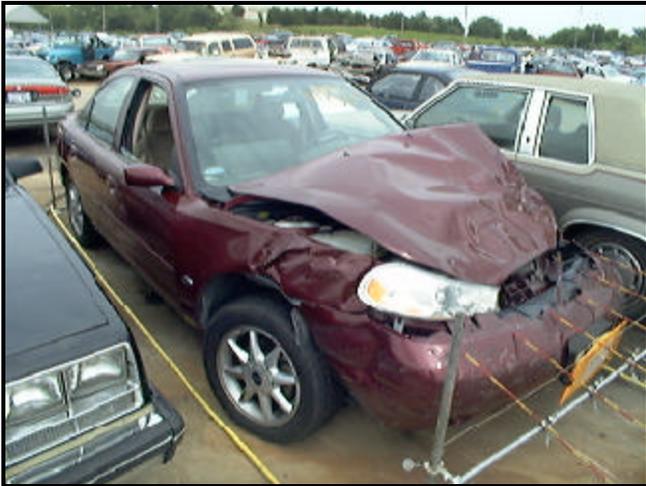
**Figure 4.** Exterior, Vehicle 1 (1999 Ford Contour)

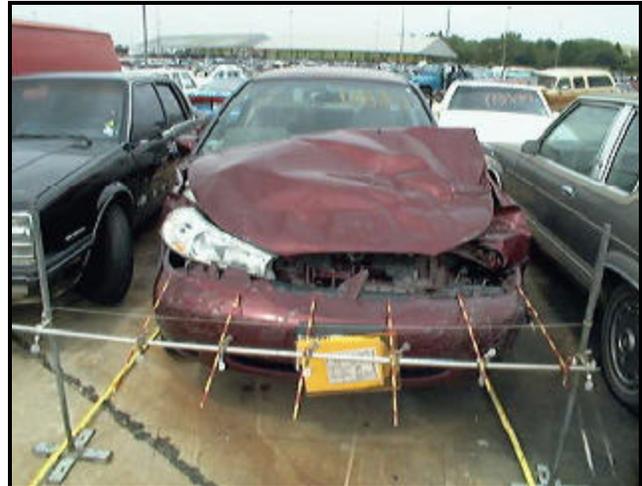
**Figure 5.** Exterior, Vehicle 1 (1999 Ford Contour)

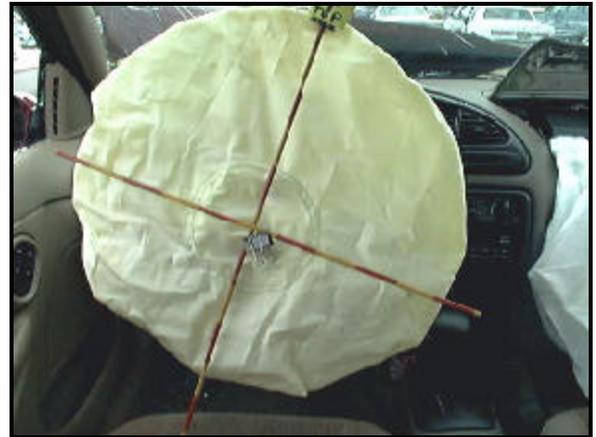
The front left air bag was housed in the steering wheel hub and was concealed by symmetrical H-configuration cover flaps which were not damaged in the crash. The circular air bag was equipped with two vent ports and two tether straps. Contact evidence consisting of a small scuff mark was found on the upper right quadrant of the front of the bag. Two tears were found on the lower half of the back of the bag from an unknown source.

**Figure 6.** Driver's frontal air bag.

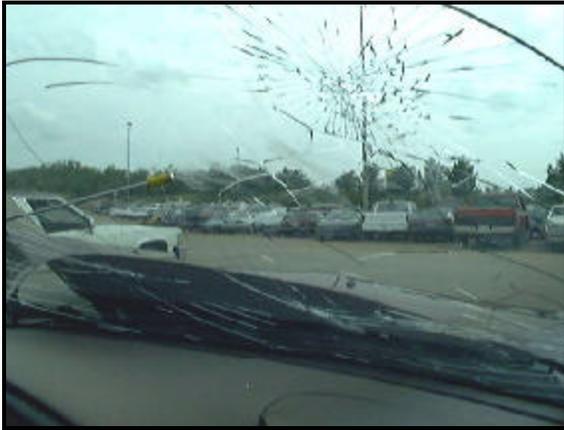
**Figure 7.** Interior, case vehicle. Windshield contact.

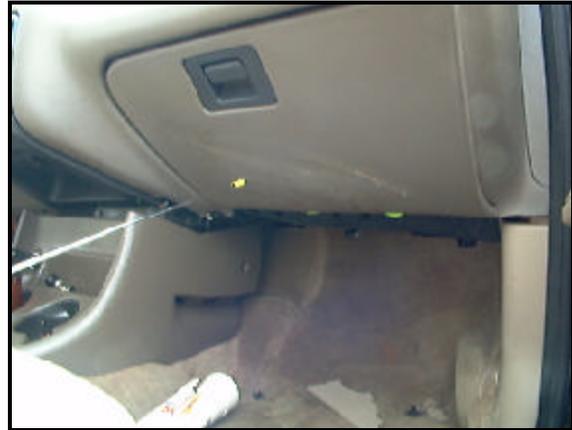
**Figure 7.** Interior, case vehicle. Glove box contact.
