Remote, Redesigned Air Bag Special Study
FOR NHTSA'S INTERNAL USE ONLY
Dynamic Science, Inc., Case Number (1999-073-027J)
1999 Dodge Dakota
Indiana
April/1999

This remote investigation focused on the redesigned air bag system deployment of a 1999 Dodge Dakota compact pickup truck. This serious injury crash occurred in April, 1999 in the early morning. The weather was clear and the bituminous roadway was dry. The crash occurred on a two-way, divided, interstate highway. The roadway is comprised of seven travel lanes; three eastbound lanes, one eastbound deceleration lane, and three westbound lanes. Eastbound traffic is separated from westbound traffic by a raised concrete "jersey" barrier. The speed limit for this road is 89 kmph (55 mph). There are no traffic controls at the area of impact. The road is level at this location.

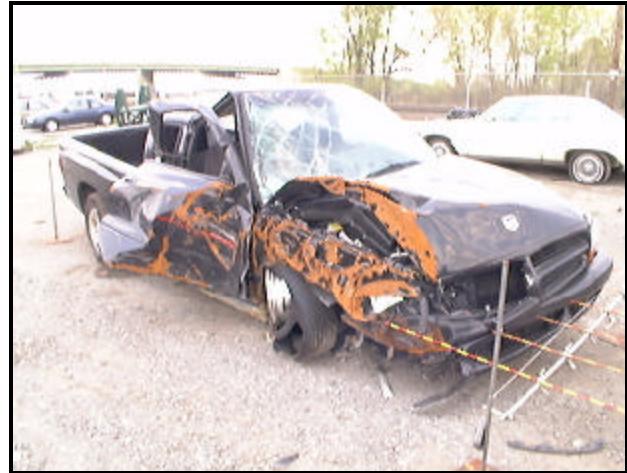
Figure 1. Exterior, Vehicle 1 (1999 Dodge Dakota)

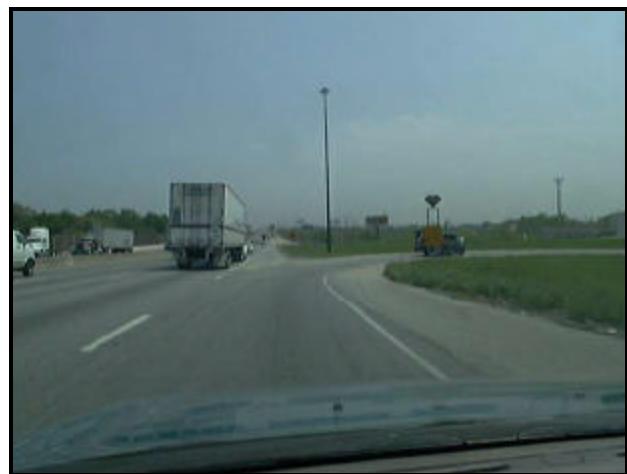
Figure 2. Crash scene. Vehicle 1 approach path.

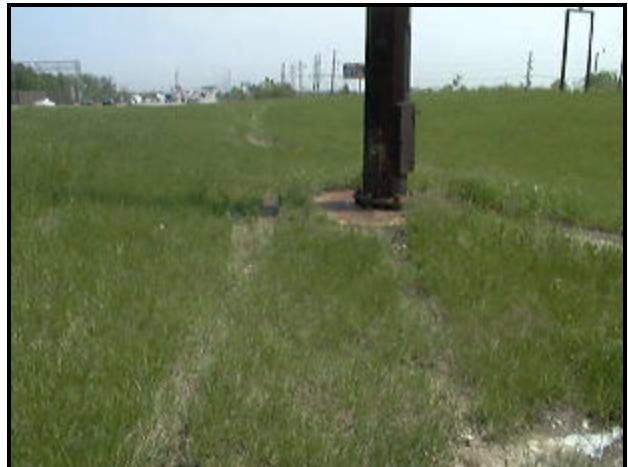
As the driver attempted to exit the highway at a very high rate of speed, he lost control of the vehicle. Vehicle 1 departed the right roadside. Vehicle 1 continued eastbound down the grassy roadside and struck a large steel light support pole with the front plane (12FREE8). Vehicle 1 rotated clockwise after impact and came to final rest to the east of the pole facing southwest.

Figure 3. Crash scene. Vehicle 1 point of impact.

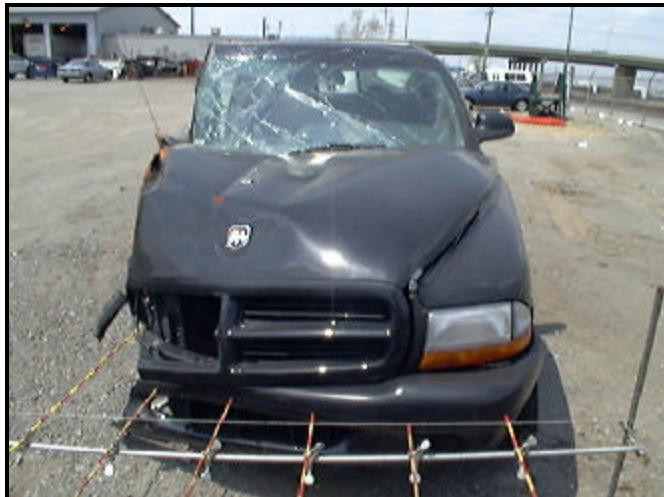
Figure 4. Exterior, Vehicle 1 (1999 Dodge Dakota pickup)

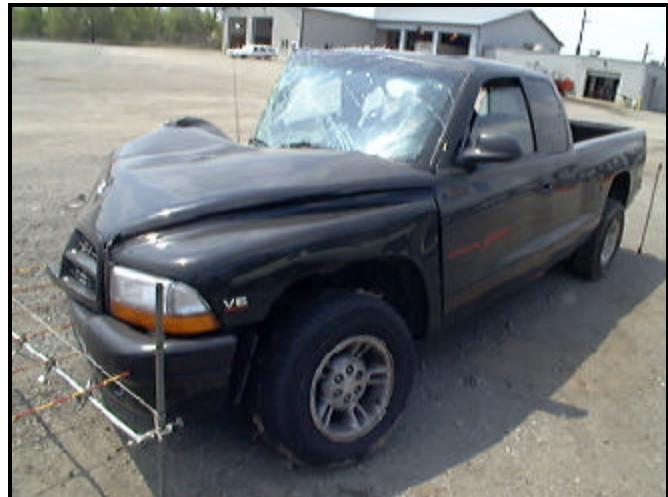
Figure 5. Exterior, Vehicle 1 (1999 Dodge Dakota pickup)

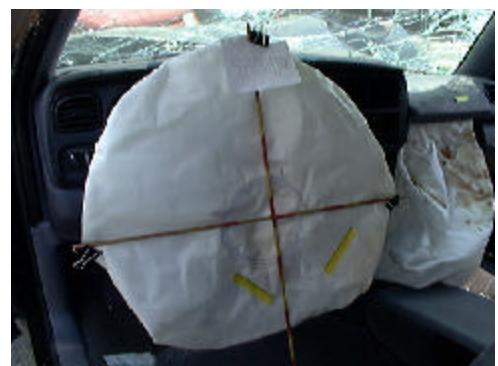
The front left air bag was housed in the steering wheel hub and was concealed by asymmetrical H-configuration cover flaps which were not damaged in the crash. The circular air bag was equipped with two tether straps and no vent ports. Contact evidence consisting of “orange faint stains” was found primarily on the top half of the front of the bag. The air bag was not damaged.

**Figure 6.** Driver's frontal air bag.

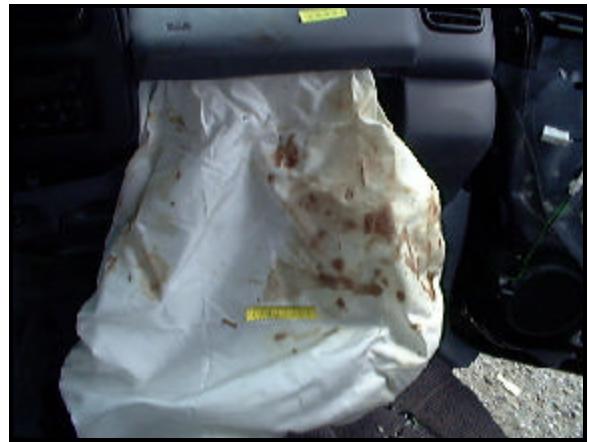
The front right air bag was housed in the mid-instrument panel position and was housed by a single inverted D-shaped cover flap which was not damaged in the crash. The rectangular air bag was not equipped with tether straps or vent ports. Contact evidence consisting of blood was found on the top half of the front and back of the bag. Blood was also bound on the cover flap. The air bag was not damaged.

Figure 7. Passenger's air bag contact evidence.
