Remote, Redesigned Air Bag Special Study

Dynamic Science, Inc., Case Number (1999-075-055K)

1999 Dodge Durango

1. Report No. 1999-075-055K	2. Government Accession No.	3. Recipient Catalog No.	
4. Title and Subtitle		5. Report Date October 6, 1999	
		6. Performing Organization Report No.

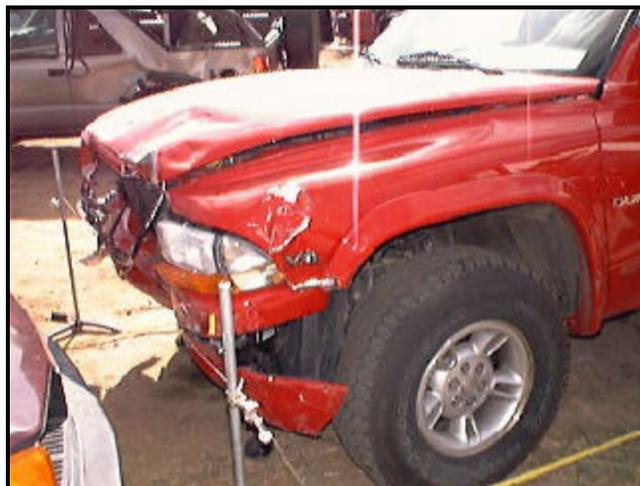
Figure 1. Exterior, Vehicle 2. Event 1 damage.

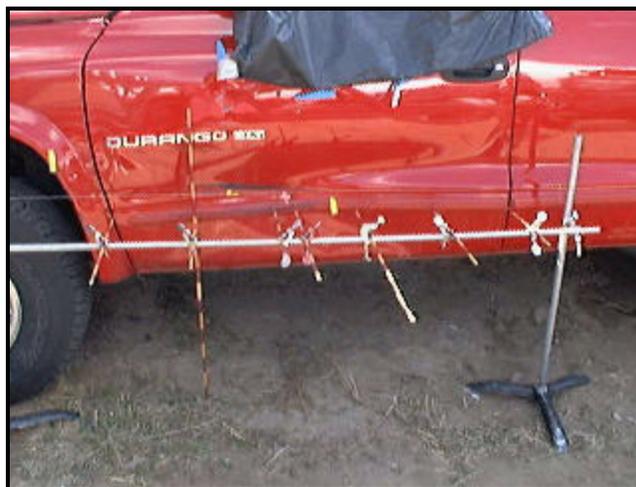
Figure 2. Exterior, Vehicle 2. Event 2 damage.

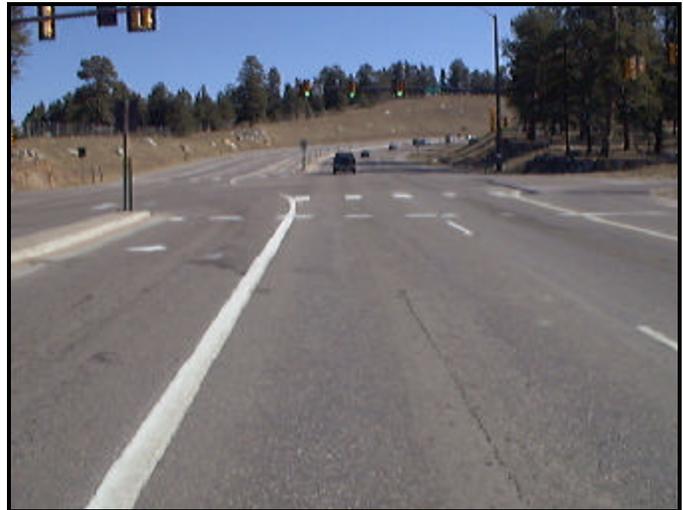
Figure 3. Crash scene. Vehicle 2 approach to impact.

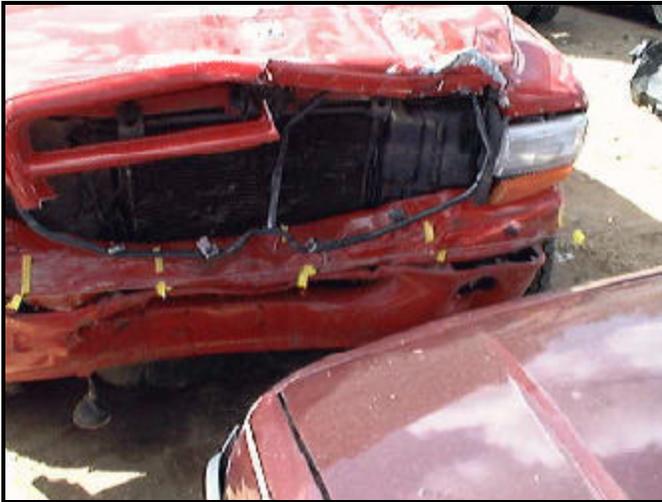
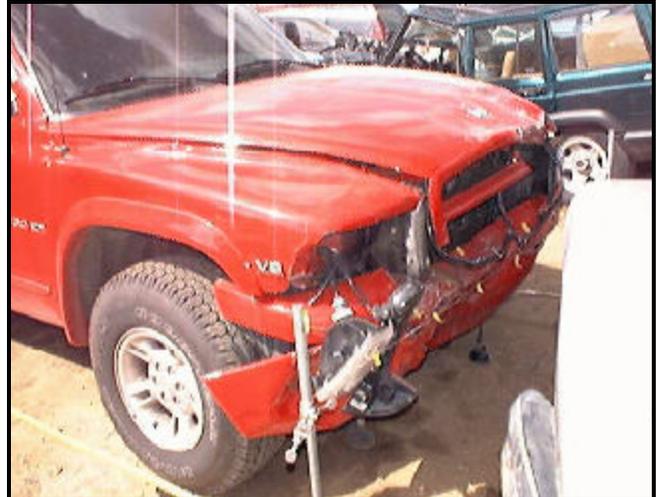
Figure 4. Exterior, Vehicle 2 (1999 Dodge Durango)

Figure 5. Exterior, Vehicle 2 (1999 Dodge Durango)

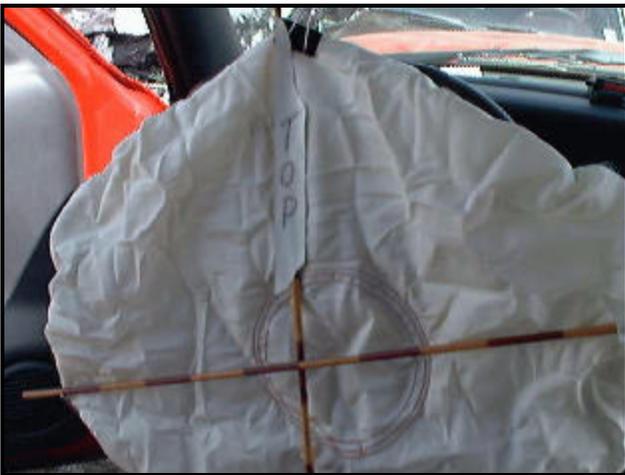
The front left air bag was housed in the steering wheel hub and was concealed by symmetrical I-configuration cover flaps which were not damaged. The circular air bag was equipped with two tether straps and no vent ports. No contact evidence was found on the bag and the bag was not damaged in the crash.

Figure 6. Interior, case vehicle. Driver's air bag.

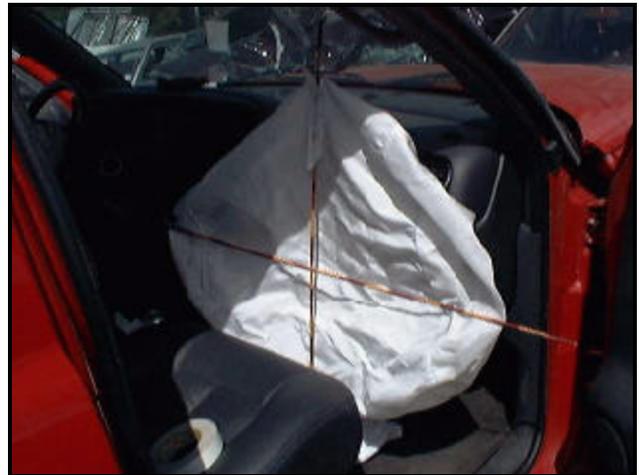
The front right air bag was housed in the mid-instrument panel position and was concealed by a single rectangular cover flap which was not damaged. The rectangular air bag was not equipped with tether straps or vent ports. No contact evidence was found on the bag and the bag was not damaged in the crash.

Figure 7. Interior, case vehicle. Passenger's air bag.

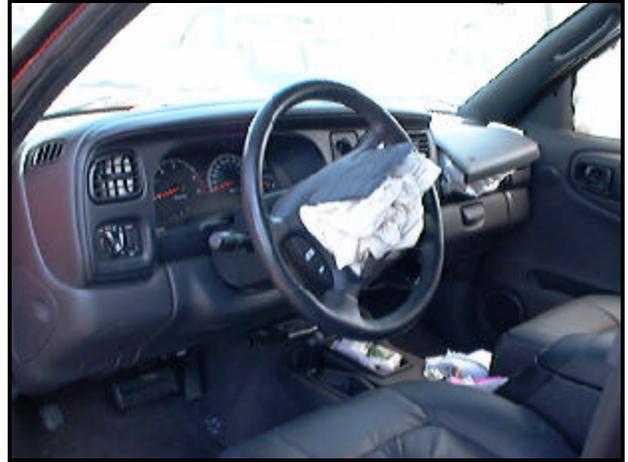
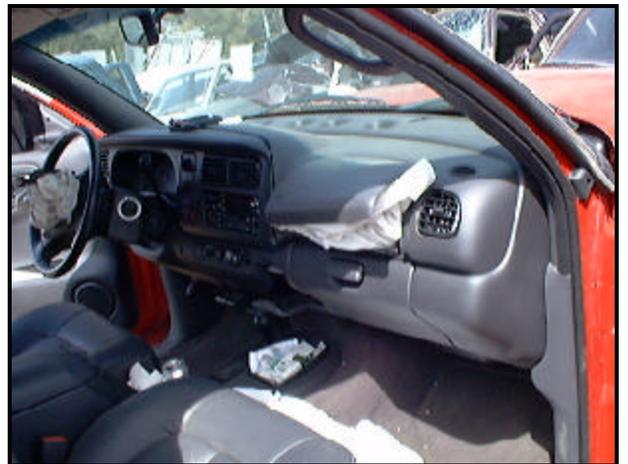
The interior of the Dodge Durango showed no evidence of occupant contact. There were no areas of intrusion into the passenger compartment.

Figure 8. Interior, case vehicle. View from left side.

Figure 9. Interior, case vehicle. View from right side.
