Remote, Redesigned Air Bag Special Study

Dynamic Science, Inc., Case Number (1999-76-082E)

1998 Dodge Neon

July/1999

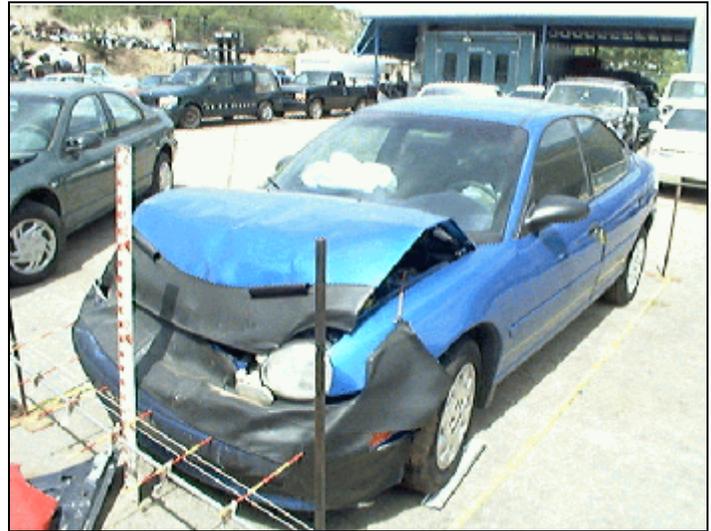
Figure 1. Left front quarter view of Vehicle 2 (Dodge Neon)

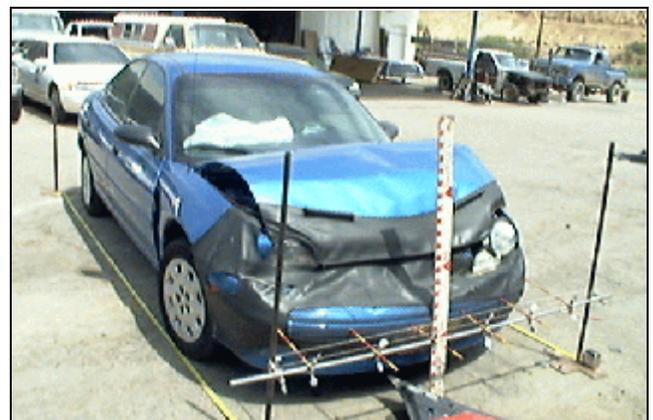
Figure 3. Right front quarter view of frontal damage

Plane of Impact	Field L cm/in.	C1 cm/in.	C2 cm/in.	C3 cm/in.	C4 cm/in.	C5 cm/in.	C6 cm/in.
Bumper	158	0	4	4	4	4	9
	62.2	0	1.6	1.6	1.6	1.6	3.5

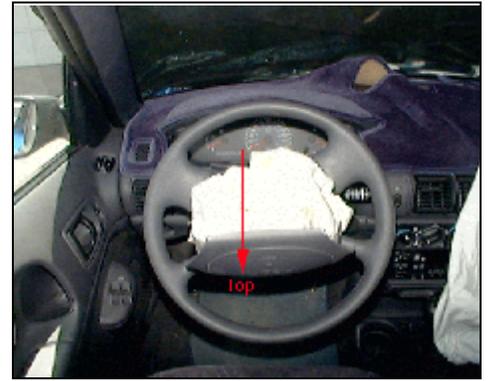
The case vehicle was equipped with bucket seats with adjustable head restraints in the front left and front right seating positions. The front left seat was adjusted to the middle track position; the front right seat was adjusted to between the forward most and middle track position. The rear of the vehicle was equipped with split bench seats with folding backs with no head restraints in all three seating positions. There was no intrusion or integrity loss.

Figure 4. Driver's seated position

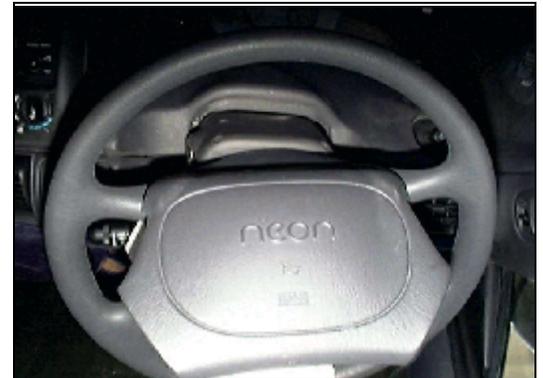
The 1998 Dodge Neon four-door was equipped with driver and passenger frontal redesigned air bags. The driver's air bag was mounted in the steering wheel and was concealed by a single cover flap that was not damaged. The circular air bag was equipped with two tethers and two vent ports. No contact evidence was found on the air bag and the air bag was not damaged.

Figure 5. Module cover for driver's frontal air bag (picture has been rotated)

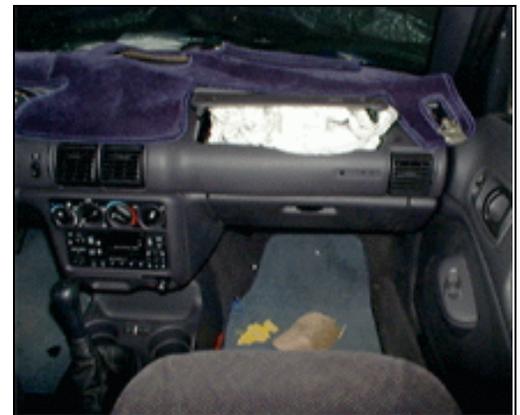
Figure 6. Front right passenger seated position

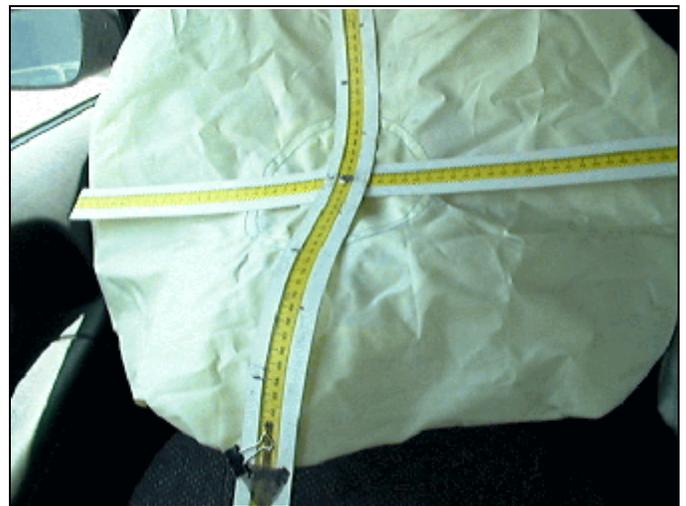
Figure 7. Deployed driver's air bag

Prior to impact, the driver began braking. All the occupants began shifting forward and loading the seat belts. At impact, the front left occupant pitched forward and to the right. The driver loaded the torso belt, causing the contusion to her left shoulder. As the driver slid forward, her left knee came into contact with the lower instrument panel. As the steering wheel mounted air bag deployed, the deploying air bag contacted both inner forearms, causing minor abrasions. The driver's arms were flung outward and the left wrist contacted the interior door surface and the right elbow contacted the center console. As the driver pitched forward into the deploying air bag, her face contacted the air bag causing her eyeglasses to interact with air bag and causing an abrasion to the bridge of her nose.

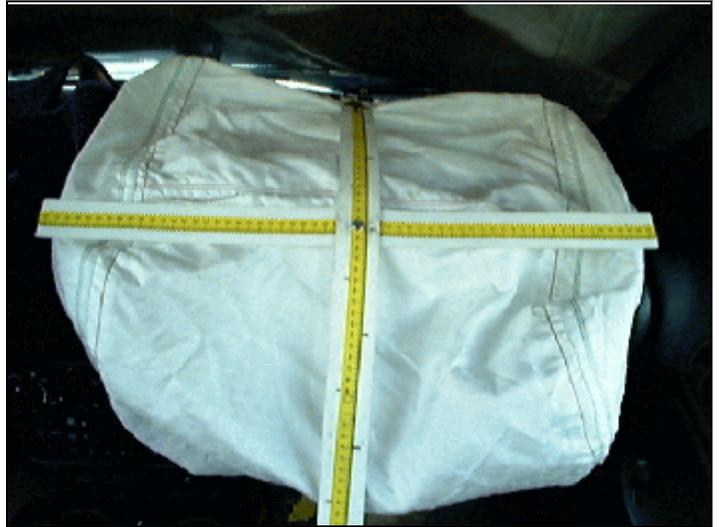
Figure 8. Deployed passenger's frontal air bag

The front right occupant pitched forward to some degree in response to vehicle braking. At impact, his face came into contact with the deploying air bag, causing an abrasion to the nose and a lip laceration.
