## SCI/NASS COMBINATION CASE REPORT

CASE NUMBER - NASS-1999-82-120K

VEHICLE - 1998 VOLKSWAGEN PASSAT

14. <i>Sponsoring Agency Code</i>		
15. <i>Supplementary Notes</i> SCI/NASS combination investigation of a side air bag deployment crash involving a 1998 Volkswagen Passat with manual safety belts and dual front and side air bags, and a 1974 Dodge Dart.

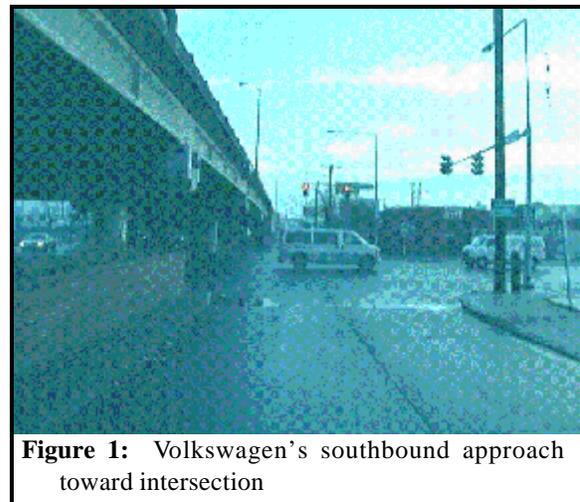
The Volkswagen was traveling south in the left lane of a two-lane, one-way<sup>1</sup> service road and was approaching a four-leg intersection, intending to turn left and travel east (the service road was adjacent to an overhead urban freeway). The Dodge was traveling west in the outside westbound lane of a four-lane city street (two lanes in each direction), approaching the same intersection, intending to pass through the intersection and continue west (**Figure 1**). Both roadways were bituminous, straight, dry, level and without defects. The intersection was controlled by an on-colors traffic signal. It was dark but lighted with no adverse weather conditions. The posted speed limit was 48 km.p.h. [35 m.p.h.] for both roadways. The two vehicles entered the intersection at the same time with the Volkswagen beginning the intended left turn. The Volkswagen's driver observed the on-coming Dodge and accelerated in an attempt to avoid the collision. It is not known if the Dodge's driver attempted any avoidance actions.

**Figure 1:** Volkswagen's southbound approach toward intersection

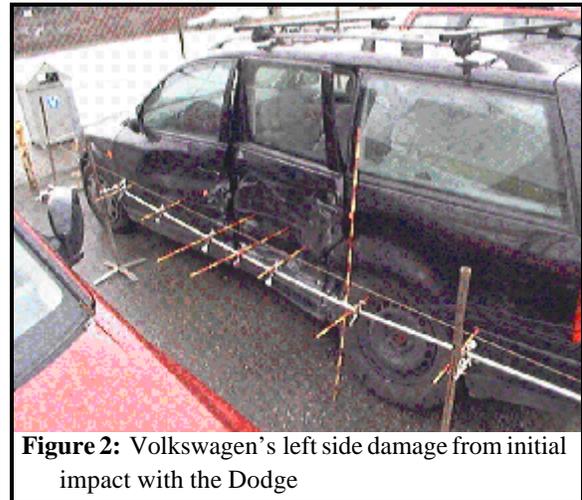
The Volkswagen's initial contact with the Dodge involved the left side immediately rearward of the B-pillar (**Figure 2**). Field L began 70 centimeters [27.6 inches] behind the left front axle and extended rearward 234 centimeters [92.1 inches]. Direct damage from the Volkswagen's initial impact started 133 centimeters [52.4 inches] behind the left front axle and extended rearward 112 centimeters [44.1 inches]. The maximum crush to the Volkswagen's left side was 23 centimeters (9.1 inches) and was located between C3 and C4 (**Figure 4**). The damage from the second impact with the Dodge was to the left front fender. The wheelbase on the left side was shortened 2 centimeters [0.8 inches], with the right side being lengthened 2 centimeters [0.8 inches]. All the Volkswagen's doors remained closed with the left front and left rear being jammed and inoperable. There was no glazing damage to the Volkswagen. There was intrusion along the Volkswagen's left side, including the left front door panel, the left B-pillar, the left back door panel, the left C-pillar, and the left side floor pan at both left side seat positions, with maximum intrusion of 20 centimeters [7.9 inches] located at left back door panel.

The CDC was determined to be: **11-LPEW-2 (330)** for the Volkswagen. The WinSMASH reconstruction program, missing vehicle algorithm based on the Volkswagen's crush profile, was used on the Volkswagen's highest severity impact. The Total, Longitudinal, and Lateral Delta Vs are, respectively: 15 km.p.h. [9 m.p.h.], -13 km.p.h. [-8 m.p.h.], and +8 km.p.h. [+5 m.p.h.]. No reconstruction program was used on the Volkswagen's secondary impact with the Dodge because of the minimal damage. This contractor's visually estimated Delta V for the second impact is between 6 km.p.h. [4 m.p.h.] and 13 km.p.h. [8 m.p.h.].

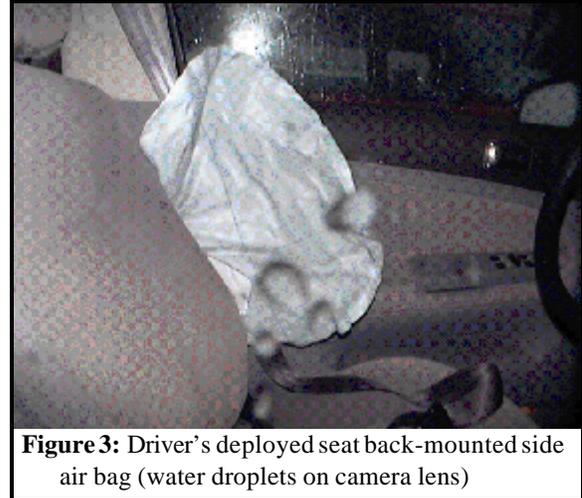
The driver's seat back-mounted side air bag deployed as a result of the Volkswagen's left side impact from the Dodge. The driver's side air bag deployed through a seam on the outboard side of the driver's seat back (**Figure 3**). The side air bag measured 30 centimeters [11.8 inches] horizontally and 45 centimeters [17.7 inches] vertically. The driver's side air bag had no vent ports and was not tethered. Black marks found on the inside and outside of the air bag appeared to be non-contact (i.e., oil and dirt).

**Figure 3:** Driver's deployed seat back-mounted side air bag (water droplets on camera lens)

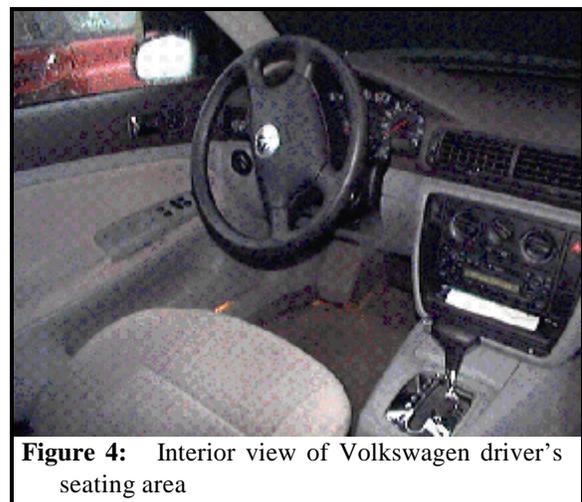
The driver was seated in an upright posture with his back against the seat back, his left foot was on the floor, his right foot on the accelerator, and both hands on the steering wheel. His seat track was located between its middle and rearmost position, the seat back was slightly reclined, and the tilt steering wheel was in the full-up position (**Figure 4**).

The driver accelerated, attempting to avoid the crash, and his pre-impact posture remained relatively unchanged prior to impact. The impact with the Dodge resulted in the Volkswagen's driver moving slightly forward but primarily leftward. He contacted the steering column with his right knee, the door panel with his left leg and his upper torso was pressed against the deploying seat back-mounted side air bag as

**Figure 4:** Interior view of Volkswagen driver's seating area

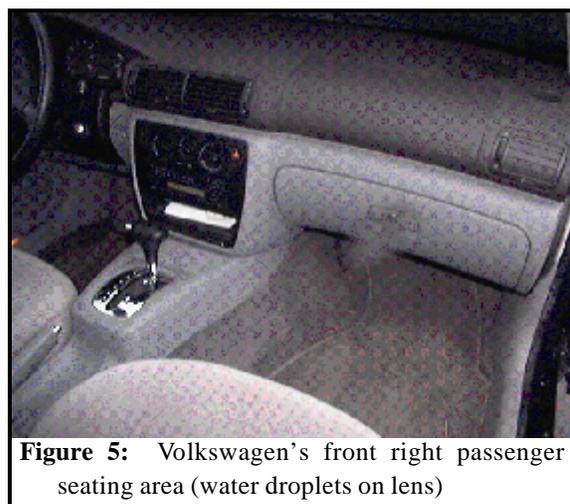
The front right passenger was seated in an upright posture with his back against the seat back, both feet on the floor, and both hands on his lap. His seat track was located between its middle and rearmost position, and the seat back was slightly reclined (**Figure 5**).

**Figure 5:** Volkswagen's front right passenger seating area (water droplets on lens)

The driver accelerated, attempting to avoid the crash; and the front right passenger's pre-impact posture remained relatively unchanged prior to impact. The impact with the Dodge caused the Volkswagen's front right passenger to move slightly forward but primarily leftward. He contacted the center arm rest with his upper left arm as the Volkswagen rotated counterclockwise. As the Volkswagen came to a stop the front right passenger rebounded back to the right, with his right elbow arm striking the door armrest or hardware. At final rest the front right passenger remained conscious and in his seat.

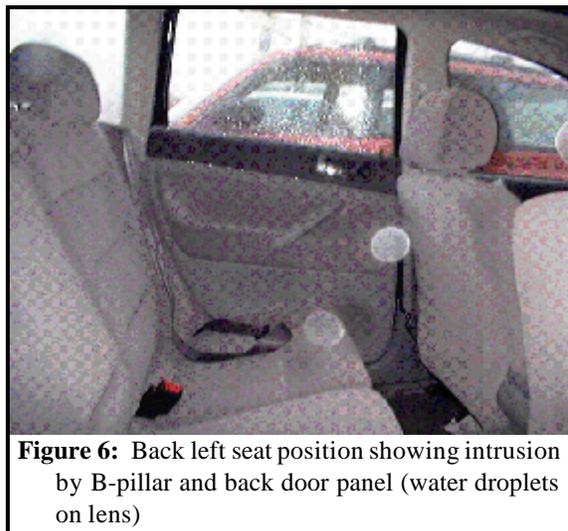
The Volkswagen's driver accelerated, attempting to avoid the crash, and the back left passenger's pre-impact posture remained relatively unchanged prior to impact. The impact with the Dodge caused the Volkswagen's back left passenger continuing slightly forward but primarily leftward, contacting the intruding door panel (**Figure 6**) with his the left side of his face, left leg, hip, and upper torso as the Volkswagen rotated counterclockwise. The back left passenger's seat belt usage kept him in his seat during the approximately 110 degree rotation. As the Volkswagen came to a stop the back left passenger rebounded back to the right. At final rest the back left passenger remained conscious and in his seat.

**Figure 6:** Back left seat position showing intrusion by B-pillar and back door panel (water droplets on lens)

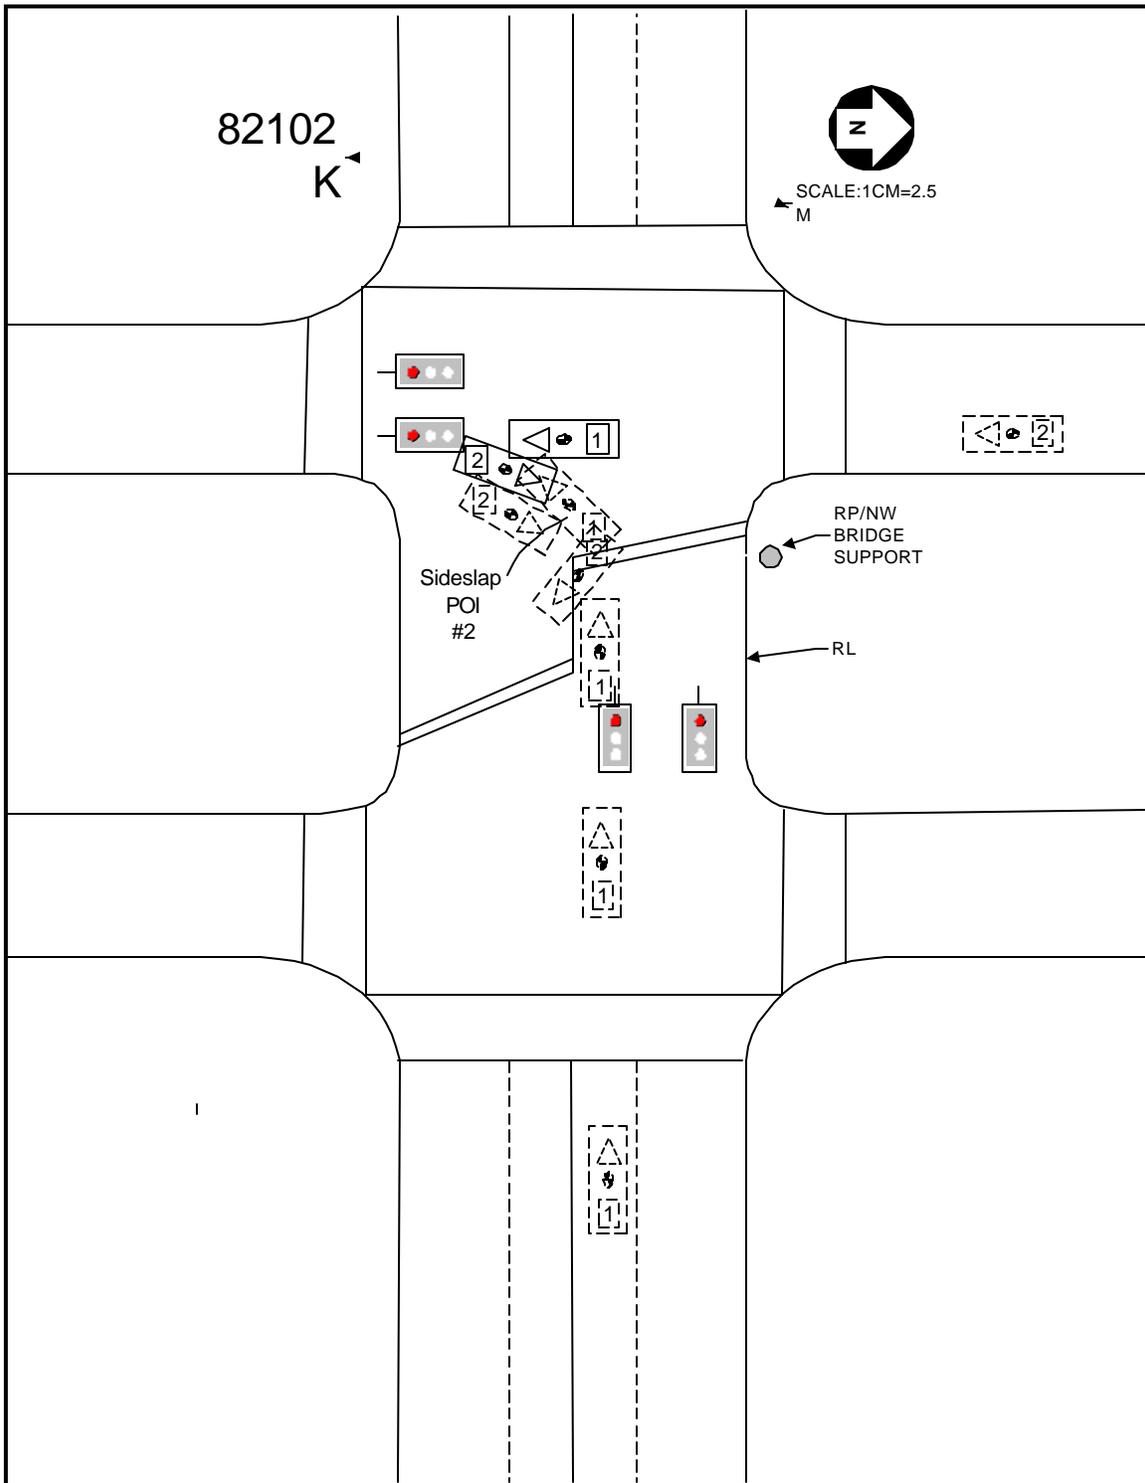
<sup>5</sup>The NASS scene diagram depicts the Volkswagen (V#2) being pushed rearward by the force of the first impact, but this is unlikely.
