School Bus Crash Investigation  
Dynamic Science, Inc.  
Case 99007  
Contract DTNH22-94-D27058  
Task 131  
Alabama  
April, 1999

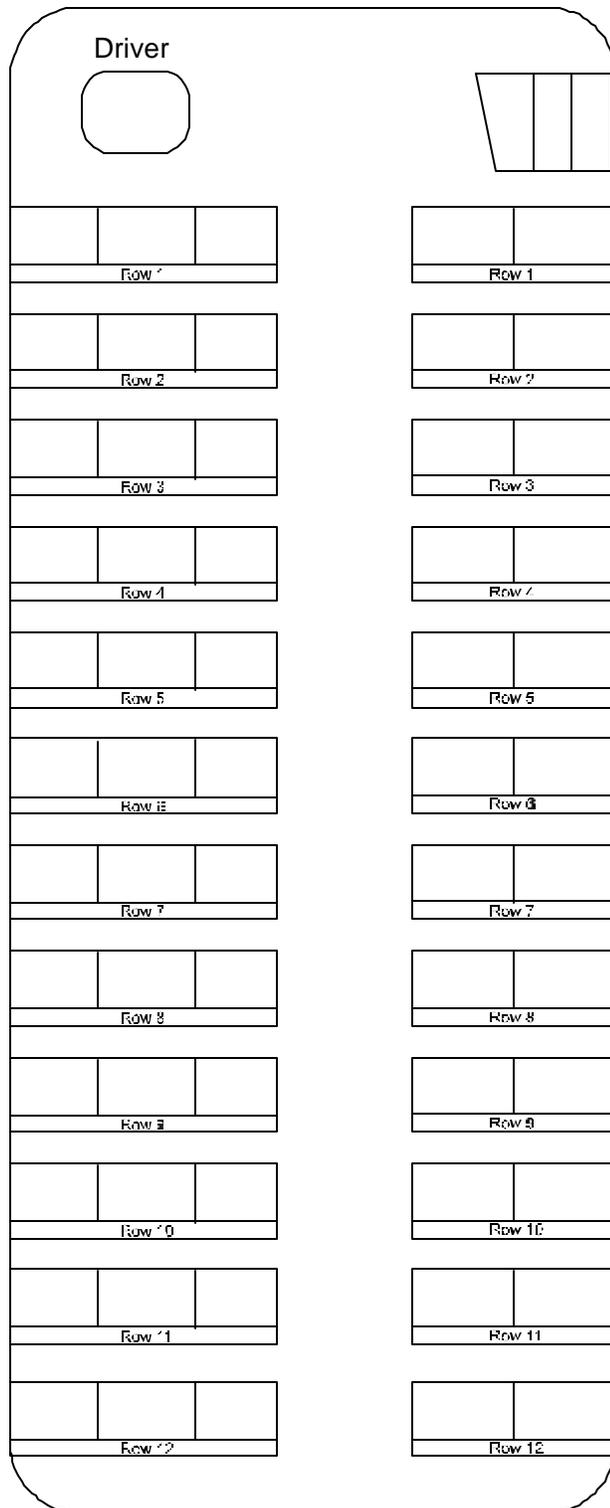
The school bus has a seating capacity of 64 passengers. It was transporting 46 children between the ages of 8 and 19, and the bus driver. There were 11 rows of seats in the bus, as depicted in figure 1, with the left side seats having 3 designated seating positions and the right side seats having 3 designated seating positions.

46 children in unknown seating positions
