## REMOTE AIR BAG DEPLOYMENT REPORT

CASE NUMBER - IN99-007

VEHICLE - 1998 FORD CONTOUR

CRASH DATE - May 1998

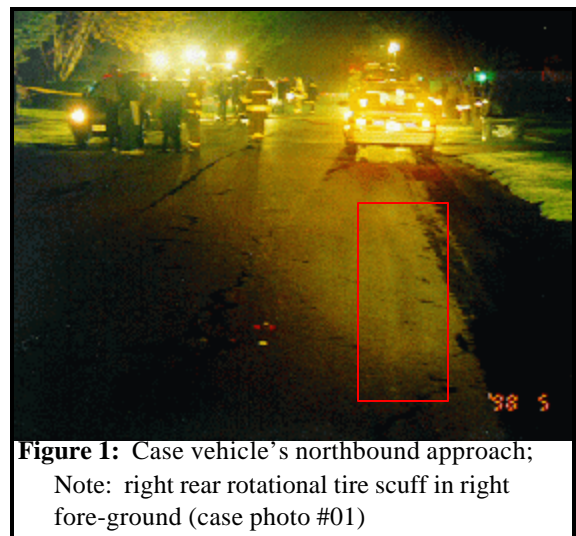
**Figure 1:** Case vehicle's northbound approach; Note: right rear rotational tire scuff in right fore-ground (case photo #01)

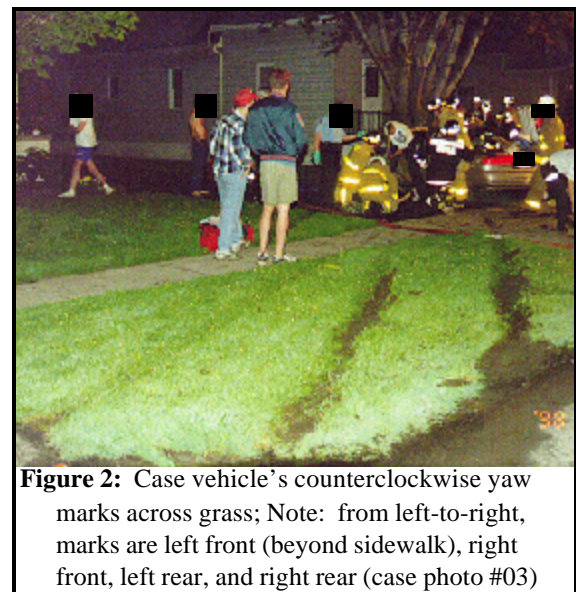
Surviving case vehicle occupants indicated that the driver began speeding down the street and they all told him to slow down. For some unknown reason, the driver lost control of the case vehicle, and the vehicle began to rotate counterclockwise. Once the vehicle began its pre-crash, counterclockwise yaw, no avoidance maneuvers are detectable in the available police photographs nor were any cited by investigating officers. Police photographs show a gradually increasing degree of yaw into the impact (**Figure 2**).

**Figure 2:** Case vehicle's counterclockwise yaw marks across grass; Note: from left-to-right, marks are left front (beyond sidewalk), right front, left rear, and right rear (case photo #03)

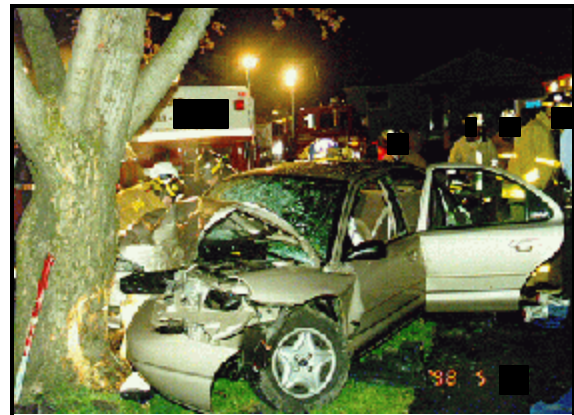
The crash occurred off the left (west) side of the trafficway, in the lawn of a private residence. The case vehicle, yawing counterclockwise, traveled off the left road edge, across a tree plat and concrete sidewalk, and impacted a large tree head-on (**Figure 3** below), causing the driver and front right passenger supplemental restraints (air bags) to deploy. While staying in contact with the tree, the case vehicle continued its counterclockwise rotation a few more degrees and came to final rest facing west-northwest. The crash

The case vehicle sustained direct contact damage to the right-center of the front (**Figure 3**). Damaged components included the hood; front fascia, bumper, grille, and engine compartment brackets; and left and right headlamp assemblies and fenders. The windshield was fractured across its entire width. The left front wheel was pulled forward and the right front wheel was pushed rearward, causing rearward displacement of the right lower "A"-pillar. The rear edge of the hood probably contacted the lower portion of the windshield and the upper right "A"-pillar. The left and right roof rails and the roof itself were buckled near the "B"-pillars. The left and right front doors were subsequently removed to enable extrication of the victims (**Figure 4**). Based on the available police photographs, the CDC for the case vehicle is estimated as: **01-FZEW-3 (+40)**. The WinSMASH reconstruction program, barrier algorithm with CDC-only estimated crush profile, provides a borderline reconstruction, but the results appear reasonable. The estimated Total, Longitudinal, and Lateral Delta Vs are, respectively: 41.1 km.p.h. (25.5 m.p.h.), -35.6 km.p.h. (-22.1 m.p.h.), and -20.6 km.p.h. (-12.8 m.p.h.).

**Figure 3:** Case vehicle at final rest showing frontal damage from tree impact; Note: tree penetration depth (case photo #05)

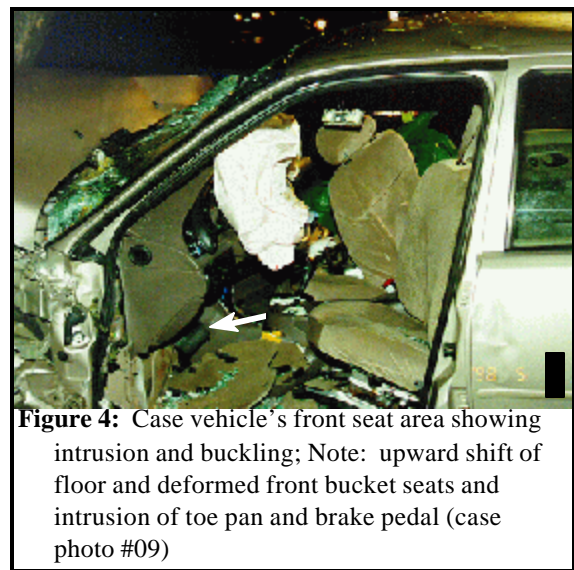
Intruding components into the front seating area included the instrument panel, toe pan, and foot well for both front occupants. The instrument panel appears to be displaced, with the bottom rotated slightly forward. The toe pan was pushed rearward, with the brake pedal visibly displaced (**Figure 4**). Based on the available police photographs, it cannot be determined whether the steering column also intruded. No steering wheel rim deformation is visible, but there are blood transfers to the rim covering (**Figure 5**). Upward movement of the driver's foot well and floor caused a similar upward movement to the forward edge of the driver's bucket seat.

**Figure 4:** Case vehicle's front seat area showing intrusion and buckling; Note: upward shift of floor and deformed front bucket seats and intrusion of toe pan and brake pedal (case photo #09)

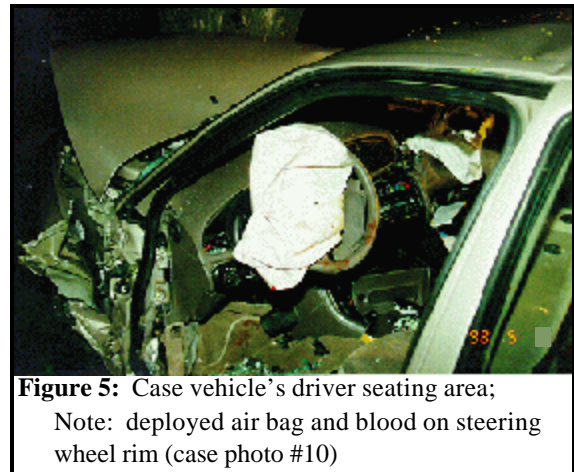
**Figure 5:** Case vehicle's driver seating area;  
Note: deployed air bag and blood on steering wheel rim (case photo #10)

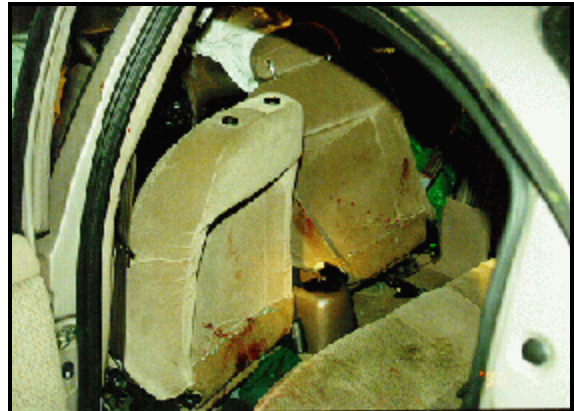
seat adjustments and posture are not known. At-impact, however, one or both of the rear seat occupants contacted the back of the front right passenger's seat and torqued the entire seat so that the left side was forward of the right, with the seat back deformed more than the seat (**Figure 6**). She was transported to a medical facility, but her treatment status is unknown. She was interviewed at home by an investigating officer two days post-crash. Her injuries were reported as "complaint of pain" to her knee/lower leg/foot.

**Figure 6:** Case vehicle's rear seating area; Note: seat back deformation to front bucket seats from contact by rear seat occupants (case photo #11)
