**TRANSPORTATION SCIENCES
CRASH DATA RESEARCH CENTER**

ON-SITE ADAPTED CONTROL VEHICLE INVESTIGATION

VERIDIAN CASE NO: CA99-008

VEHICLE: 1995 PLYMOUTH VOYAGER/BRAUN CONVERSION

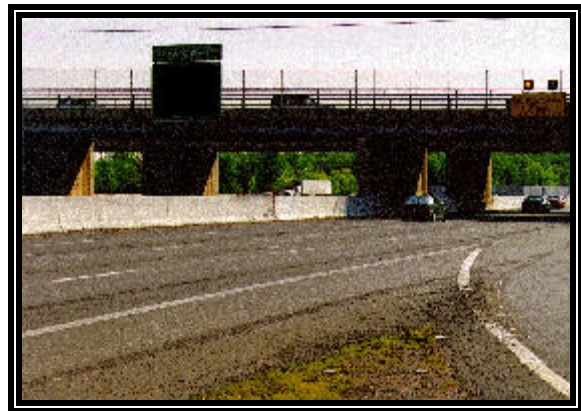
Figure 1: Easterly view of the crash scene.

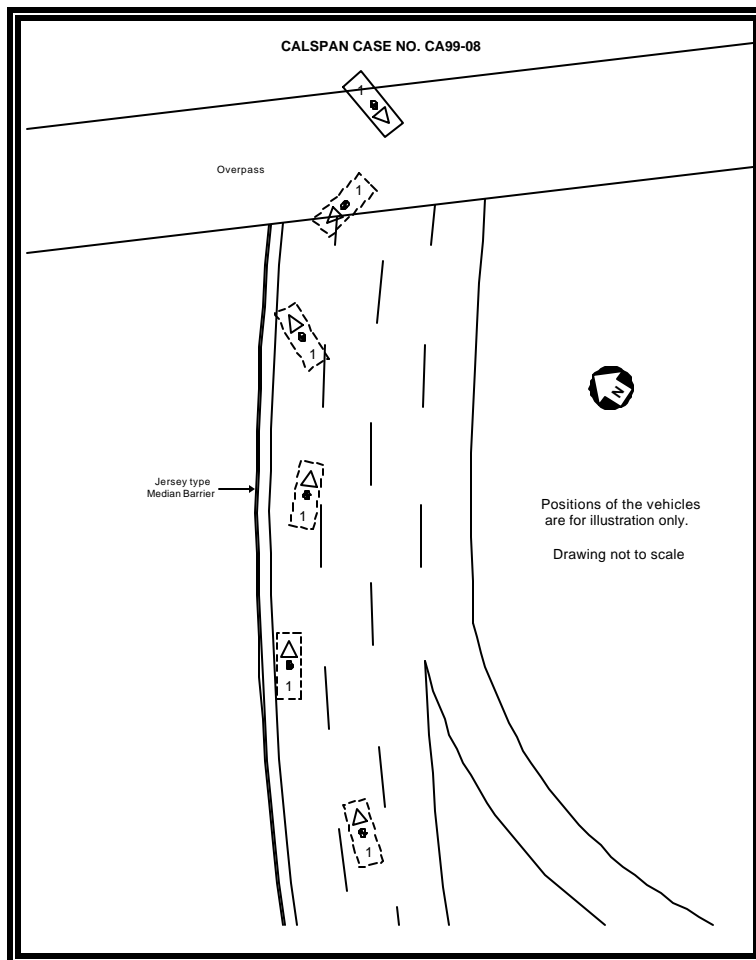
A witness traveling behind the Plymouth recalled the vehicle traveling in the left center lane. Due to a probable combination of alcohol and drowsiness, the driver relinquished directional control and allowed the vehicle to drift to the left. Post-crash police investigation determined the driver's Blood Alcohol Content (BAC) was above the legal limit. The van drifted through the in-board lane and sideswiped the median barrier with the vehicle's left side. The driver probably was awakened by the contact and reacted by steering to the right and then over-corrected back to the left. The crash occurred with the left frontal area of the van striking the median barrier. The delta V of the impact was determined to be approximately 27 km/h (17 mph). The force of the impact caused the deployment of the vehicle's driver and front right passenger air bags. The location and extent of the vehicle's damage indicated the Plymouth departed the road at a heading angle of approximately 15-20 degrees (relative to the road). After the impact, the van rotated approximately 180 degrees, while sliding eastward approximately 23 m (75 ft) to rest. The police officer indicated the van came to rest facing southward, under the overpass in Figure 1. **Figure 2** is a schematic of the crash scene.

Figure 2: Crash Schematic.

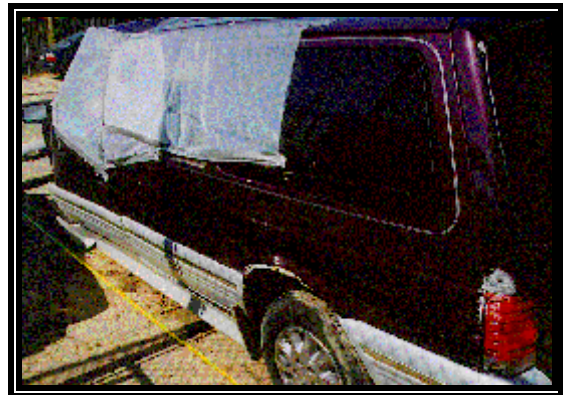
The left side of the Plymouth, **Figure 3**, sustained longitudinal scratches and abrasions consistent with sideswiping contact to the Jersey median barrier. The damage was centered primarily about the left rear wheel well, began 49.0 cm (19.3 in) forward of the left rear axle and extended 141.7 cm (55.8 in) rearward to the left rear corner. There also was a 7.6 cm (3.0 in) wide band of scratches located 129.5 cm (51.0 in) forward of the left rear axle, immediately aft of the left door. There was no measurable lateral deformation associated to the left side damage, only surface (paint) scratches and abrasions. The damage occurred in the front to rear direction. The Collision Deformation Classification (CDC) of the contact was 12-LZES-01.

Figure 3: View of the left side scratches/abrasions.

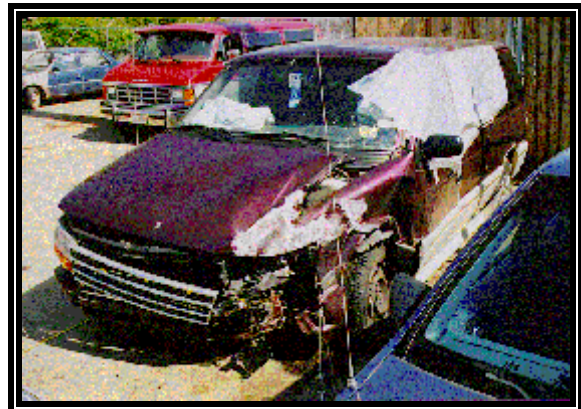
The vehicle's frontal plane sustained direct and induced damage across the its entire 138.4 cm (54.5 in) frontal end width, **Figure 4**. The width of the direct contact damage measured 38 cm (15 in), began 21.6 cm (8.5 in) left of center and extended to the left front bumper corner. The crush profile measured as follows: C1=61.0 cm (24.0 in), C2=30.5 cm (12.0 in), C3=19.1 cm (7.5 in), C4=10.2 cm (4.0 in), C5=2.5 cm (1.0 in), C6=10.7 cm (4.2 in). The bumper fascia was displaced from the reinforcement bar by the impact. The left front fender deformed laterally and buckled rearward into contact with the left door. The left door also was buckled. The door was operational, but very restricted. The forward left aspect of the roof buckled above the driver's position. The lower left aspect of the windshield was fractured by the frontal deformation. The left front and middle side glazings disintegrated. The left wheelbase was foreshortened approximately 23 cm (9 in). The left front wheel rim

Figure 4: Left front view of the frontal damage.

was bent and the tire had aired out. The CDC of the impact was 11-FLEW-3. The Barrier Equivalent Delta V calculated by the WINSMASH model was 26.5 km/h (16.5 mph). The longitudinal and lateral components of the velocity change were -23.0 km/h (-14.3 mph) and 13.3 km/h (8.3 mph), respectively.

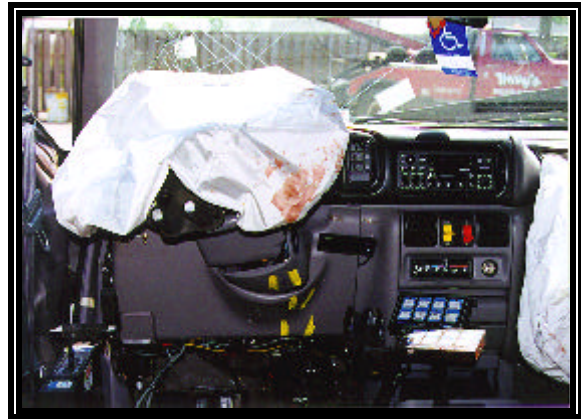
The interior damage to the Plymouth Voyager was associated to both the intrusion caused by the exterior crash forces and the occupant contacts within the compartment. The intrusion into the vehicle consisted of 15-20 cm (6-8 in) of rearward deformation of the left toe pan. The brake pedal was bound by the deformation and would not move. The deformation also caused a rotation of the auxiliary stepper motor which applied the brakes. The driver's bolster exhibited a contact from the right lower extremity. The contact was located approximately 7 cm (3 in) right of the steering column centerline and measured approximately 18 cm x 3 cm (7 in x 1 in). The contact occurred due to the driver's forward kinematic pattern in response to the impact. The tilt steering wheel/column, **Figure 5**, was in the full up position at inspection and appeared to have been loaded forward and left, consistent with the 11 o'clock direction of the impact force. The right shear capsule displacement measured approximately 1.5 cm (0.6 in). The left shear capsule was not accessible.

Figure 5: View of the steering wheel/column.

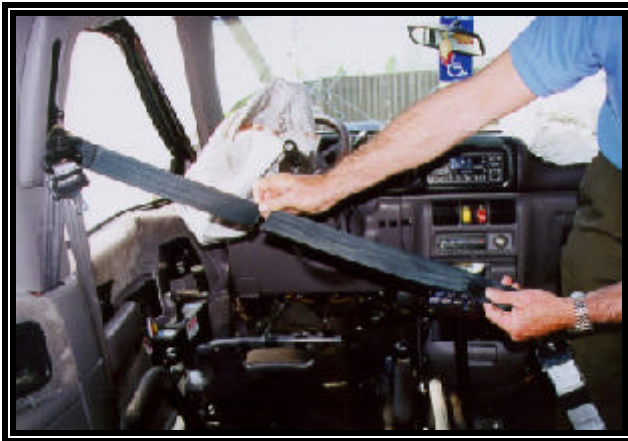
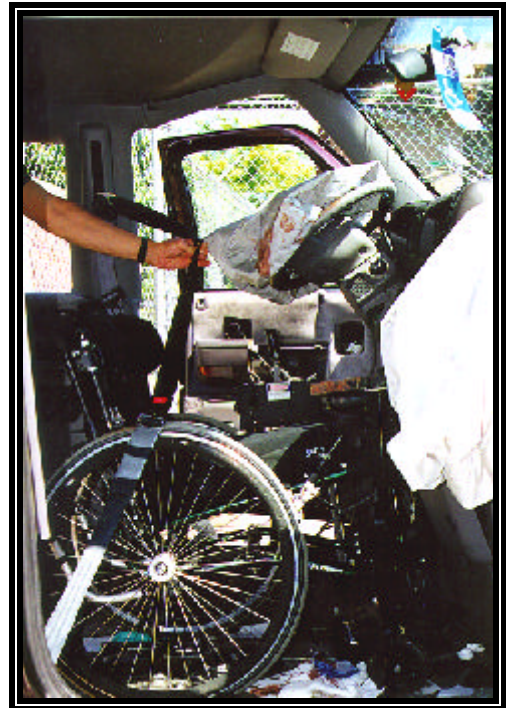
Figures 6 and 7 are views of the modified chest restraint used by the disabled driver. The upper outboard anchor of the chest restraint was fastened to the adjustable D-ring, (attached using the same fastener as the OEM belt). The belt webbing was attached to the floor of the van via a modified floor anchor. Refer to **Figure 8**. The anchor consisted of a formed steel section that was spot-welded to the floor. The section measured 130 cm (51 in) and spanned the width of the vehicle. There were thirteen 1 cm x 5 cm (0.5 in x 2.0 in) slots to allow for the adjustment of the lateral position of the inboard anchor. The third slot, approximately 33 cm (13 in) from the vehicle's right side, was the inboard anchor location. The webbing was worn across the driver's chest and was routed over the inboard side of the wheelchair. The total length of the webbing section measured 173 cm (68 in) in the buckled condition. The length of the restraint

Figure 6: View of the modified chest restraint.

Figure 7: Right interior view of the chest restraint.

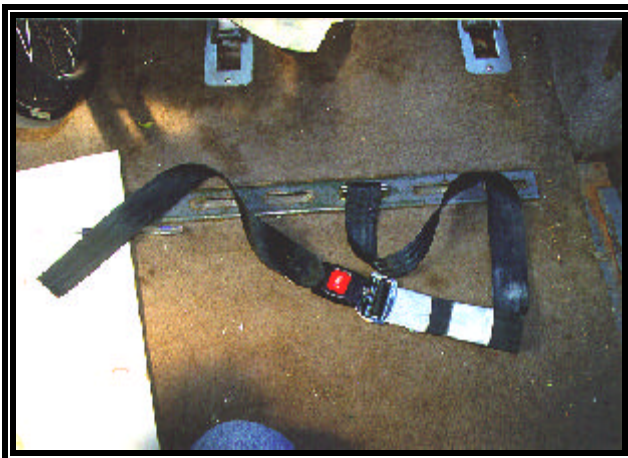
was adjusted on the inboard aspect of the webbing with a locking latch plate. Duct tape had been used to secure the adjusted (loose) end of the webbing. It could not have been easily re-adjusted. Refer to Figure 8. Due to the chest restraint's overall length and geometry, belt slack was in this restraint system. This belt slack reduced the efficiency of the restraint. It should be noted, there was no lap belt available for the wheel-chaired driver. The modified chest restraint would typically be left in the buckled condition, such that the handicapped driver could simply enter the vehicle and lock the wheelchair in the driver's position and the chest restraint would already be positioned - ready for use.

The belt webbing was cut 34.3 cm (13.5 in) from the D-ring, by the EMS personnel, during driver extrication. A 15 cm (6 in) transfer was identified on webbing from driver inertial loading. The transfer began approximately 41.9 cm (16.5 in) from the upper outboard anchor, (8 cm (3 in) from the cut end of the webbing).

Figure 8: View of the cut restraint and inboard anchorage.

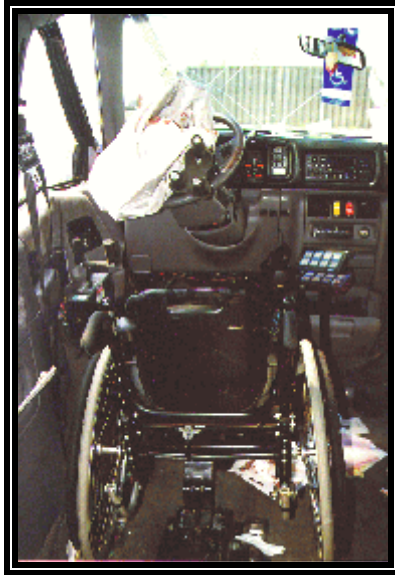
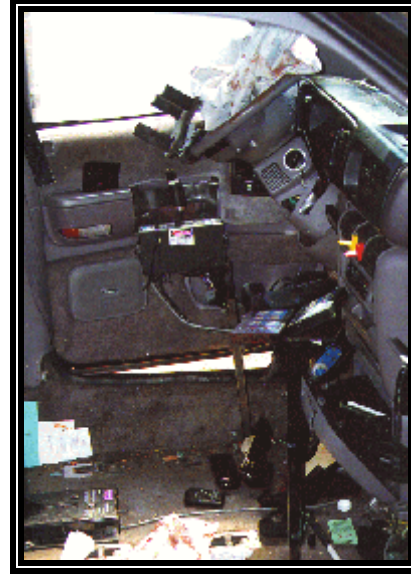
A Tri-pin steering control device was attached to the 5 o'clock sector of the steering wheel rim. The device was fastened to the rim by a band clamp. During installation the device was mounted to the steering wheel rim with its base plane parallel to the plane of the rim. At inspection, the device was rotated approximately 23 degrees counterclockwise relative to the steering wheel, Figure 10. The rotation occurred due to a combination of loading caused by the deployment of the air bag and the occupant. It was also noted during the inspection, the finishing grommet on top of the "palm grip" pin was missing. The grommet was found on the floor and had been displaced by contact with the occupant's head. The driver sustained a forehead laceration consistent with this contact.

Figure 9: Rear view of the driver's position.

Figure 10: Right view of the driver's position.

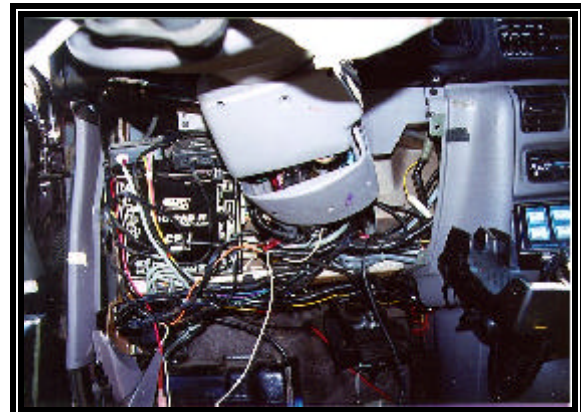
The Plymouth Voyager's power train and electrical accessories were controlled electro-mechanically by the EGB II control system, manufactured by EMC Incorporated. The Central Processing Unit (CPU) for the EGB II was mounted under the left aspect of the instrument panel, behind the bolster panel, **Figure 11**. The CPU controlled and integrated the functions of the individual EGB components.

Figure 11: View of the adaptive controls CPU location.

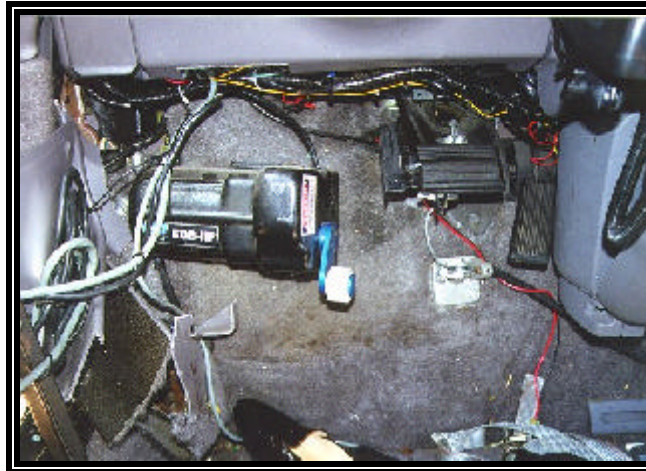
Mechanical brake action was achieved via the stepper motor mounted to the left toe pan, **Figure 12**. The brakes operated through movement of the hand shuttle, which in-turn activated the operation of the stepper motor. The lever mounted roller, on the inboard side of the motor, engaged the modified brake pedal. The rotation of the lever caused the brake pedal to depress. The brake pedal was modified by the addition of a steel section welded to the pedal's left side. The flat surface of the steel section was the reactive surface for the stepper motor. The pedal was also modified by the addition of the cable-activated instructor's training brake. This cable modification is depicted in the right center aspect of Figure 12. The opposite end of the cable was attached to a brake pedal that was fastened to the toe pan in the front right passenger location. The training brake was disconnected at the time of the inspection.

The toe pan deformed rearward as a result of the impact. This deformation caused the stepper motor to rotate away from the brake pedal as depicted in figure 12. The brake pedal was jammed by the deformation.

Figure 12: View of the modified brake actuation.
