**VERIDIAN REMOTE AIR BAG RELATED
ADULT DRIVER FATALITY INVESTIGATION**

VERIDIAN CASE NO. CA99-012

VEHICLE - 1998 BUICK REGAL GS

CRASH DATE - DECEMBER, 1998

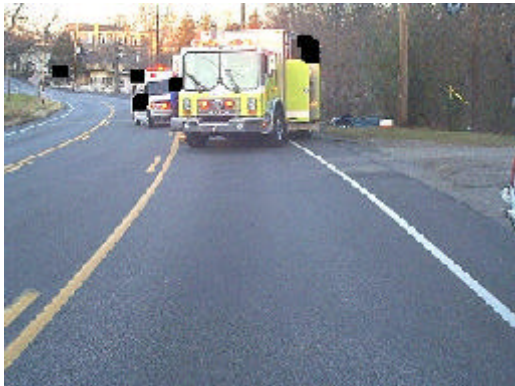
The travel direction of the vehicle suggested that the driver was en route to her residence which was located approximately 4 km (2.5 miles) north of the crash scene. The roadway was designed with one travel lane in each direction (north/south) which were separated by a continuous median left-turn lane and a posted speed limit of 64 km/h (40 mph). The asphalt surface was dry, level, with good lane and roadway edge lines (**refer to Figure 1**).

Figure 1 View northbound prior to the POI showing the roadway geometry

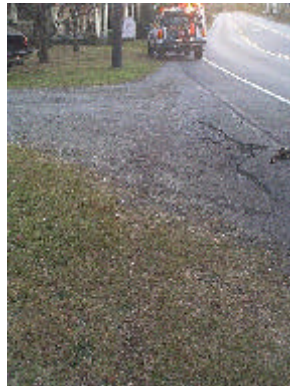
At the point of departure, the roadway transitioned from a straight segment to a left curve (**refer to Figure 2**). The vehicle traversed a paved shoulder, a stone driveway apron, and an adjacent grass shoulder a police reported distance of 25.6 m (84.0') before impacting the blunt end of an unprotected concrete bridge railing (**refer to Figure 3**). The contact on the vehicle was located between the left front bumper corner and the centerline of the vehicle. Maximum crush was estimated at 51 cm (20") by the police. The vehicle rotated approximately 45 degrees counterclockwise and traveled 1.5 m (5.0') to the FRP which was located on a negative embankment.

Figure 2 Look back view of the Buick's trajectory showing the point of roadway departure

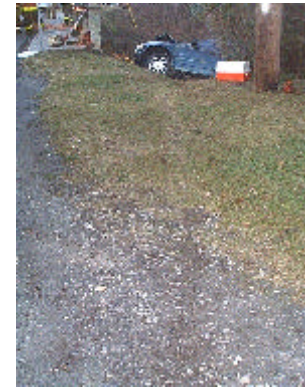
Figure 3 View showing the vehicle's precrash trajectory and its final rest position

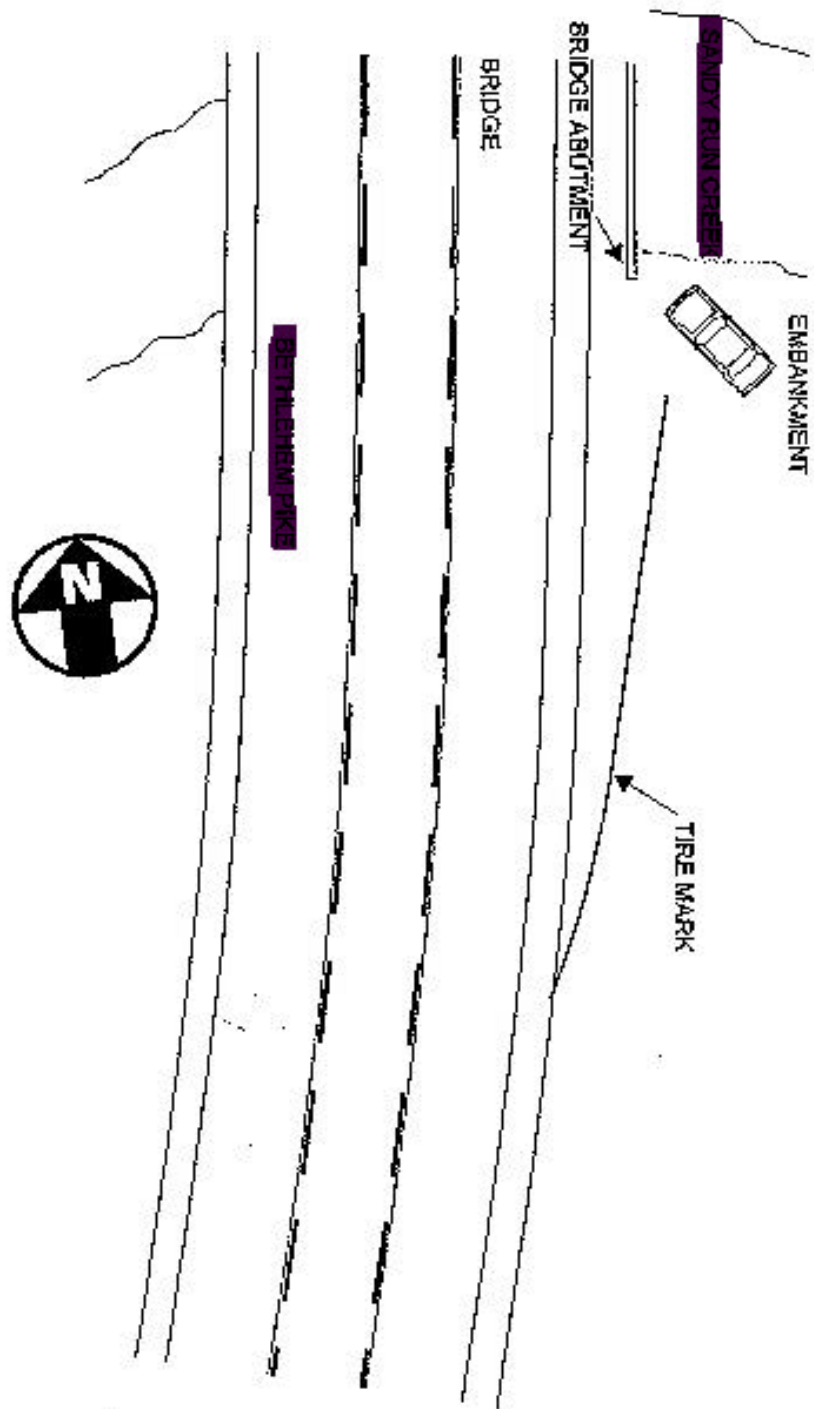
Figure 4 Police scene diagram

A rolling tire print in the grass was associated with the right side tires and indicated that the driver did not lockup the brakes prior the impact. The trajectory appeared to curve slightly to the left which indicated that the driver may have attempted to steer left. This maneuver was viewed more as a matter of returning to the roadway rather than avoiding the bridge wall end (**refer to scene schematic in Figure 4**). There were no adverse weather conditions at the time with the temperature listed as 45 degrees F.

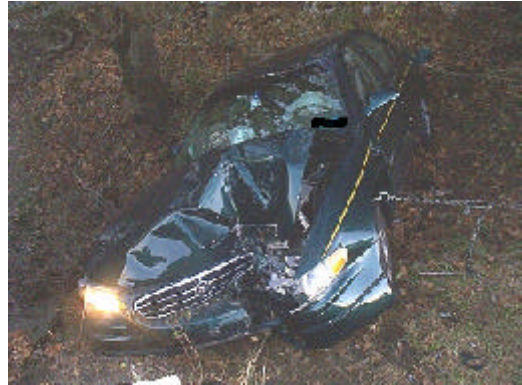
The 1998 Buick Regal GS was equipped with a redesigned dual frontal air bag system which deployed as the result of the impact with a concrete bridge wall end. The bridge wall end measured 24.8 cm (9.75") wide and 121.9 cm (48.0") tall). Exterior damage to the vehicle involved the front bumper, left headlight assembly, grille, hood, left front fender, and windshield. The 24.8 cm (9.75") wide contact pattern began an estimated 22.9 cm (9.0") left of the vehicle centerline. The police reported a maximum crush of 50.8 cm (20.0") located an estimated 35.5 cm (14") left of the centerline (**refer to Figure 5**). Crush values in the following table were estimated from police photographs.

Figure 5 View of the damage to the front of the Buick Regal

1998 Buick Regal GS - Crush Profile			
Impact with the 24.8 cm (9.75") wide bridge	C ₁ = 50.8 cm (2.0")	C ₂ = 25.4 cm (10.0")	C ₃ = 50.8 cm (20.0")
	C ₄ = 25.4 cm (10.0")	C ₅ = 10.2 cm (4.0")	C ₆ = 0

The CDC for the front impact was assigned as follows: 12-FYEN-2.

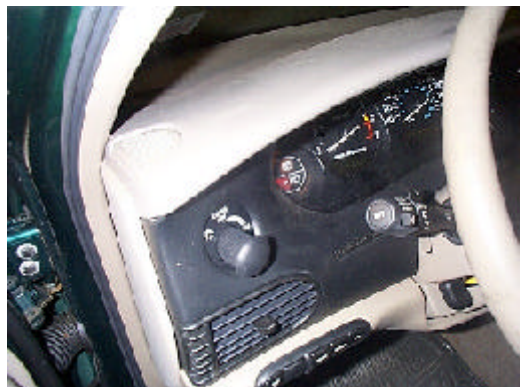
The interior of the 1998 Buick Regal GS exhibited minor driver contact evidence which involved the headlight switch located left of the steering column and the transmission gear shift lever. The headlight switch was deformed downward which was attributed to contact by the driver's left hand (**refer to Figure 6**). The knee bolster did not appear to be damaged, however, there were limited views to fully evaluate contact mechanisms. There did not appear to be any deformation of the steering wheel rim (**refer to Figure 7**). The tilt steering wheel was viewed as being adjusted in a center tilt position. The police noted that the housing surrounding the console mounted transmission selector lever was slightly damaged and the shift lever was bent slightly toward the passenger side (**refer to Figure 8**).

Figure 6 View of the left instrument panel showing the headlight switch which was deformed downward by the driver's left hand

The drivers left hand moved forward and contacted the top aspect of the headlight switch as her forearm moved in an downward direction. This contact resulted in a contusion of the left middle finger. He right forearm moved forward and contacted the instrument panel resulting in a contusion.

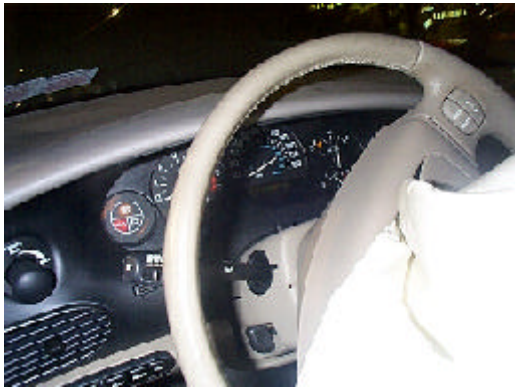
Figure 7 View of the steering wheel assembly which shows a lack of driver related deformation

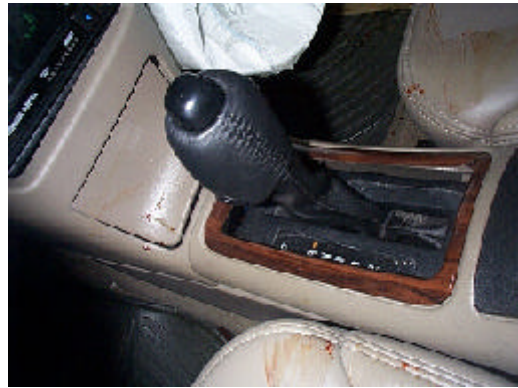
Figure 8 View of the center console mounted transmission gear selection lever as viewed from the driver's seat toward the right front instrument panel

The driver's upper body rebounded laterally to the right with her head coming to rest on the right front seat cushion against the lower right B-pillar with her shoulders and back resting on the seat cushion. Her hip area contacted the console mounted transmission gear selector lever which resulted in the selector lever being deformed slightly to the right and being moved forward where it was found in the "reverse"

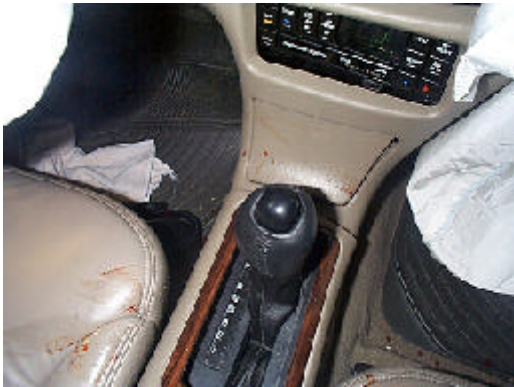
The seat track position of the front bucket seats were adjusted such that the driver seat appeared to be in a more forward position as noted by its relative position with respect to the right front seat (**refer to Figure 9**). The driver seat back was reclined in a normal angle with an adjustable head restraint that was in a full down position. The front restraint belts were a manual three point continuous loop lap and torso belt. The left front adjustable D-ring was in the full up position (**refer to Figure 10**).

Figure 9 Overhead view showing the relative seat positions

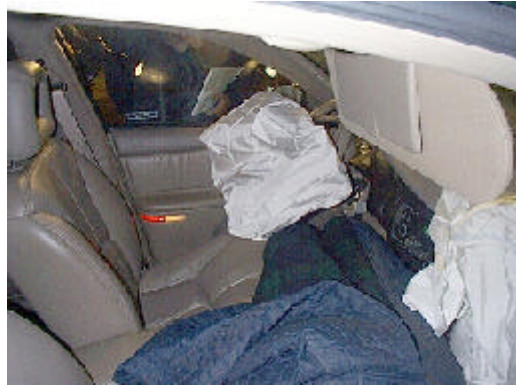
Figure 10 Lateral view of the front seat area showing the frontal air bags, driver's final rest position, and the adjustment height of the D-ring for the torso belt

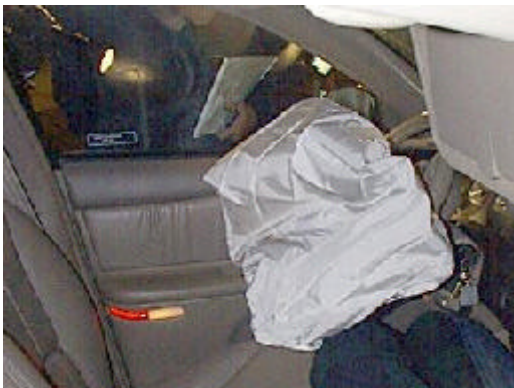
The supplemental restraint system (SRS) comprised of dual front air bags which deployed during the crash as designed. The front left driver module cover opened in the usual symmetrical “T” pattern. The air bag was an untethered design which did not exhibit any driver contact evidence as captured in police photographs (refer to **Figure 11**). The front right passenger air bag was top mounted and also appeared devoid of occupant contact (refer to **Figure 12**).

Figure 11 Lateral view of the front left driver air bag

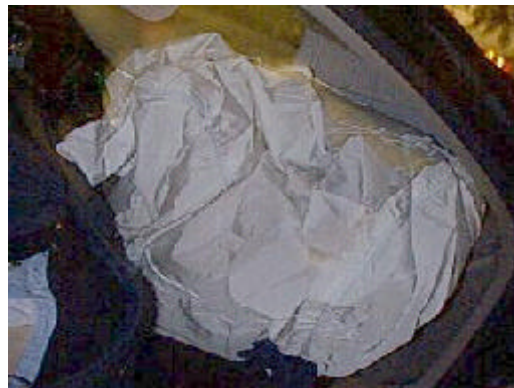
Figure 12 View of the front right passenger side air bag
