School Bus Crash Investigation
Dynamic Science, Inc.
Case DS99012
Contract DTNH22-94-D27058
Task 131
Iowa
April, 1999

Background

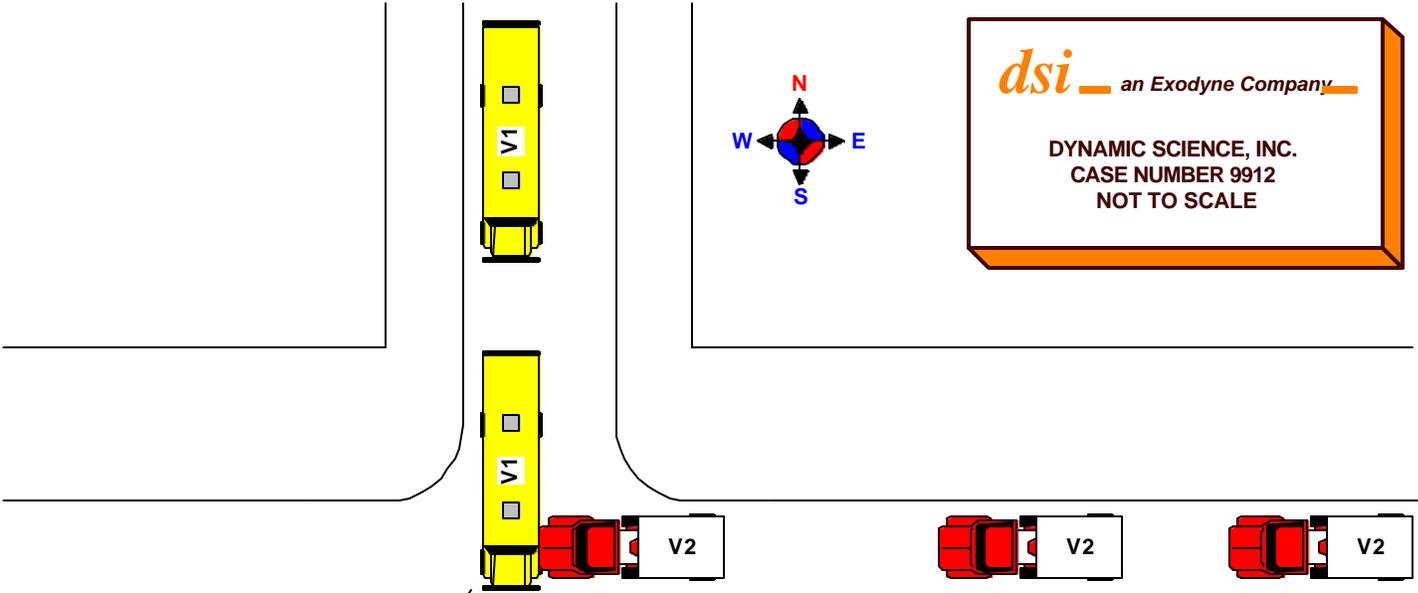
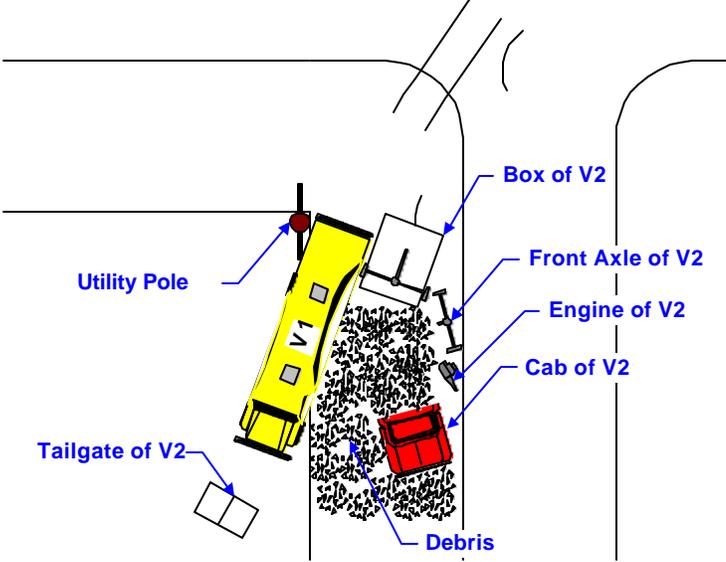
DYNAMIC SCIENCE, INC.
CASE NUMBER 9912
NOT TO SCALE

Following the initial impact, Vehicle 1 rotated slightly in a clockwise direction and Vehicle 2 rotated in a counterclockwise direction, moving in a side-by side configuration. During this movement, the box portion of the truck which was heavily laden with dead livestock, broke away, and the box impacted the mid-section of the passenger compartment on the left side of the bus in a sideslap type configuration. The vehicles continued in a southwesterly direction, and the right side of the bus impacted and cracked a utility pole, and sheared an underground utility box. Both vehicles came to their final rest positions in a ditch on the southwest corner of the intersection.

The box of the truck, with the frame attached, was resting on the roof of the school bus.

Damage to Vehicle 1 is shown on the police report sketch as including the left front fender, and extensive damage along the left side of the bus including the roof area. There was extensive intrusion on the left side from the impact with the truck box. In addition, there is severe damage noted to the right side door area, and crush extending along the frame rail area to the rear wheels. Undercarriage damage was also noted, and the right front tire was apparently restricted by the front bumper. The windshield was shattered.
