On-scene Investigation / Vehicle to Vehicle Dynamic Science, Inc. / Case Number: DS99014 1998 Oldsmobile Intrigue California January, 1999 This document is disseminated under the sponsorship of the Department of Transportation in the interest of information exchange. The United States Government assumes no responsibility for the contents or use thereof.

# Dynamic Science, Inc. Accident Investigation Case Number: DS99014

Description:	This case was initiated in response to a report of an inadvertent air bag deployment. This case is being conducted as an on-scene investigation. NHTSA was notified by the driver of the case vehicle.
Investigation Type:	On-scene
Crash Location: Crash Date: Notification Date: Field Work Completed:	California January 1999 January 29, 1999. February 17, 1999

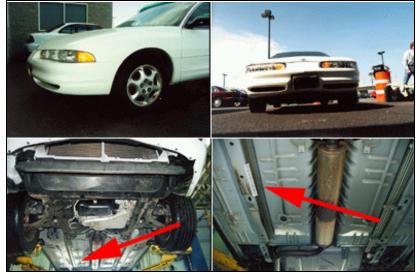
Figure 2. Exterior, Vehicle 1

An in-depth inspection of the vehicle exterior–and in particular the undercarriage–was conducted. While there are several minor scrapes to the undercarriage, there is no indication of any impactrelated damage which may have caused the deployments.

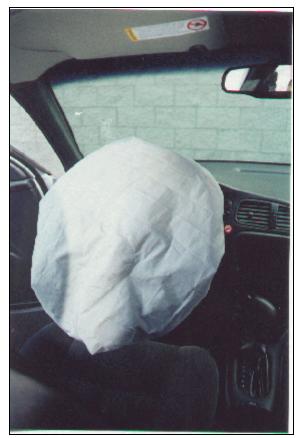
Figure 3. Driver air bag.

A GM representative attached the diagnostic tool and downloaded the data from the SDM<sup>1</sup>. Three copies of the data were printed out. On August 3, 1999, the GM representative reported on the interpretation of the codes. The bottom line is that the engineers do not know why the air bags deployed inadvertently. There was no indication of an above-threshold event. The highest delta v recorded was 2.7 km/h (1.7 mph). They report the deployment as essentially a mystery.

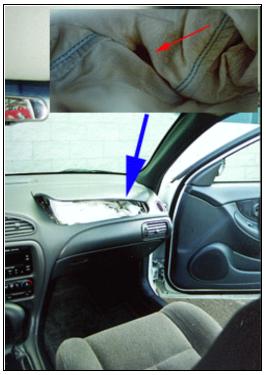
Figure 5. Passenger side air bag.

During the interior inspection, it was determined that there was a problem with the passenger side frontal air bag. The air bag had not fully deployed. Some mechanism had restricted the air bag's movement. The air bag was unfurled in a step by step fashion. Further investigation revealed that the air bag (in the area near the middle and right side seams) had been heat-fused to a piece of plastic that is approximately  $2.5 \times 15.2 \text{ cm} (1 \times 6 \text{ in.})$ . The air bag had melted and burned in this area. The piece of plastic has several rivets in it. Its origin or purpose is not known.

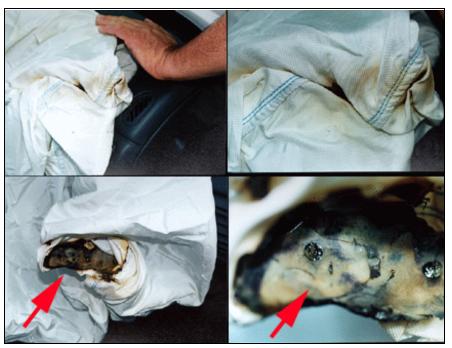
**Figure 6**. Passenger air bag. Shows exterior of air bag first, then the melted pieces of plastic found on the inside.
