Remote, Redesigned Air Bag Special Study
FOR NHTSA'S INTERNAL USE ONLY
Dynamic Science, Inc., Case Number (DS99025)
1998 Mercury Mystique
California
June / 1998

1. Report No. DS99025	2. Government Accession No.	3. Recipient Catalog No.	
4. Title and Subtitle		5. Report Date January 12, 2000	
		6. Performing Organization Report No.

Summary

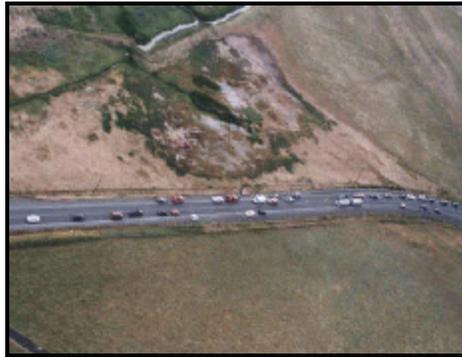
Figure 1. Aerial view of crash scene

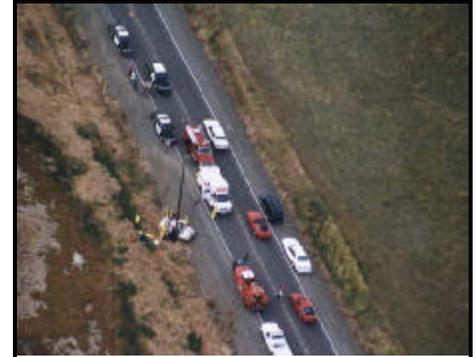
Figure 2. Aerial view of crash scene

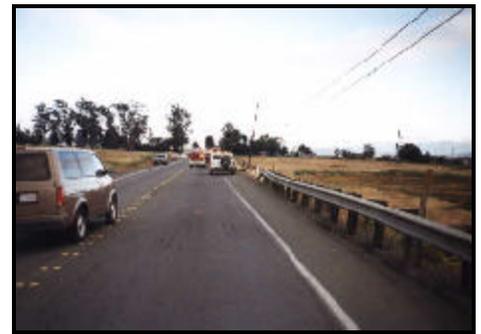
Figure 3. Pre-impact trajectory of Vehicle 1

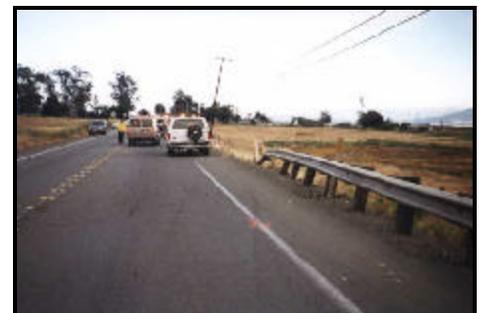
Figure 4. Vehicle 1 initiates clockwise rotation

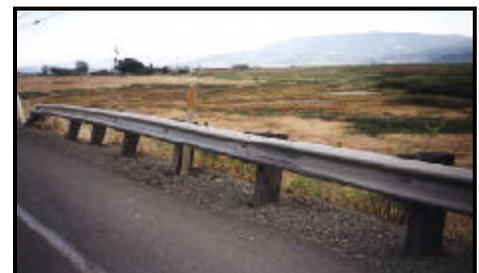
Figure 5. Guardrail impact

After the pole impact, Vehicle 1 rebounded, coming to rest on all four tires and facing southeast. The front, right bumper corner impact with the guardrail was of insufficient force to deploy the redesigned frontal air bags and the rollover and utility pole impacts were non-horizontal directions of force. The driver of the Mystique was partially ejected through the front, left window opening. Driver 1 was fatally injured as her head impacted the utility pole.

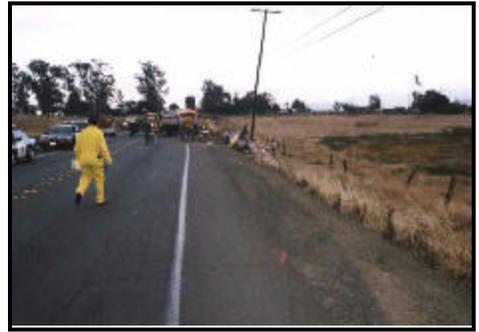
Figure 6. Pre-Rollover View

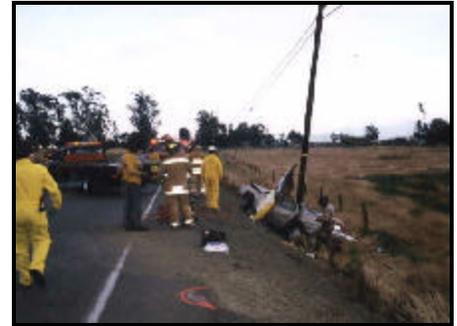
Figure 7. View showing rollover area

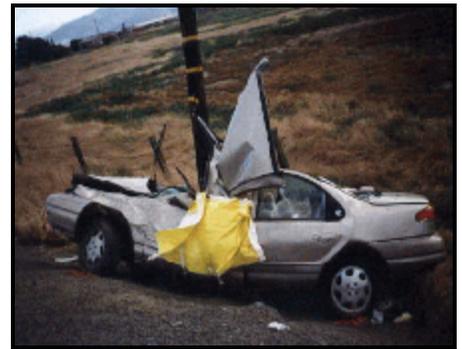
Figure 8. View showing pole impact and Vehicle 1's final rest

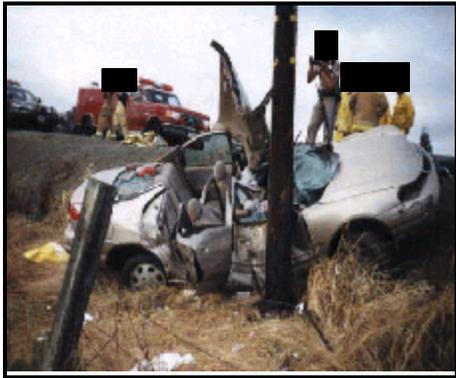
Figure 9. Right side of Mercury

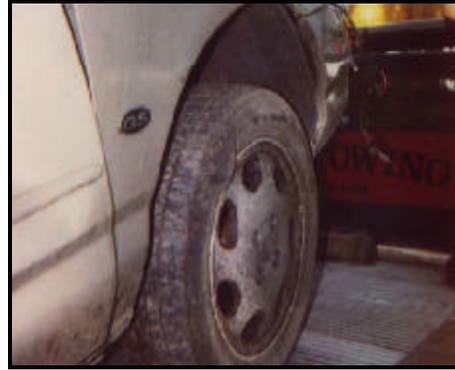
Figure 10. Damaged front, right tire/
tripping force resulting in rollover
