Remote, Redesigned Air Bag Special Study  
**FOR NHTSA'S INTERNAL USE ONLY**  
Dynamic Science, Inc., Case Number ( DS9928)  
1998 Dodge Ram pickup  
California  
August/1998

1. Report No. DS9928		2. Government Accession No.		3. Recipient Catalog No.	
4. Title and Subtitle				5. Report Date December 21, 1999	
				6. Performing Organization Report No.

**Summary**

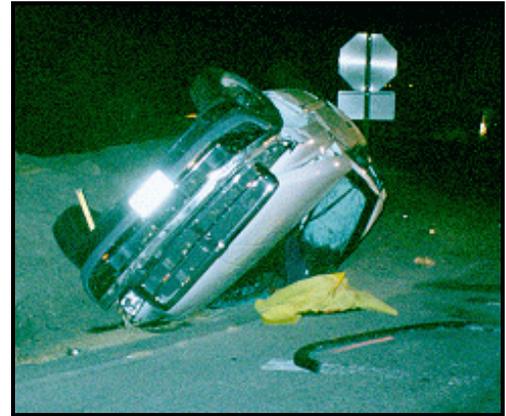
**Figure 1.** Exterior, Vehicle 1 (case vehicle)

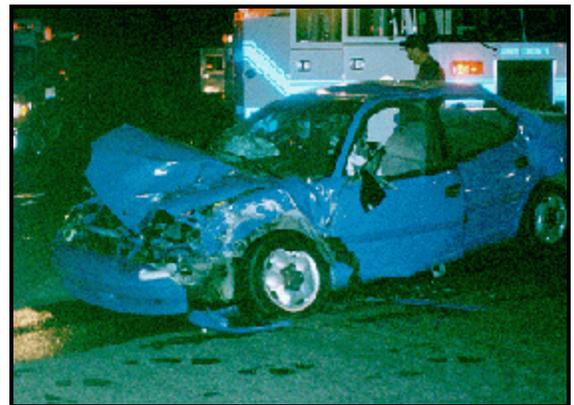
**Figure 2.** Exterior, Vehicle 2

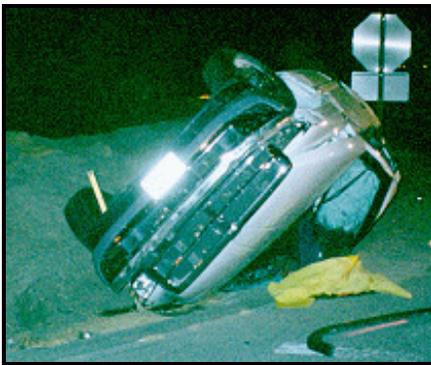
**Figure 3.** Exterior, Vehicle 1

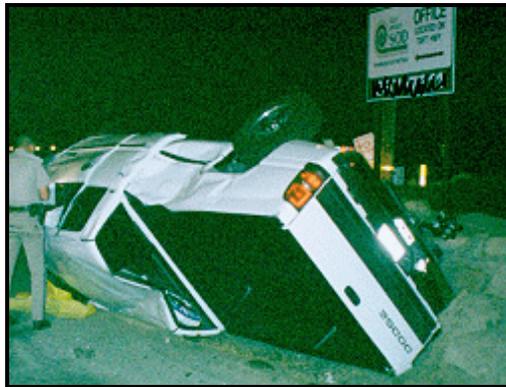
**Figure 4.** Exterior, Vehicle 1
