REMOTE AIR BAG DEPLOYMENT REPORT

CASE NUMBER - IN99-028

VEHICLE - 1998 PLYMOUTH NEON

CRASH DATE - May 1998

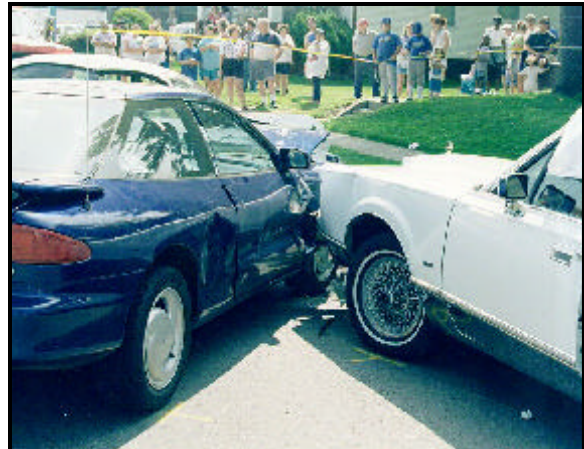
Figure 2: Southeast view of final rest positions of the case vehicle (top visible at top left), the Ford (center-left), and the parked vehicle (center-right) (case photo #12)

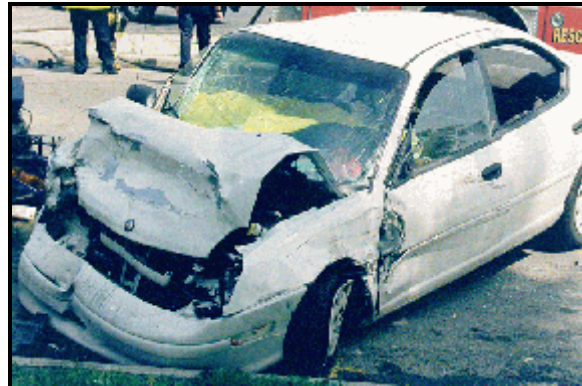
Additional direct contact damage was sustained by the case vehicle during the crash sequence's second impact (head-on) with the Ford (**Figure 3**). Damaged components included: the front bumper and fascia pushed rearward; the front grille shattered; the left and right headlamp assemblies shattered; the front radiator and engine compartment brackets shoved rearward; the front of the hood was overridden, buckled, and the right rear corner contacted the right upper A-pillar; and the right front fender was pushed rearward into the lower right A-pillar. The interior right side of the windshield was contacted by the driver's head. Induced damage included: the right front door buckled vertically in the middle and sprung open; the right roof rail buckled at the right B-pillar; the right rear door was sprung open; and the left side of the windshield was splintered. The CDC for the case vehicle's second impact (head-on), estimated from police photographs, is: **12-FDEW-2**, with a principal direction of force of 0 degrees. The WinSMASH reconstruction program was used to calculate Delta V based on a CDC-only estimated crush profile. These CDC-only calculations provide a borderline reconstruction, but the results appear to be reasonable. The case vehicle's estimated Total, Longitudinal, and Lateral Delta Vs are, respectively: 48 km.p.h. (30 m.p.h.), -48 km.p.h. (-30 m.p.h.), and 0.0 km.p.h. (0.0 m.p.h.). The crash severity for the case vehicle was high [greater than 40 km.p.h. (25 m.p.h.)].

Figure 3: Case vehicle damaged planes, side damage on the left and head-on damage across frontal plane (case photo #03)

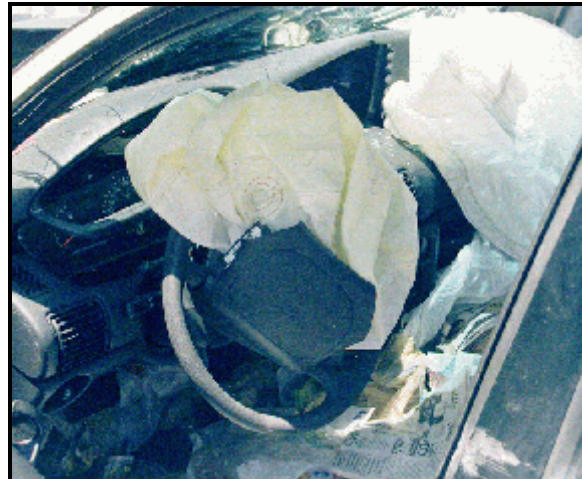
Figure 4: Case vehicle's deployed, dual, redesigned air bags (case photo #16)

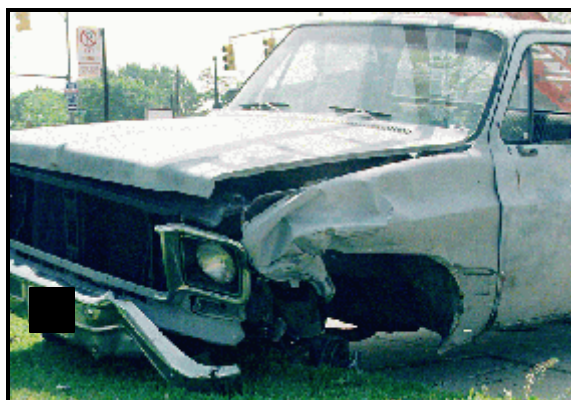
Figure 5: Chevrolet's left side damage from side impact with the case vehicle's left side; Note: missing left front tire and wheel (case photo #08)

#1 in the crash sequence), direct contact damage to the Chevrolet included: the wrap-around portion of the front left bumper corner scraped and the left third of the front bumper bent forward; the left side of the left headlamp assembly's chrome molding dented; the left front fender pushed back and scraped; the left front tire and wheel torn off; and the lower forward edge of the left door seam scraped (**Figure 5**). Based on available police photographs, the CDC for the Chevrolet is: **12-LYEW-2**. The WinSMASH reconstruction program was not run for this left side to left side impact. The Chevrolet was equipped with aftermarket cast aluminum recessed wheels. It appears that the left front wheel snagged against the case vehicle's left front tire and wheel and the Chevrolet's wheel broke off at the lug nuts, leaving the wheel's hub attached to the axle. The force required to cause such a break was likely sufficient to deploy the case vehicle's air bags. The Chevrolet's driver [27-year-old male; race, ethnicity, height, and weight unknown] did not have his restraint use reported. He was the only occupant in the Chevrolet. He sustained minor, visible injuries and was transported by ambulance to a medical facility.

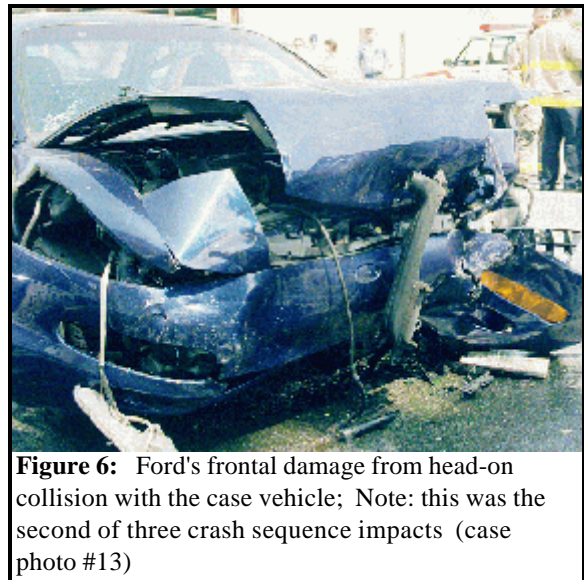
Figure 6: Ford's frontal damage from head-on collision with the case vehicle; Note: this was the second of three crash sequence impacts (case photo #13)

From the collision with the case vehicle (impact #2 in the crash sequence), direct contact damage to the Ford included: the front bumper and fascia pushed rearward; the front grille shattered; both headlamp assemblies shattered; the right front turn signal assembly dangling by a wire and its lens broken; the left front and right front fenders pushed rearward; and the front of the hood pushed rearward, with the back two-thirds moderately tented (**Figure 6**). The bottom right corner of the windshield was splintered due to contact with the back right corner of the hood. Based on available police photographs, the CDC for the Ford's impact (the second of three in this crash sequence) with the case vehicle was: **12-FDEW-2**, with a principal direction of force of 0 degrees. The WinSMASH reconstruction program was used to calculate Delta V based on a CDC-only estimated crush profile. These CDC-only calculations provide a borderline reconstruction, but the results appear reasonable. The Ford's estimated Total, Longitudinal, and Lateral Delta Vs are, respectively: 48 km.p.h. (30 m.p.h.), -48 km.p.h. (-30 m.p.h.), and 0.0 km.p.h. (0.0 m.p.h.).

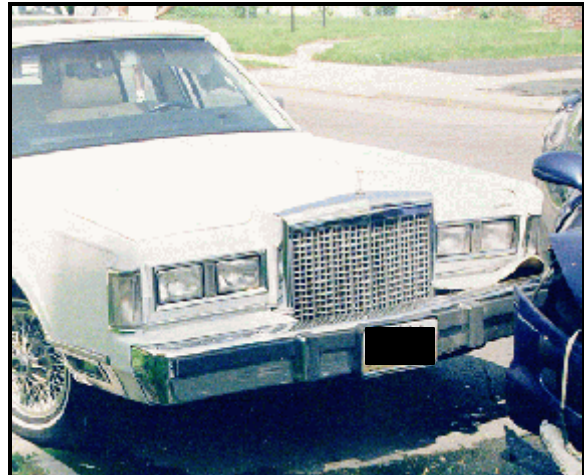
Recall that the parked vehicle was unoccupied. According to the Police Crash Report, the parked vehicle was a 1985 Lincoln Town Car. If that is correct, then it is a rear wheel drive, six-passenger, four-door sedan. No vehicle identification number (VIN) was provided on the police report. The parked vehicle did not contact the case vehicle. Direct contact damage to the parked vehicle was limited to the front left bumper corner, the front left bumper flashing, and the front of the left front fender (**Figure 7** above). An estimated CDC for the parked vehicle's impact (the third of three in this crash sequence) with the Ford was: **10-LFEE-1**.

Figure 7: Unoccupied and parked vehicle's front left corner damage from third of three crash sequence events (case photo #14)
