Remote, Redesigned Air Bag Special Study
FOR NHTSA'S INTERNAL USE ONLY
Dynamic Science, Inc., Case Number (DS99045)
1998 Dodge Caravan
Oregon
September/1998

Summary

This remote investigation was initiated in response to a possible redesigned air bag deployment. The case was selected from the FARS data files. The redesigned air bag was installed in a 1998 Dodge Caravan.

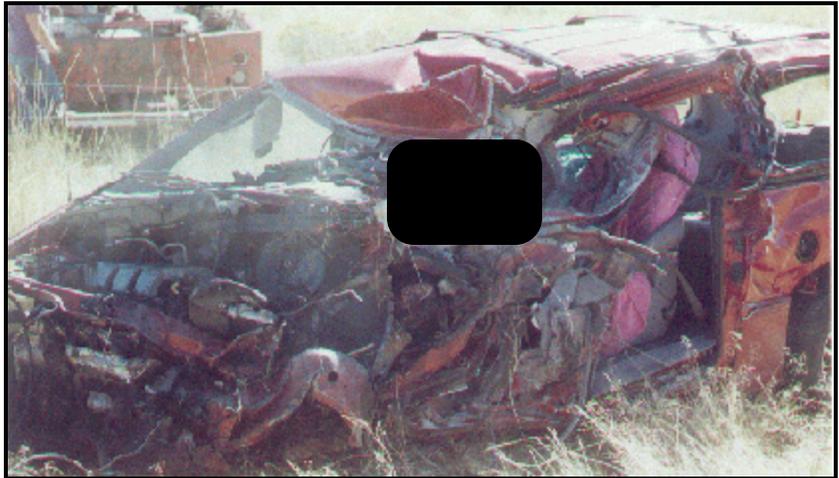
Figure 1. Front left, Dodge Caravan

The case vehicles sustained substantial longitudinal intrusion of the left instrument panel, toe pan, and A-pillar. There was intrusion along the entire left side. There was integrity loss through the windshield, left front side window, and both left rear windows. There are photos that indicate there might be some integrity loss on the right rear side but this is most likely due to extrication efforts.

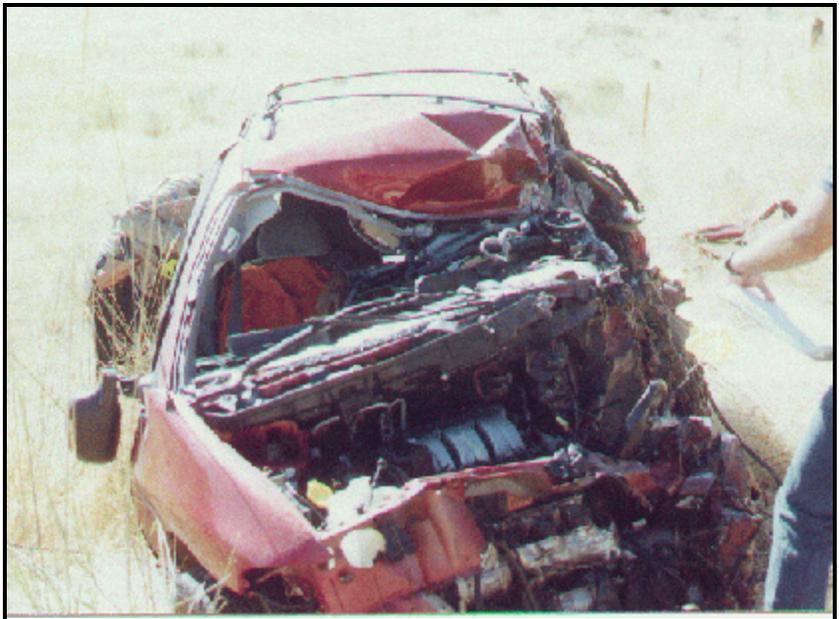
Figure 2. Front, Dodge Caravan

The driver of the Dodge Caravan was apparently tired. A witness in the case vehicle indicated that he kept falling asleep. Just prior to the crash, she saw the driver adjust his seat and saw his hands slip off the steering wheel. The Dodge Caravan crossed the center line and struck the Freightliner head-on. A longitudinal delta v of -83.5 km/h (-51.9 mph) was calculated using the WinSmash barrier option for the Dodge Caravan using a CDC of 12FLAE9. The driver of the Freightliner saw the case vehicle but was unable to stop in time.

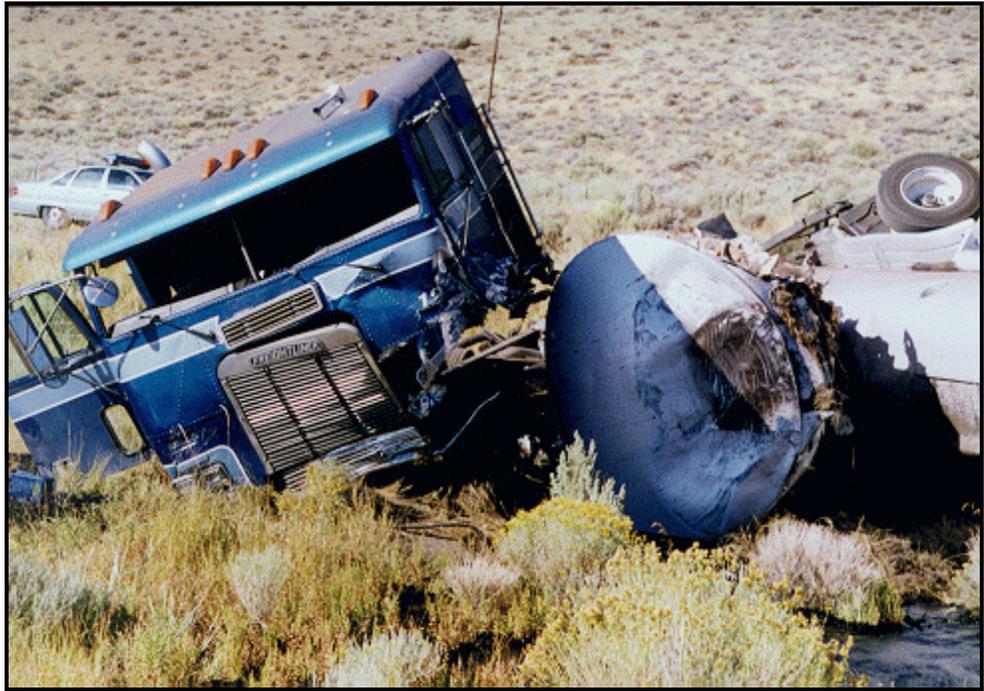
Figure 3. Freightliner at final rest

The Freightliner began a counterclockwise rotation after impact. The vehicle crossed the northbound travel lanes and departed the roadway. The trailer separated from the tractor and overturned. This vehicle came to rest off the roadway, on top of a fence, facing northwest.
