U.S. Department  
Of Transportation

National Highway  
Traffic Safety  
Administration

# **Technical Assessment of Toyota Electronic Throttle Control (ETC) Systems**

**February 2011**

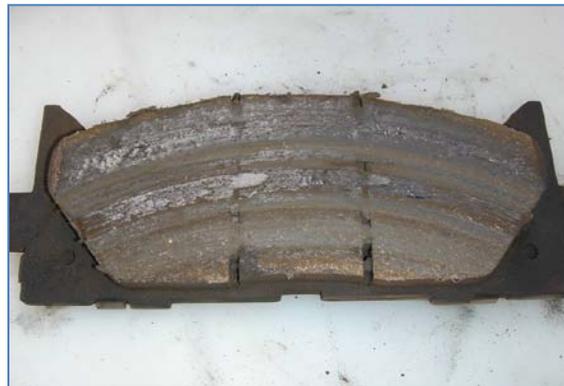
Brake fade is a reduction in braking effectiveness or stopping power that occurs due to friction-related thermal effects of repeated and/or sustained brake application, especially in high-speed conditions. Post-incident inspections of brake components removed from vehicles involved in high-speed, long-duration incidents have revealed evidence of this type of thermal degradation of friction materials indicative of prolonged braking at speed (Figures 4 and 5). This type of damage has only been observed in incidents that originated at highway speeds and involved prolonged open-throttle braking.<sup>45</sup> These types of events were first observed by NHTSA in 2006 in MY 2007 Lexus ES 350 vehicles<sup>46</sup> and, to date, such brake system overheating in UA incidents has only been observed in events involving throttles stuck wide-open due to pedal entrapment.

**Figure 4: Left-front inboard brake pad; 2007 Lexus ES350 (ODI 10182245)**

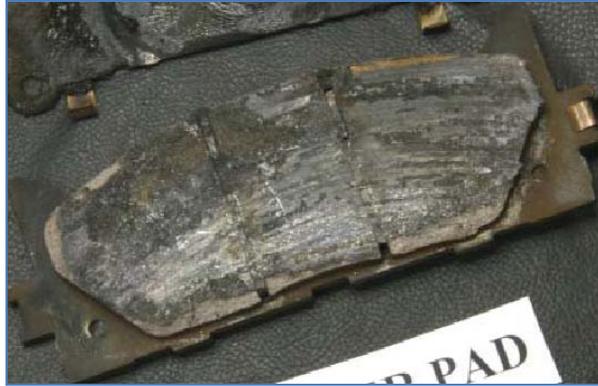
**Figure 5: Left-front inboard brake pad; 2009 Lexus ES350 (ODI 10284881)**
