Case 366 : Narrative

Case Vehicle (A): 2002 Ford	Vehicle (B): 2002 Chevrolet
Type: Explorer XLT, 4-door, SUV	Type: Silverado, 4-door, pickup
Driver: 57-year-old female	Driver: 25-year-old female
CDC: 99-0000-0, 12-FDEW-3	CDC: 99-0000-0

CASE NO: 366-03

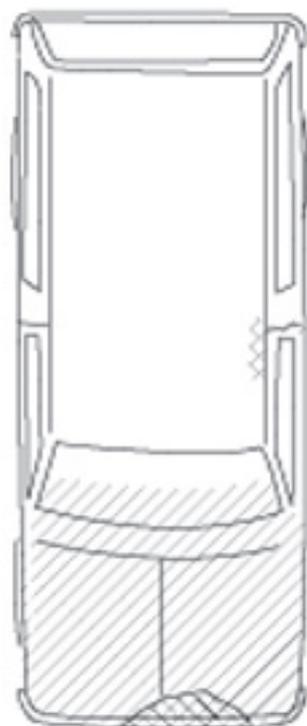
64 cm max crush
located left of center
at front bumper

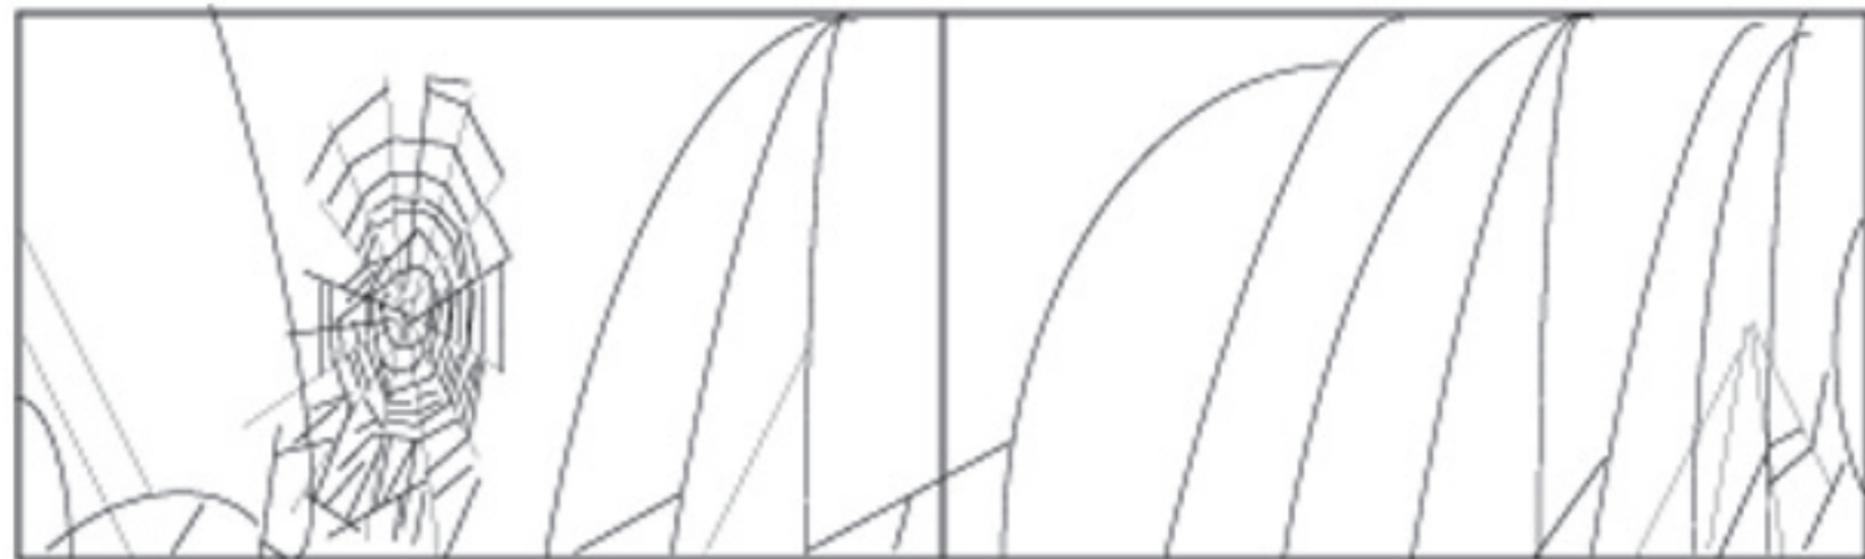
- A= windshield, spiderweb-crack**
- B= steering-wheel airbag, blood**
- C= steering wheel, deformed**
- D= knee bolster, scuffmark**
- E= knee bolster, scuffmark**
- F= brake pedal, deformed**
- G= dash-mounted airbag, blood**
- H= passenger seat cushion, blood**
