## Case 370 : Narrative

Case Vehicle (A): 2002 Pontiac	Vehicle (B): 1991 Chevrolet
Type: Grand Prix GT, 4-door sedan	Type: S-10 pickup truck
Driver: 23-year-old female	Driver: 17-year-old male
CDC: 12-FDEW-1	CDC: 03-RZEW-3

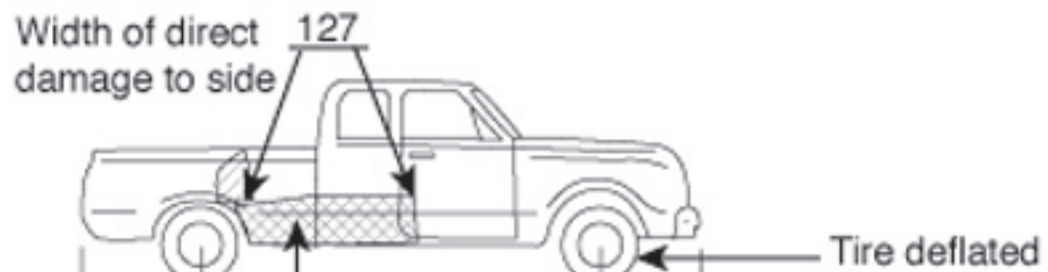
40  
Max. lateral crush  
to truck bed at  
frame level

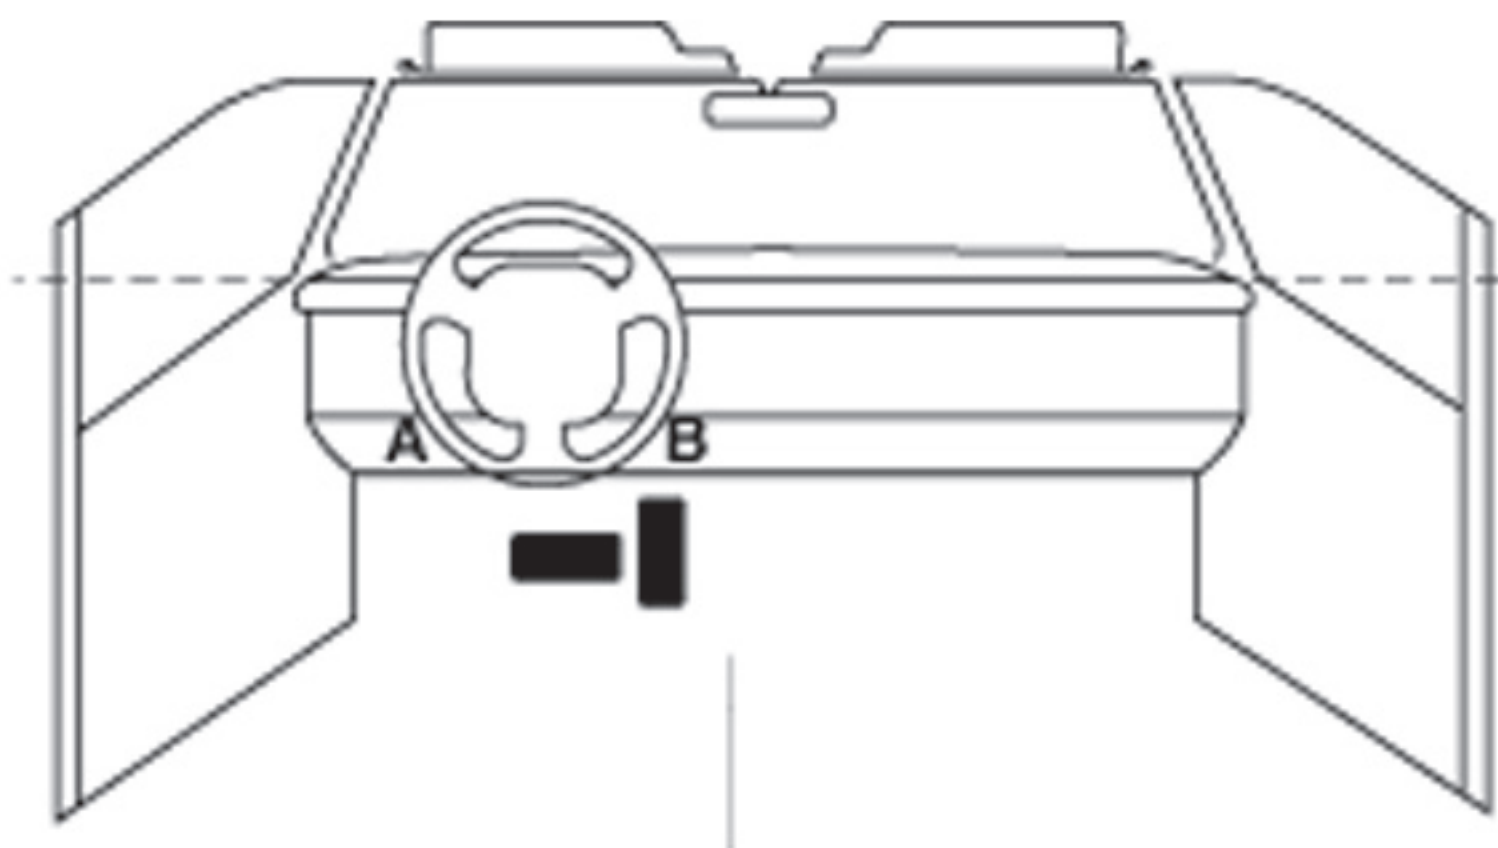
**A = Scuff mark**  
**B = Scuff mark**
