Case 422 : Narrative

Case Vehicle (A): 2001 Jeep	Vehicle (B): 2002 Ford
Type: Cherokee Sport, 4x4, 4-door SUV	Type: Mustang, 2-door convertible
Driver: 43-year-old male	Driver: 41-year-old female
CDC: 01-FDEW-2	CDC: 10-LYAW-3

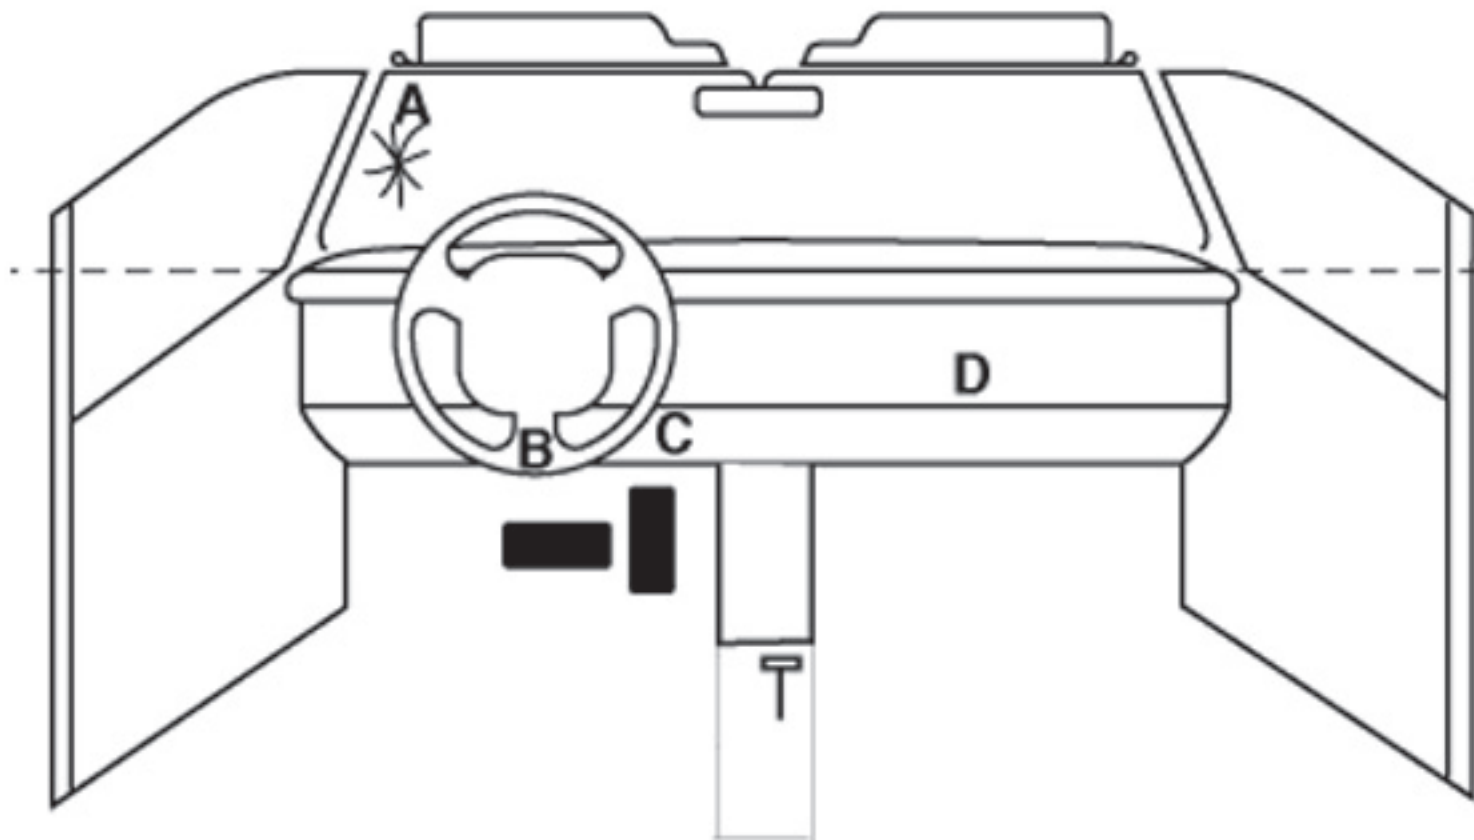
- A = windshield, cracked**
- B = steering-wheel rim, bent forward**
- C = knee bolster, scuffed**
- D = glove box area, food deposit**

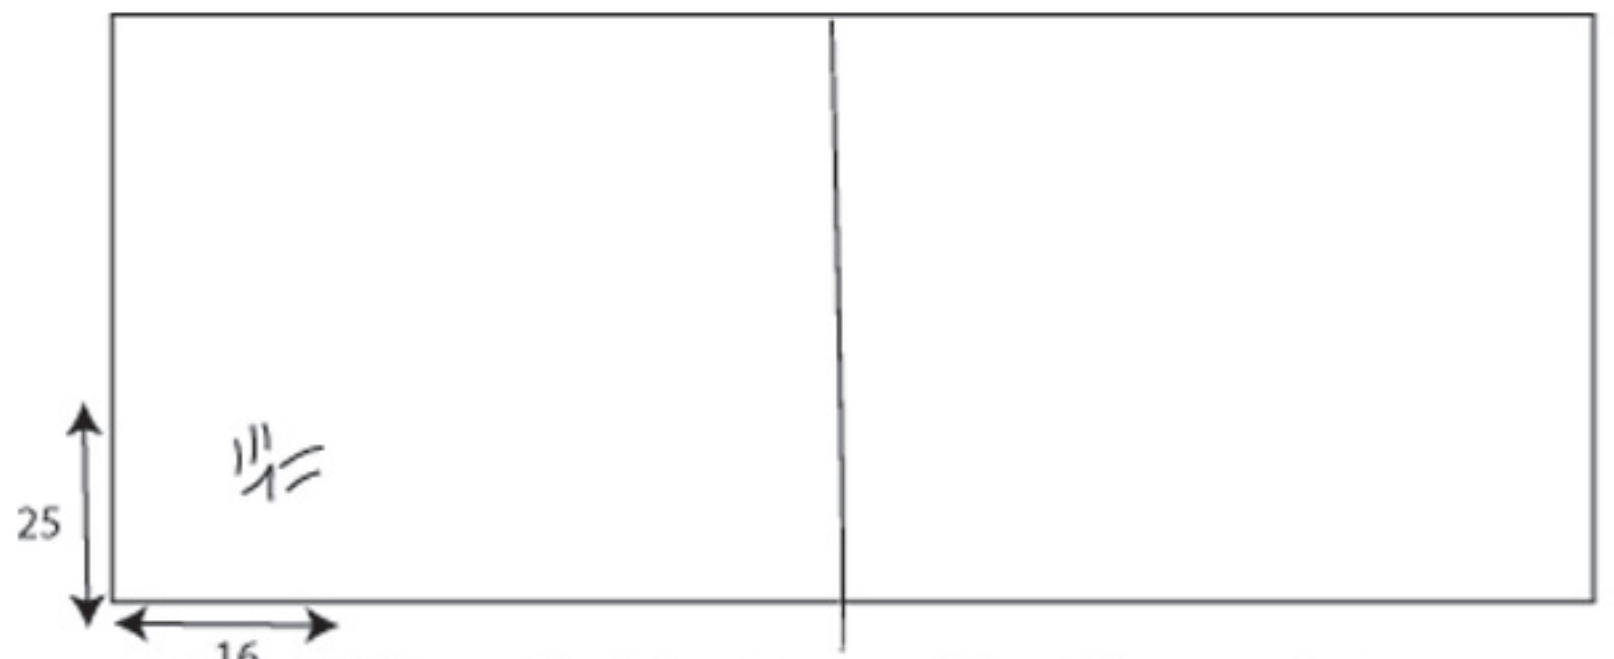
Windshield cracked due to possible driver contact
