## Case 457 : Narrative

Case Vehicle (A): 2002 Ford	Vehicle (B): 2004 Kenworth
Type: Mustang, 2-door coupe	Type: T800 tractor with double trailer
Driver: 40-year-old female	Driver: 38-year-old male
CDC: 12-FDEW-2	CDC: 99-0000-0

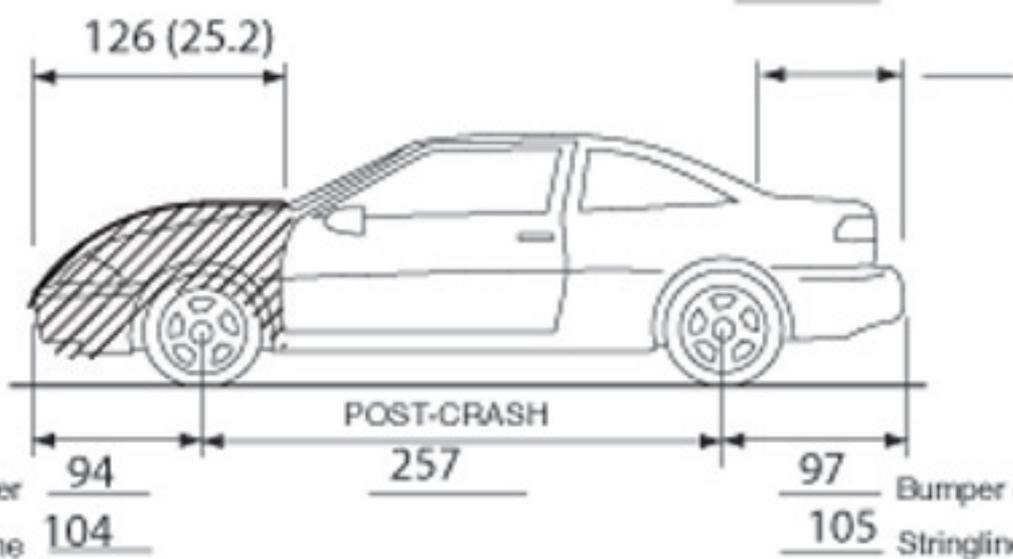
142-cm direct damage  
49-cm max above bumper crush  
31-cm max bumper crush  
40-cm average max bumper crush
