Case 474 : Narrative

| Case Vehicle (A): 2002 Mercury | Vehicle (B): 1997 Ford |
| Type: Grand Marquis LS, 4-door sedan | Type: Ranger XL, 4x2, 2-door pickup |

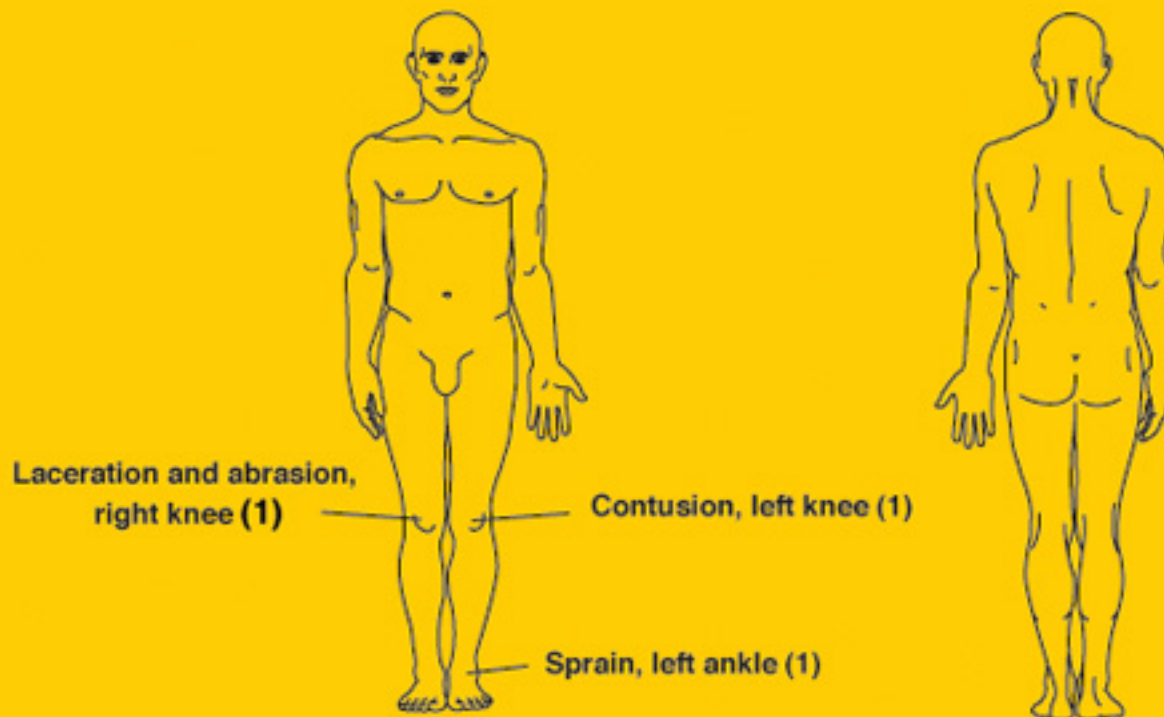
The following table and drawing [55](#) summarize the injuries for the driver of case vehicle (A).

| Occupant: Driver | Age: 77 years | Gender: Male | | |
|---|---|---|---|---|
| Laceration, right knee | 1 | — | Ashtray bracket | — |
| Abrasion, right knee | 1 | — | Knee bolster | — |
| Contusion, left knee | 1 | — | Knee bolster | — |
| Sprain, left ankle | 1 | — | Toepan | — |

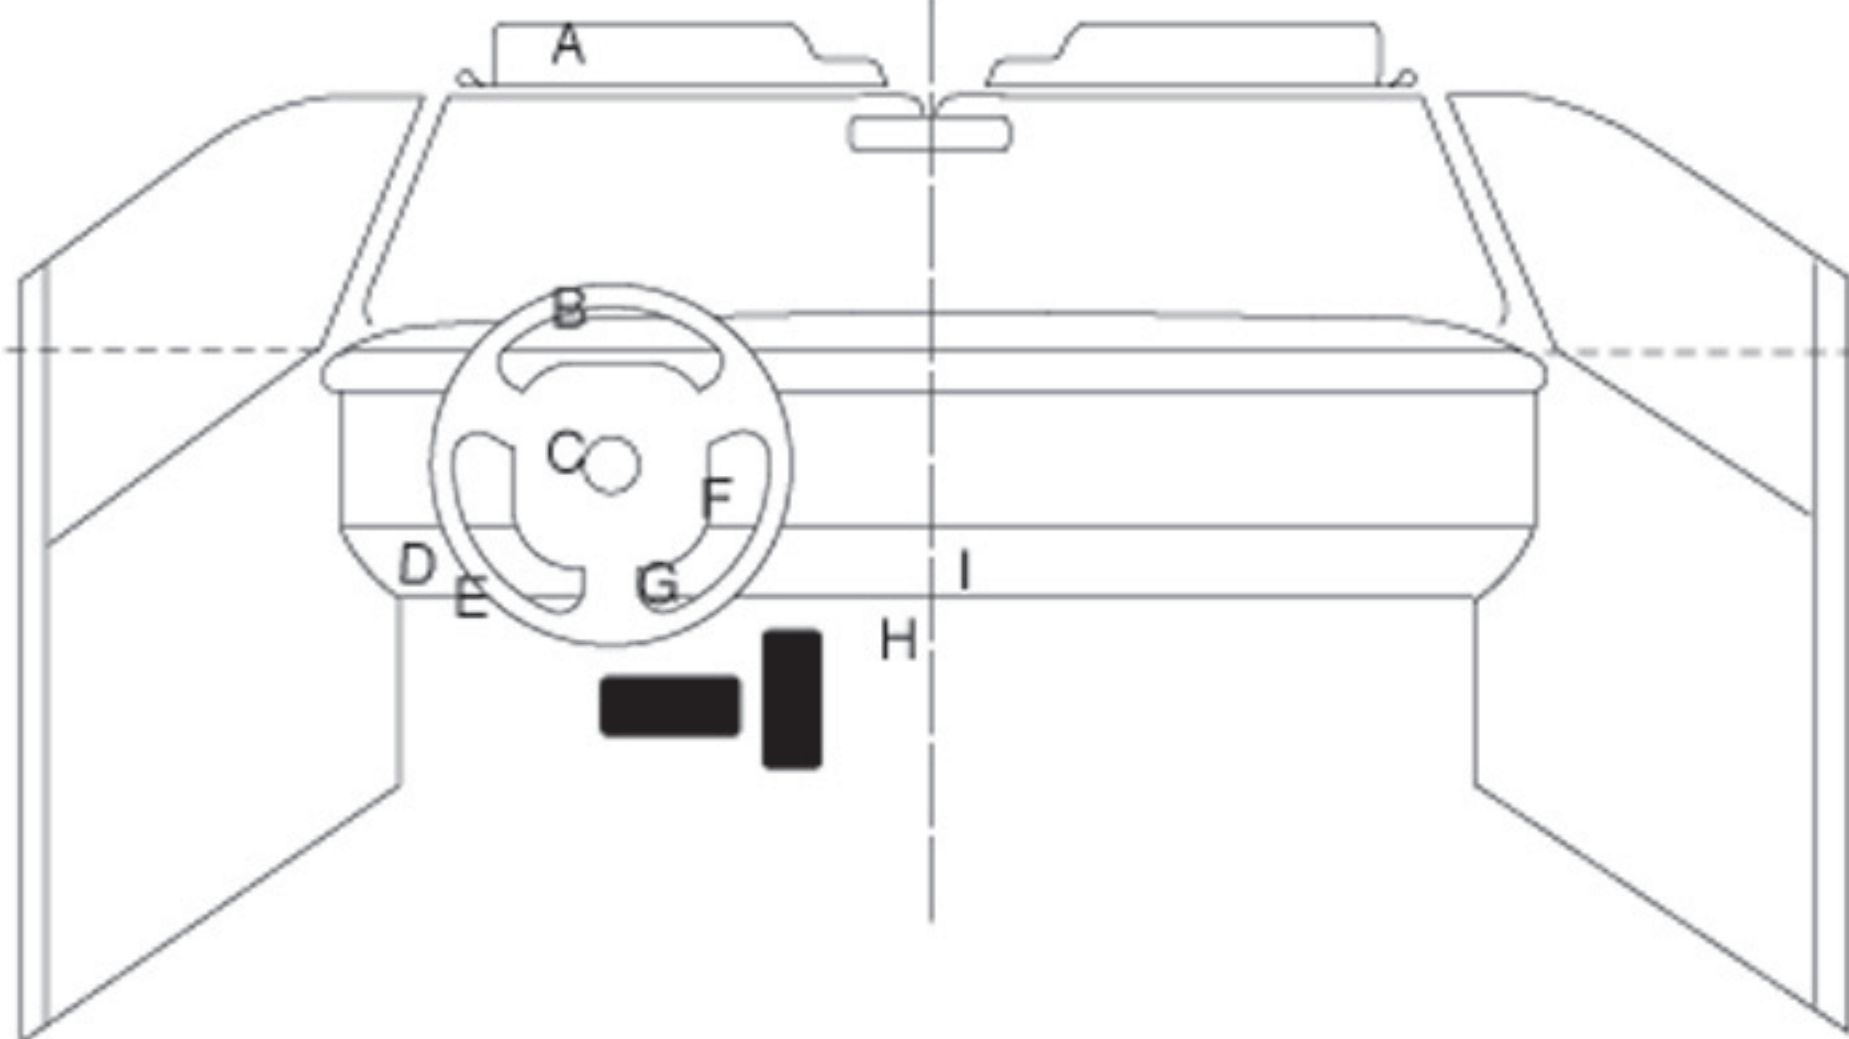
A = Sunvisor - scuff, hair, and vanity mirror broken

B = Steering wheel rim - cracked, bent

D = Knee bolster - crack

H = Knee bolster - dented, cracked and displaced forward

I = Ashtray and bracket - broken/bent

| Contact | Interior Component Contacted | Occupant No. if Known | Body Region if Known | Supporting Physical Evidence | Confidence Level of Contact Point |
|---|---|---|---|---|---|
| A | Sunvisor | Dr | Head | Scuff, hair, and vanity mirror broken | 1 |
| B | Steering-wheel rim | Dr | Chest | Cracked, bent | 1 |
| D | Knee bolster | Dr | Lt. LX | Crack | 1 |
| H | Knee bolster | Dr | Rt. knee | Dented, cracked and displaced forward | 1 |
| I | Ashtray & bracket | Dr | Rt. knee | Broken and bent | 1 |

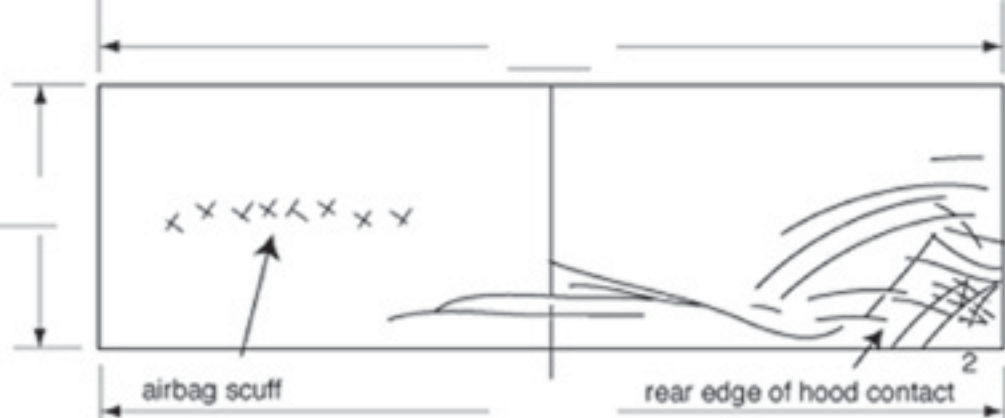
WINDSHIELD MARK ON CASE VEHICLE:

| V1168 | Windshield Cracked | 1 | Yes | more |

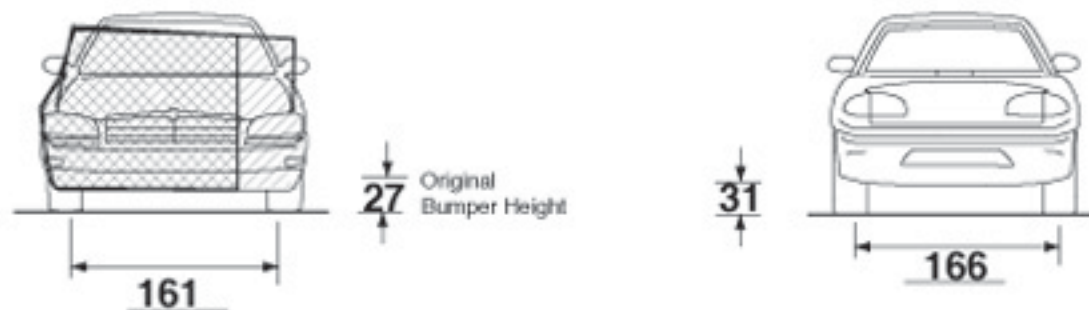
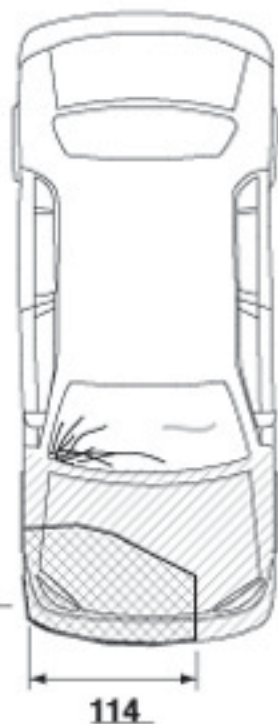
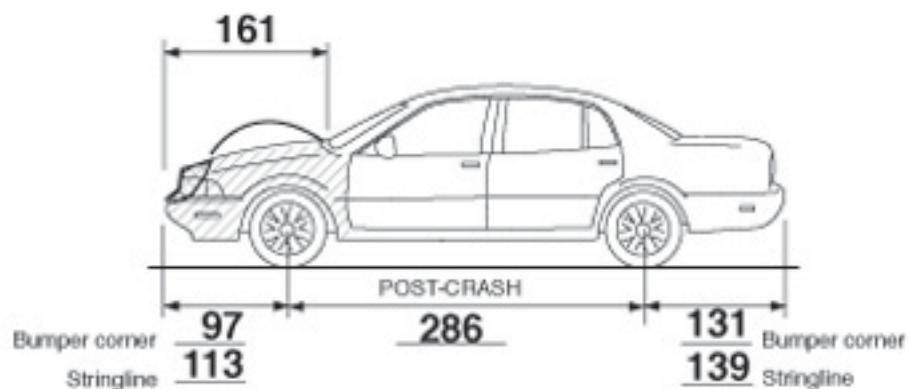
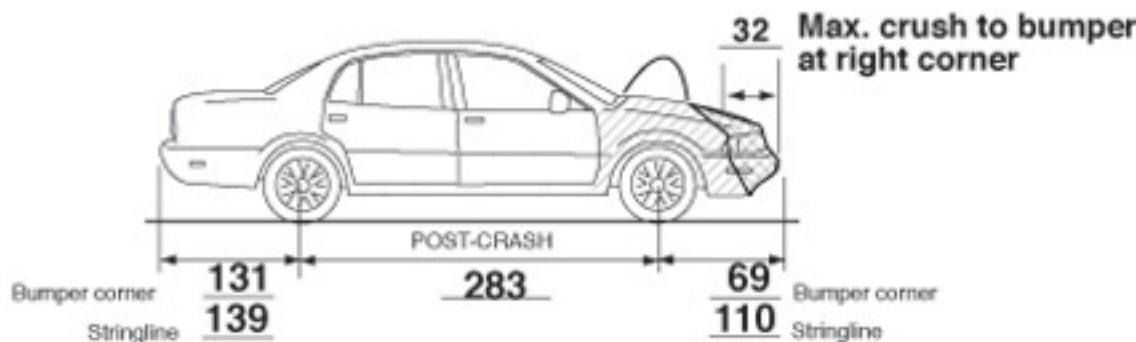
Using the missing-vehicle algorithm of the WinSMASH crash-reconstruction program and a crush profile measured for the front of case vehicle (A) [9](#) [10](#) [11](#) [12](#) at the level of the upper radiator support, the following impact severities were estimated:

Max. crush to right portion of upper radiator support - 57

Width of direct damage to front
