Case 476 : Narrative

Case Vehicle (A): 2003 Lincoln
Type: Town Car Signature, 4-door sedan
Driver: 79-year-old male
CDC: 12-LZES-1, 12-LBWN-2, 12-FZEN-4

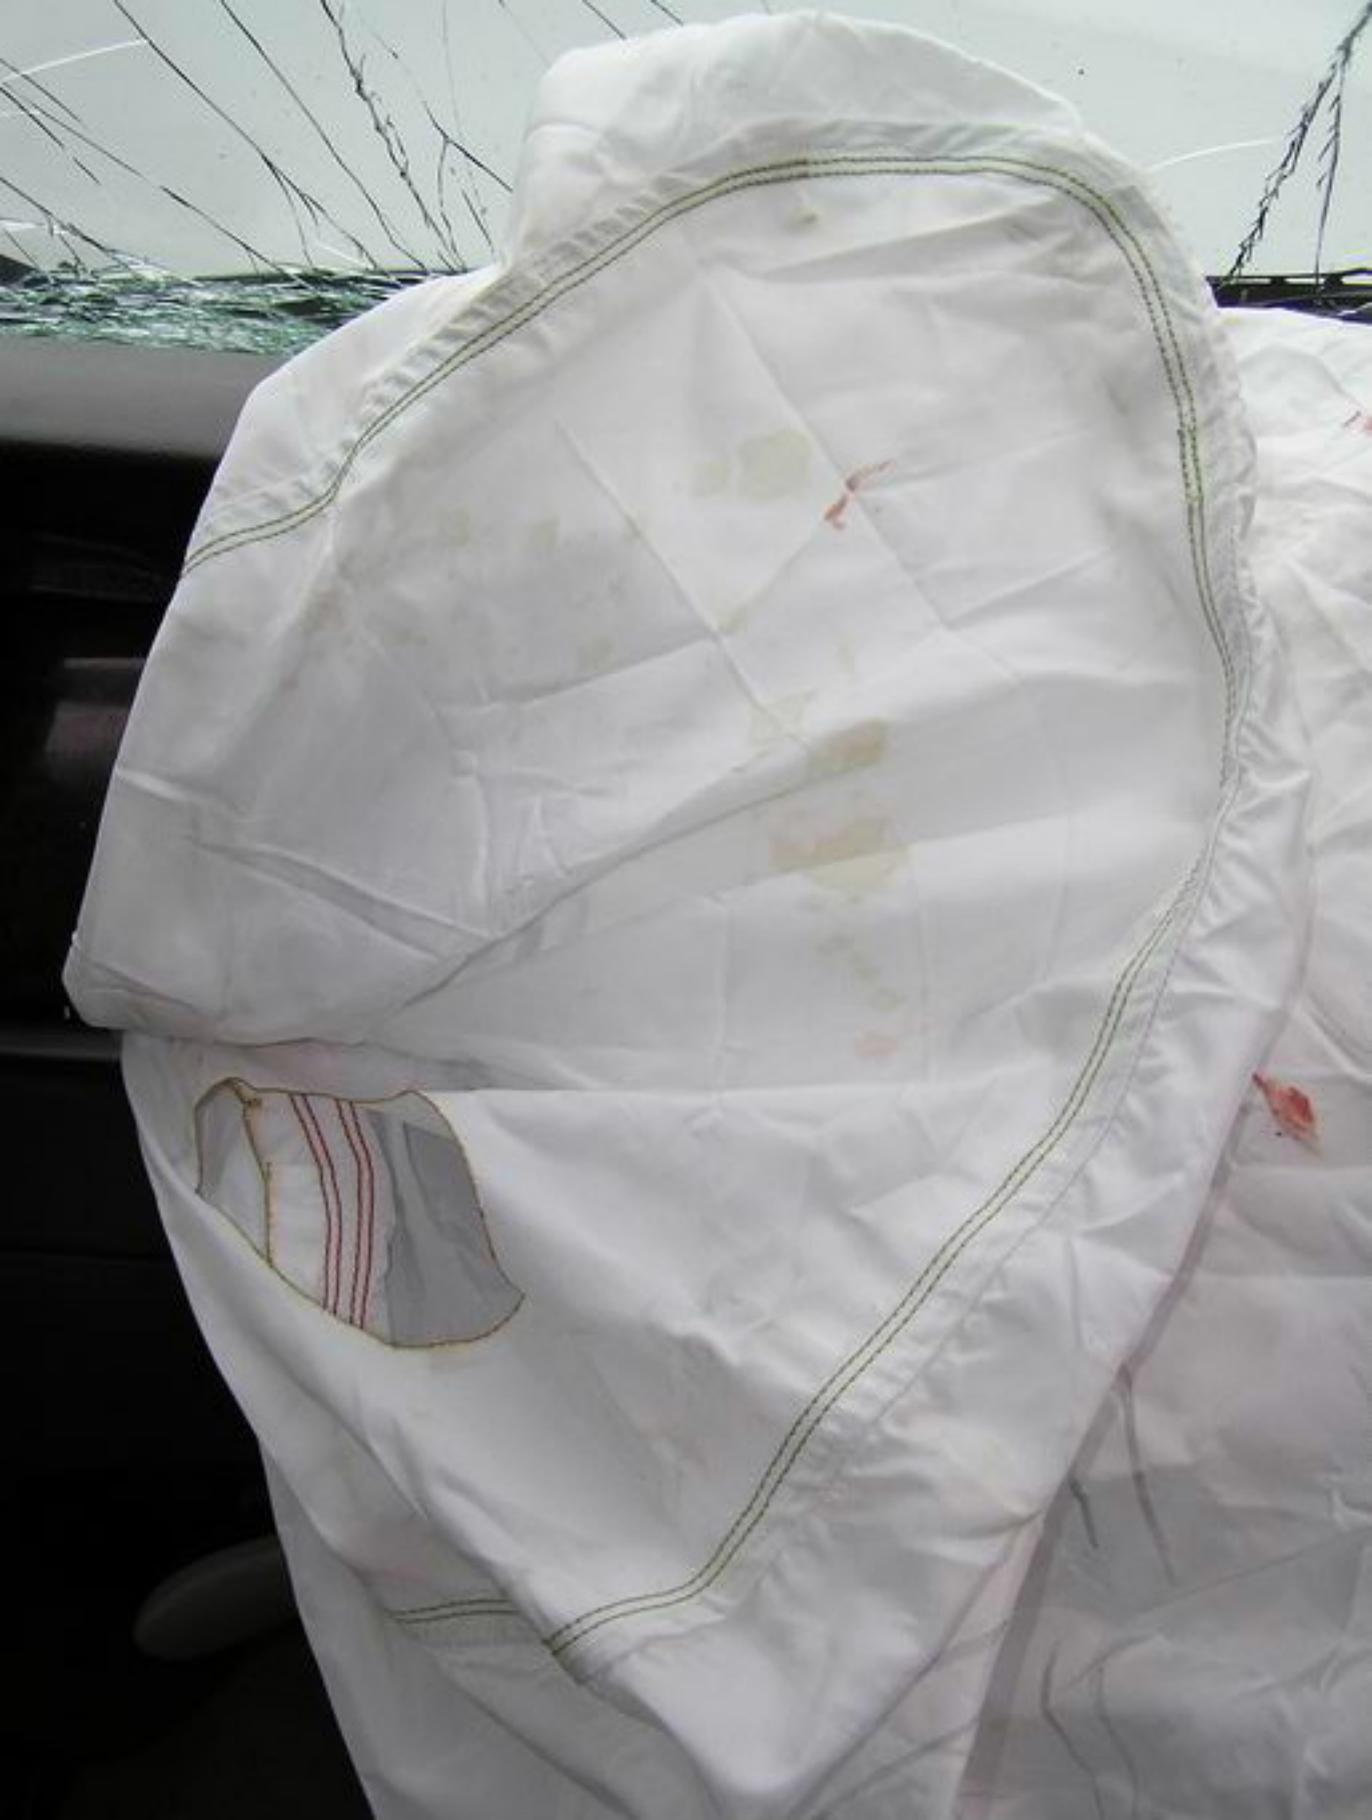
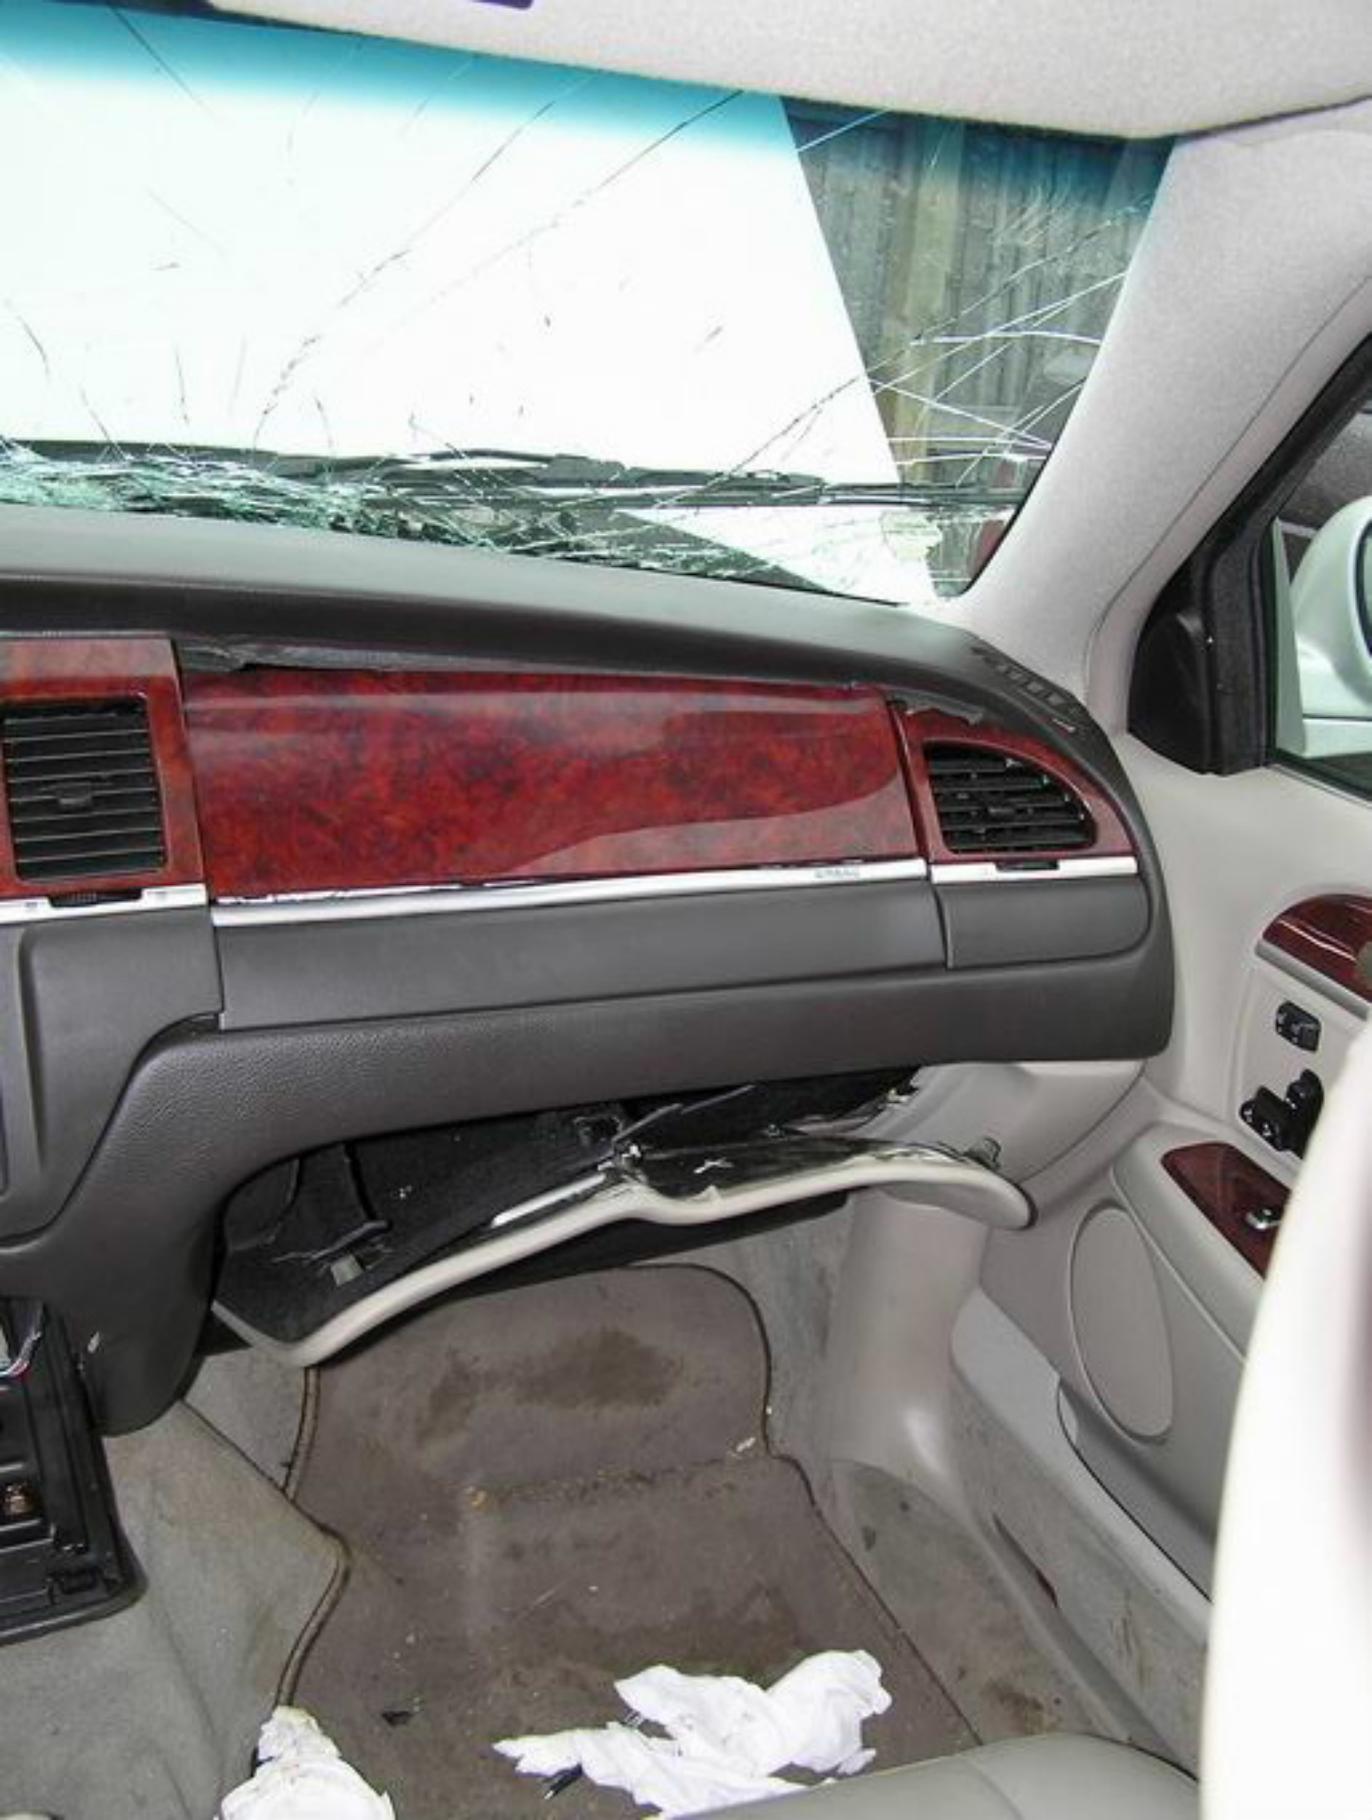
[34](#) This vehicle was equipped with steering-wheel and [35](#) dash-mounted frontal-impact airbags, and both deployed during the frontal impact with the tree. It was also equipped with head/thorax side-impact airbags installed in both of the front seatbacks and [36](#) [37](#) the right-front passenger side-impact airbag deployed.

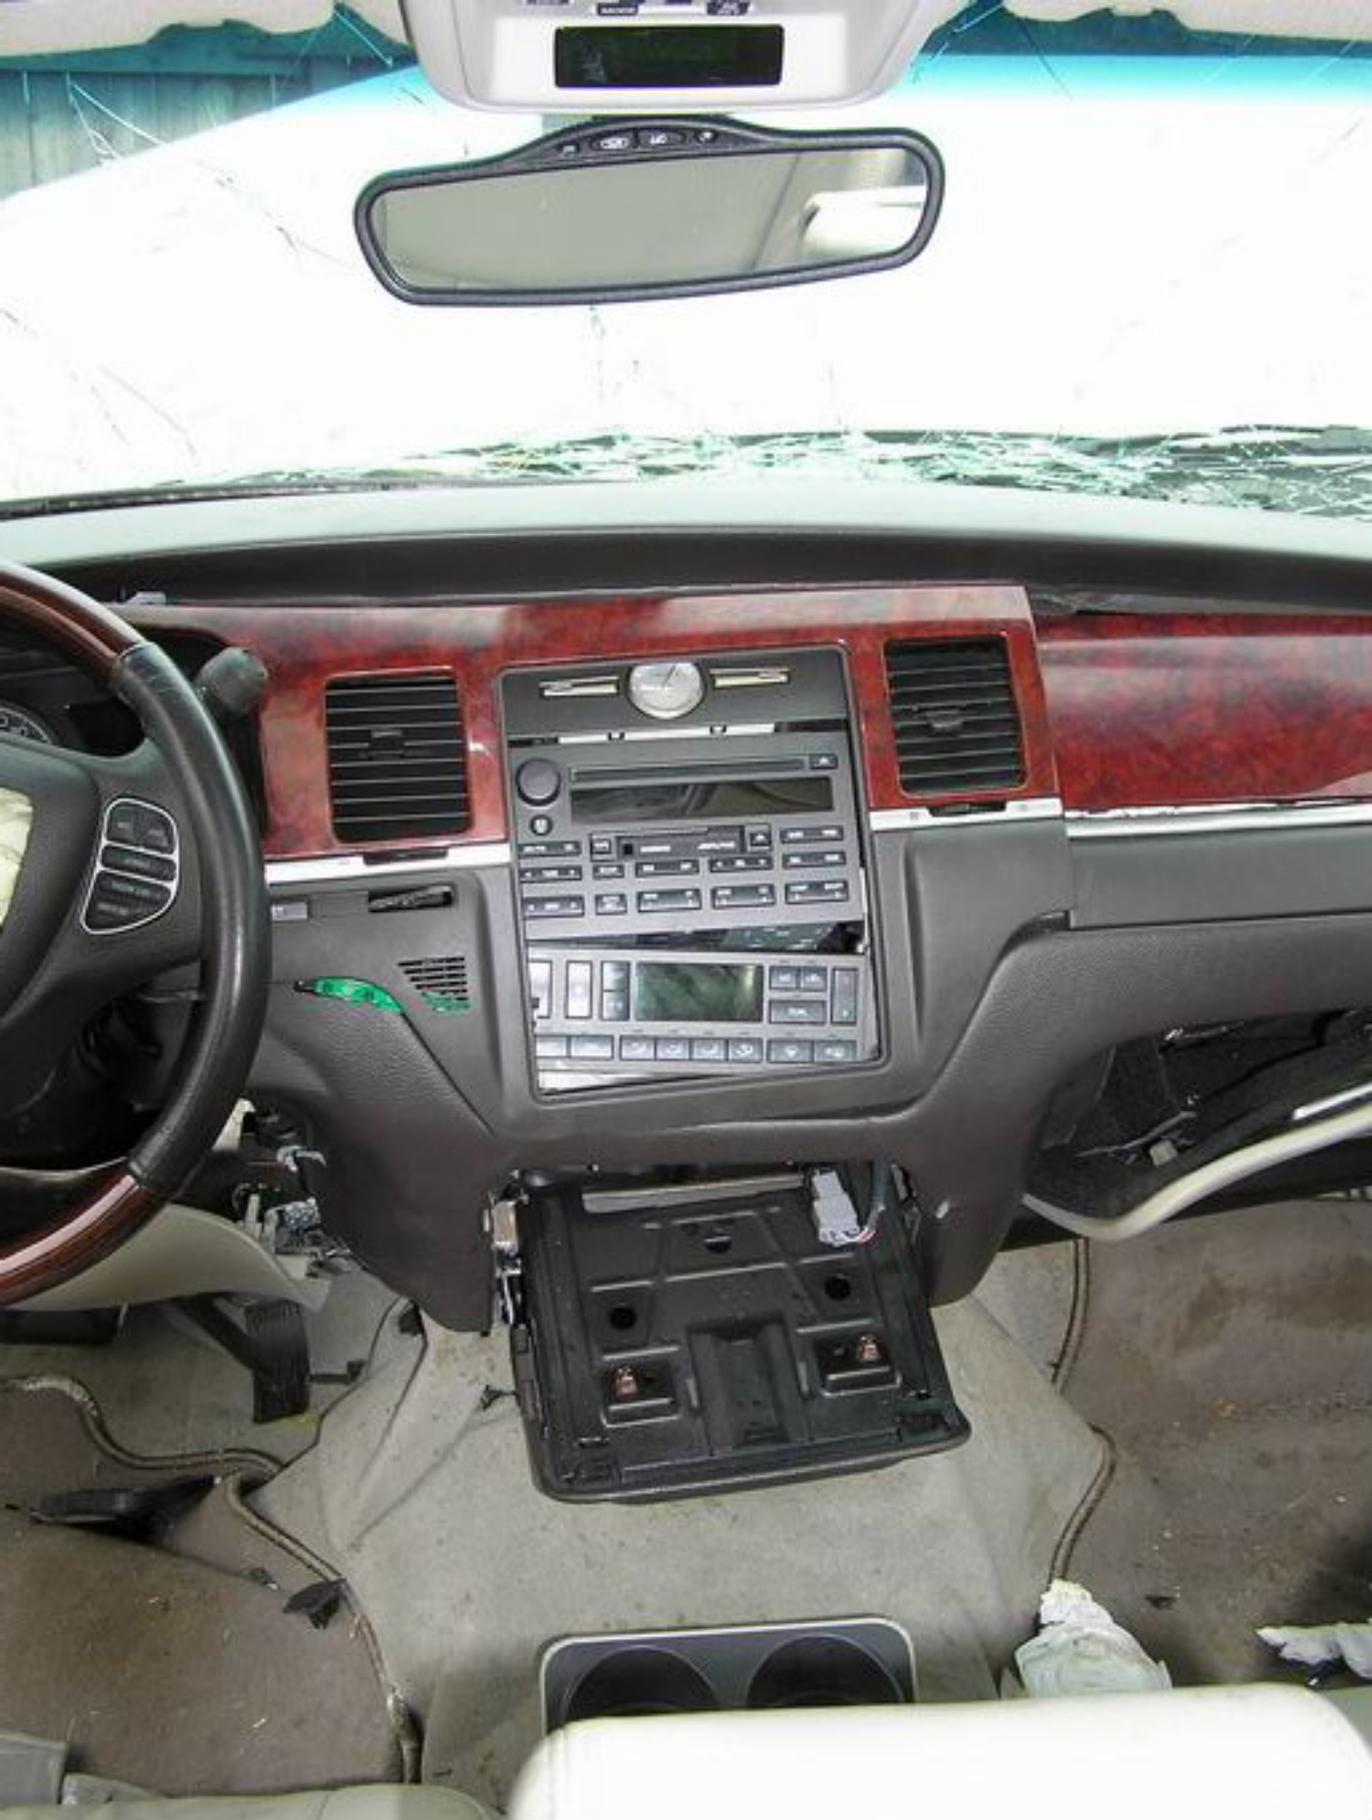
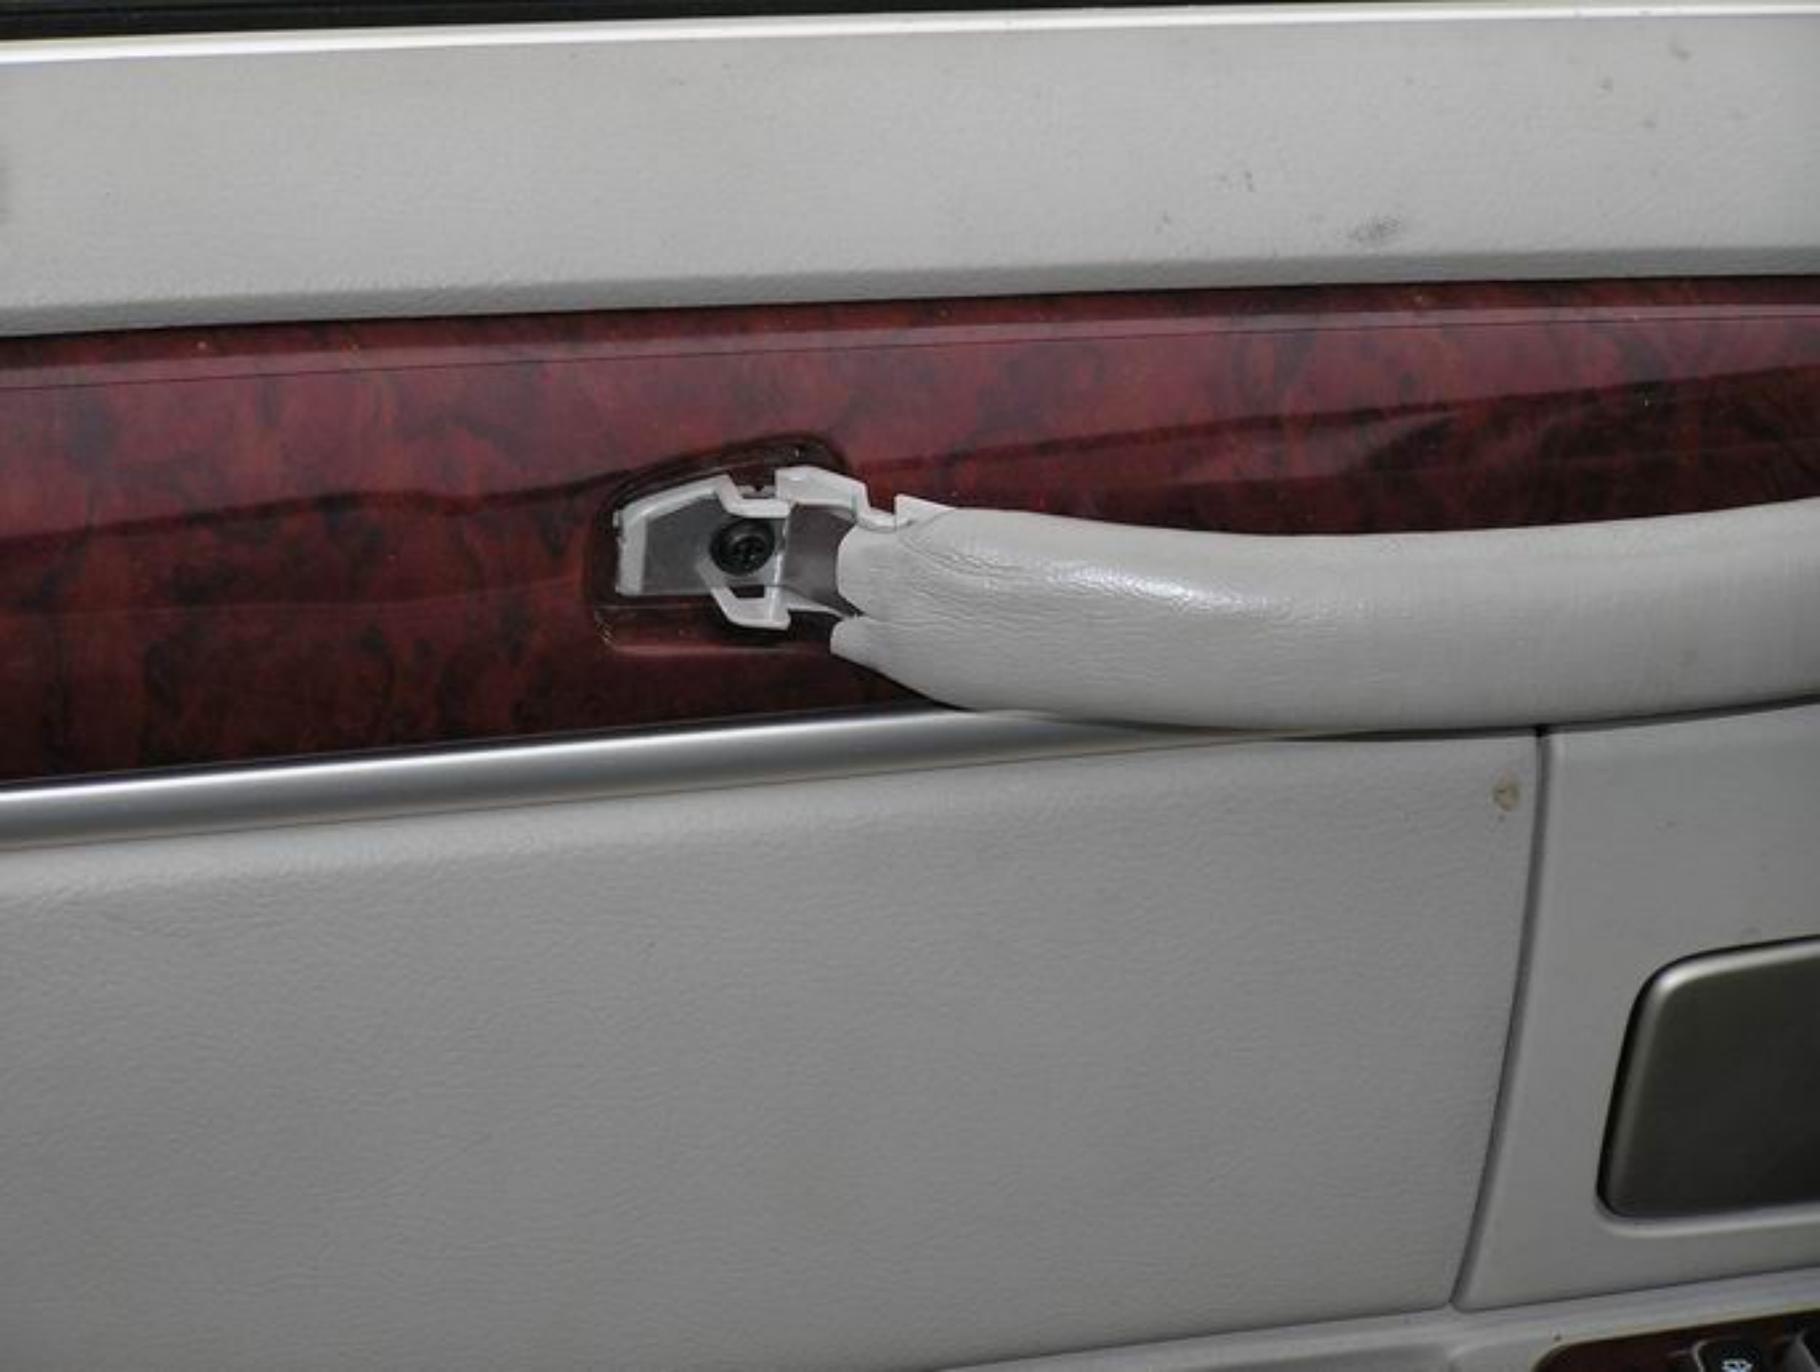
[38](#) [39](#) In the driver area, there was no damage to the deployed steering-wheel airbag but there were bloodstains on the middle-left section of the fabric. [40](#) [41](#) [42](#) The steering wheel was rotated 180o from the straight-ahead position and the upper half of the steering-wheel rim, which was at the rotated down, was bent and deflected forward about 5 cm, but there was no apparent rotation of the steering column. [43](#) [44](#) There was no damage to the upper or mid sections of the instrument panel but the trim piece was pulled out from its attachment on the left side. [45](#) [46](#) [47](#) The driver knee bolster was partially separated from the right-side attachment and there was a scuffmark on the knee-bolster cover. [48](#) The driver floor was buckled, the toepan was displaced rearward about 5 cm, and the pedals were bent to the right. [49](#) [50](#) The grab handle on the driver door above the door armrest WAS partially pulled away from its attachment.

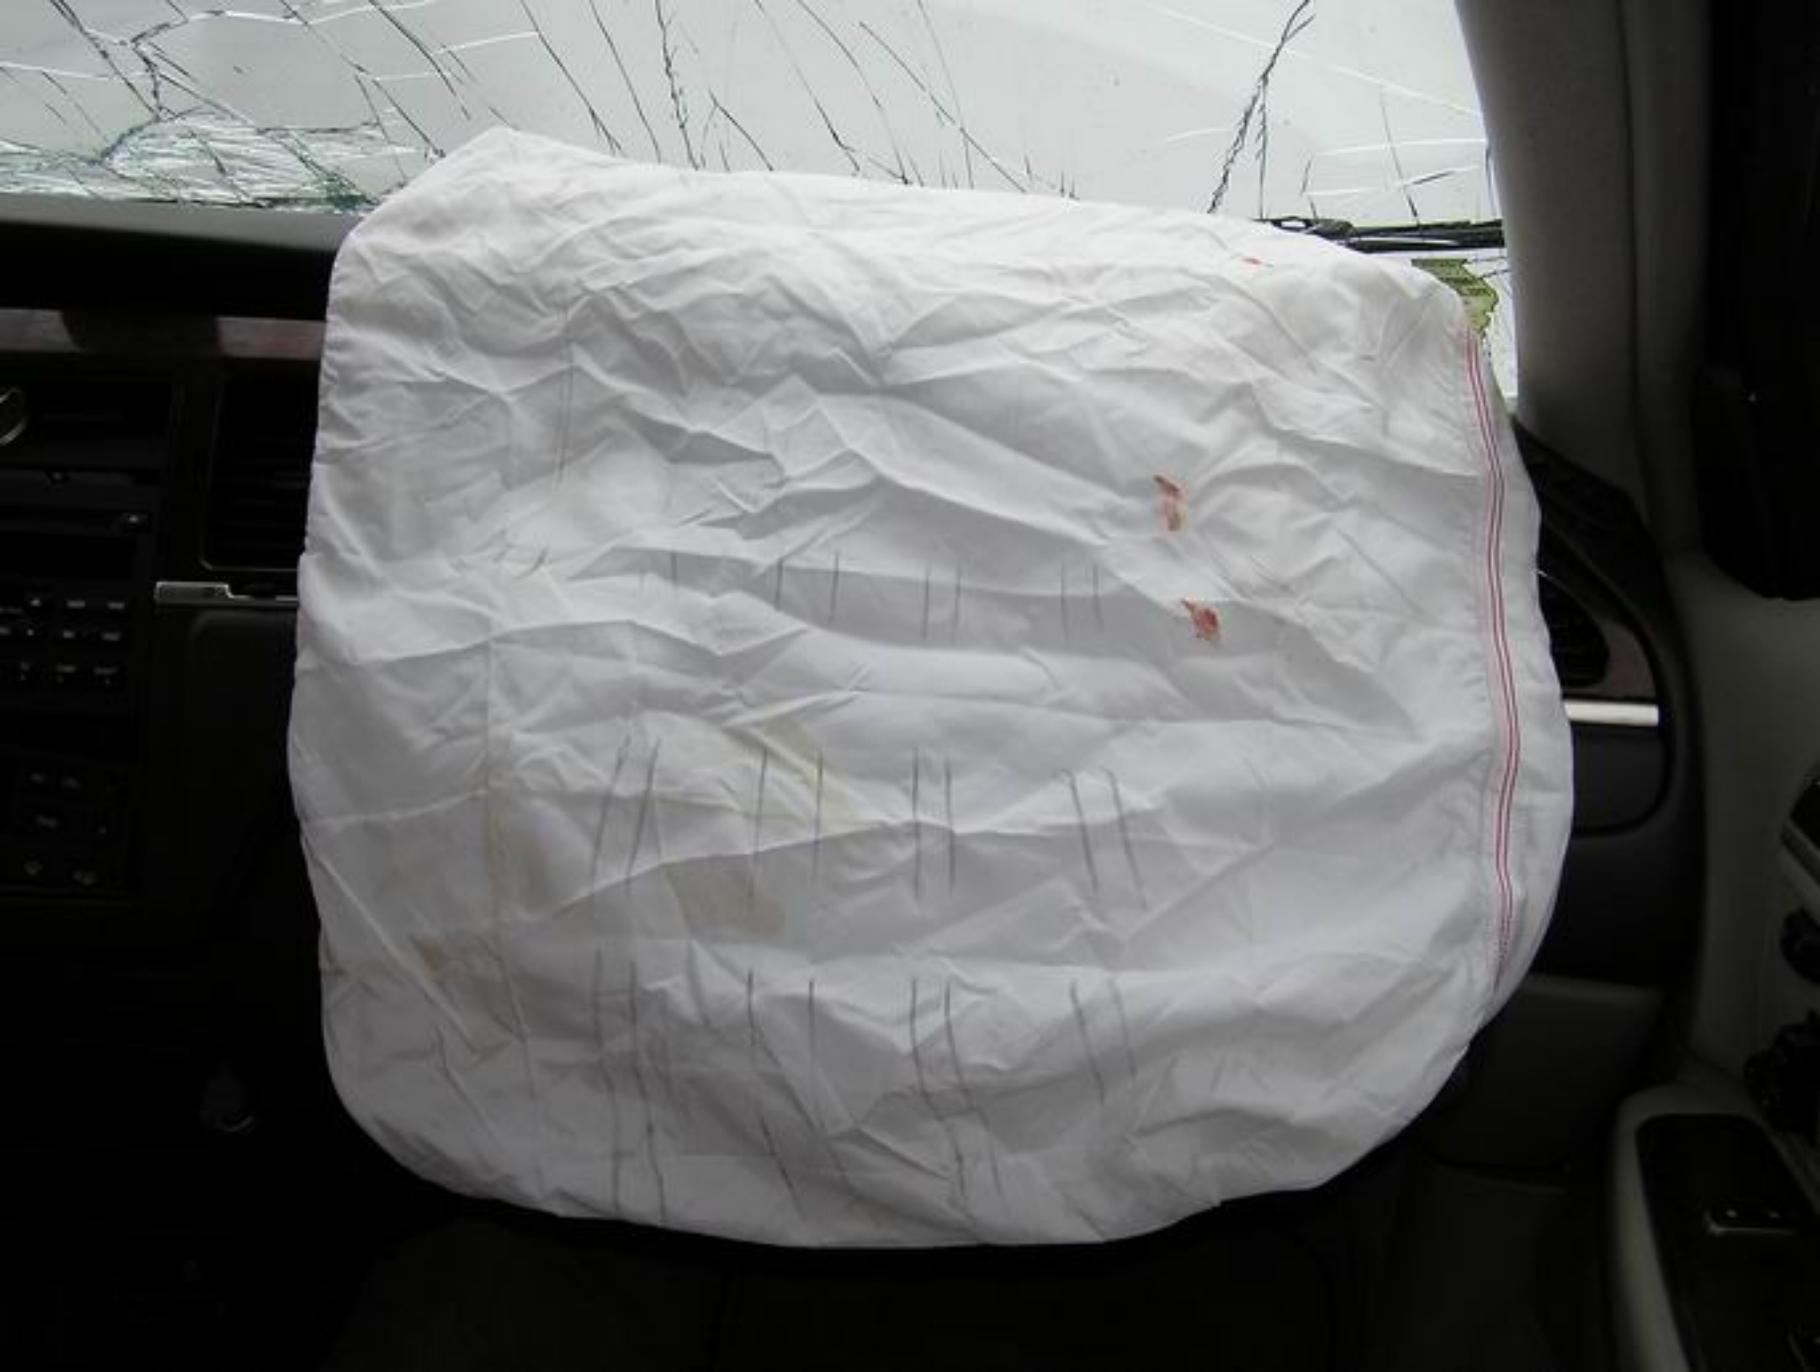
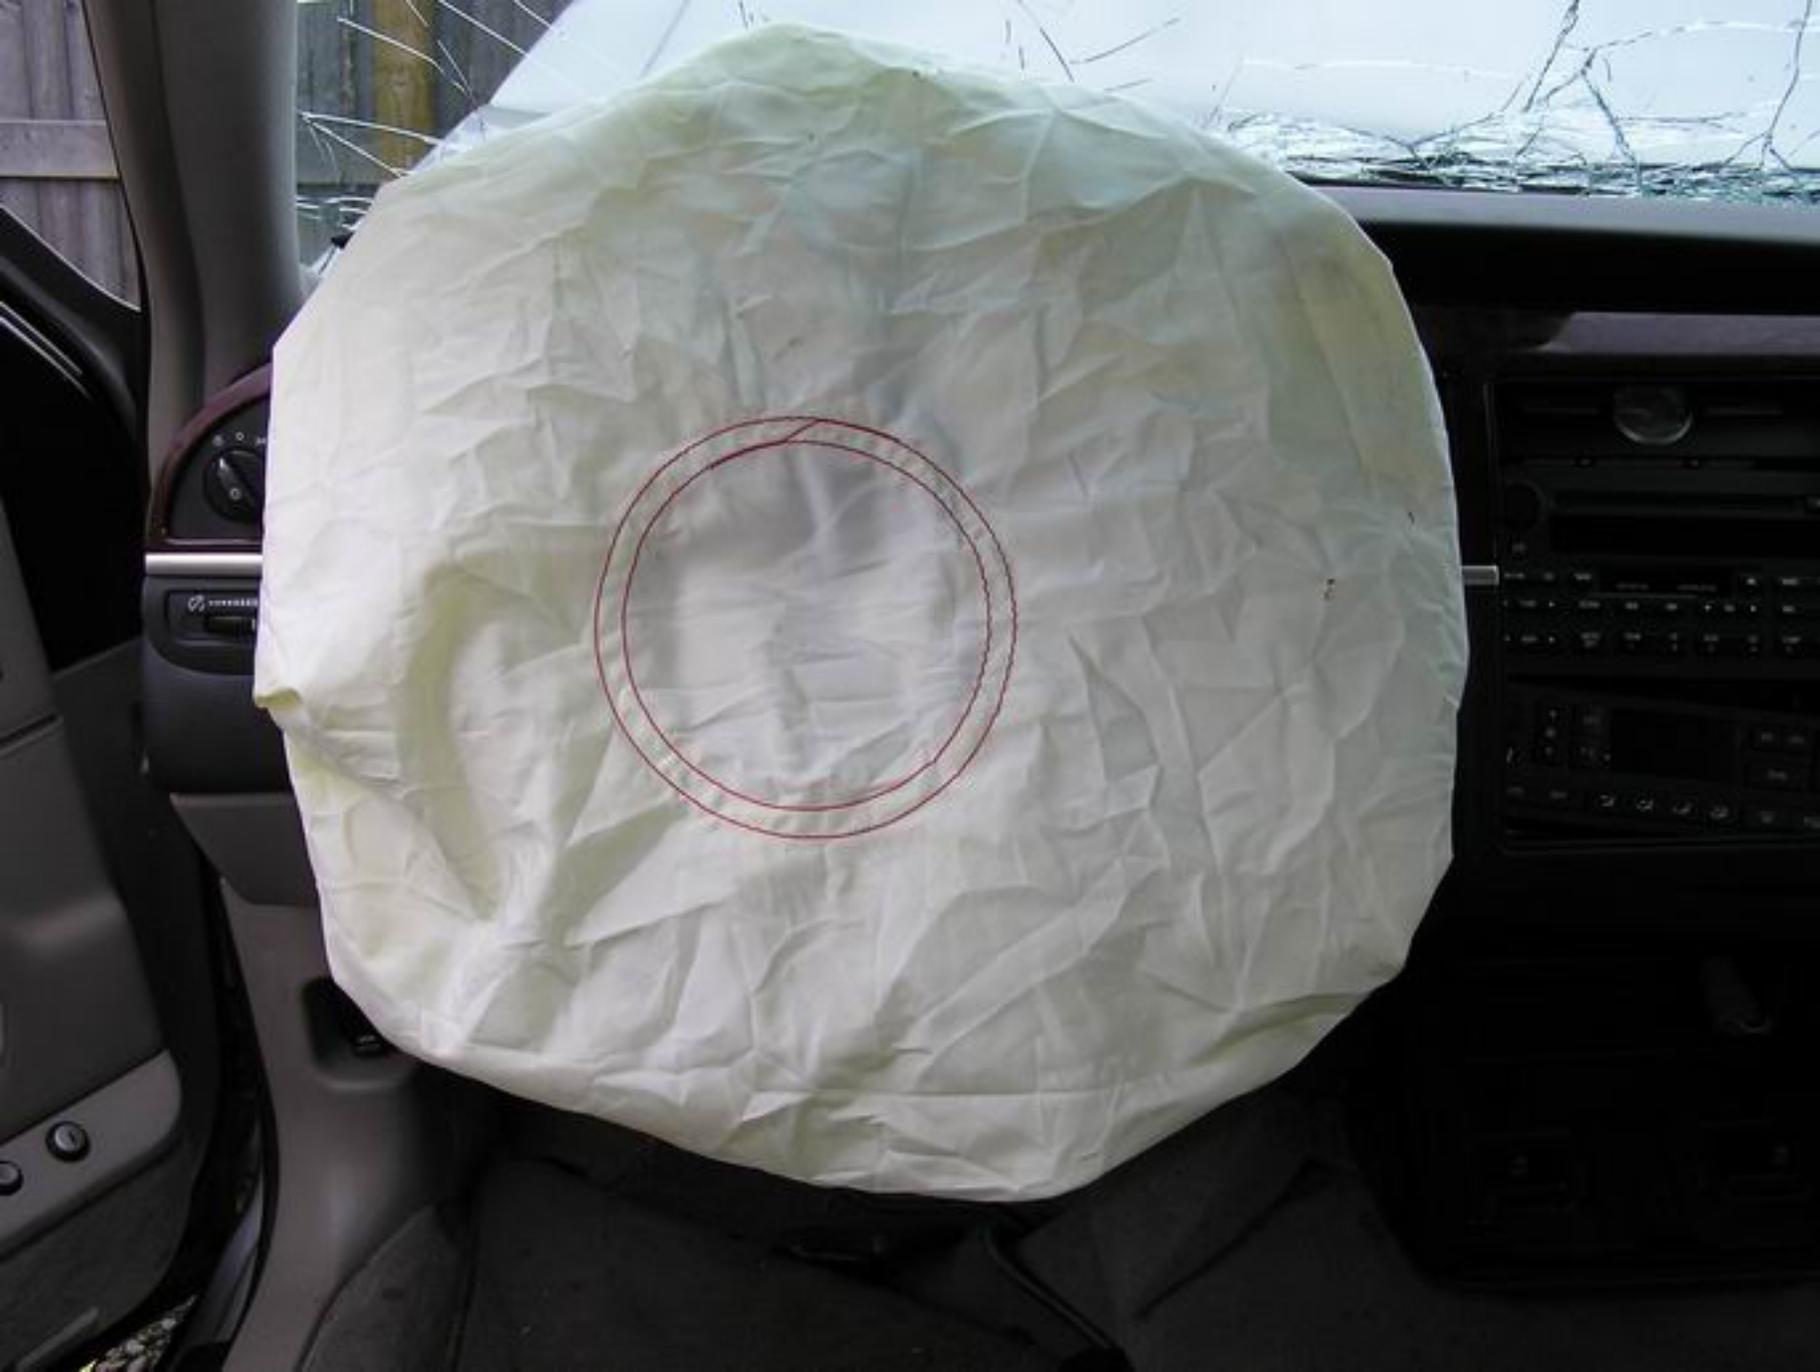
[54](#) In the right-front seating area, there was no damage to the deployed dash-mounted airbag, [55](#) but there were bloodstains on the upper-right section of the fabric and [56](#) [57](#) and the airbag cover was

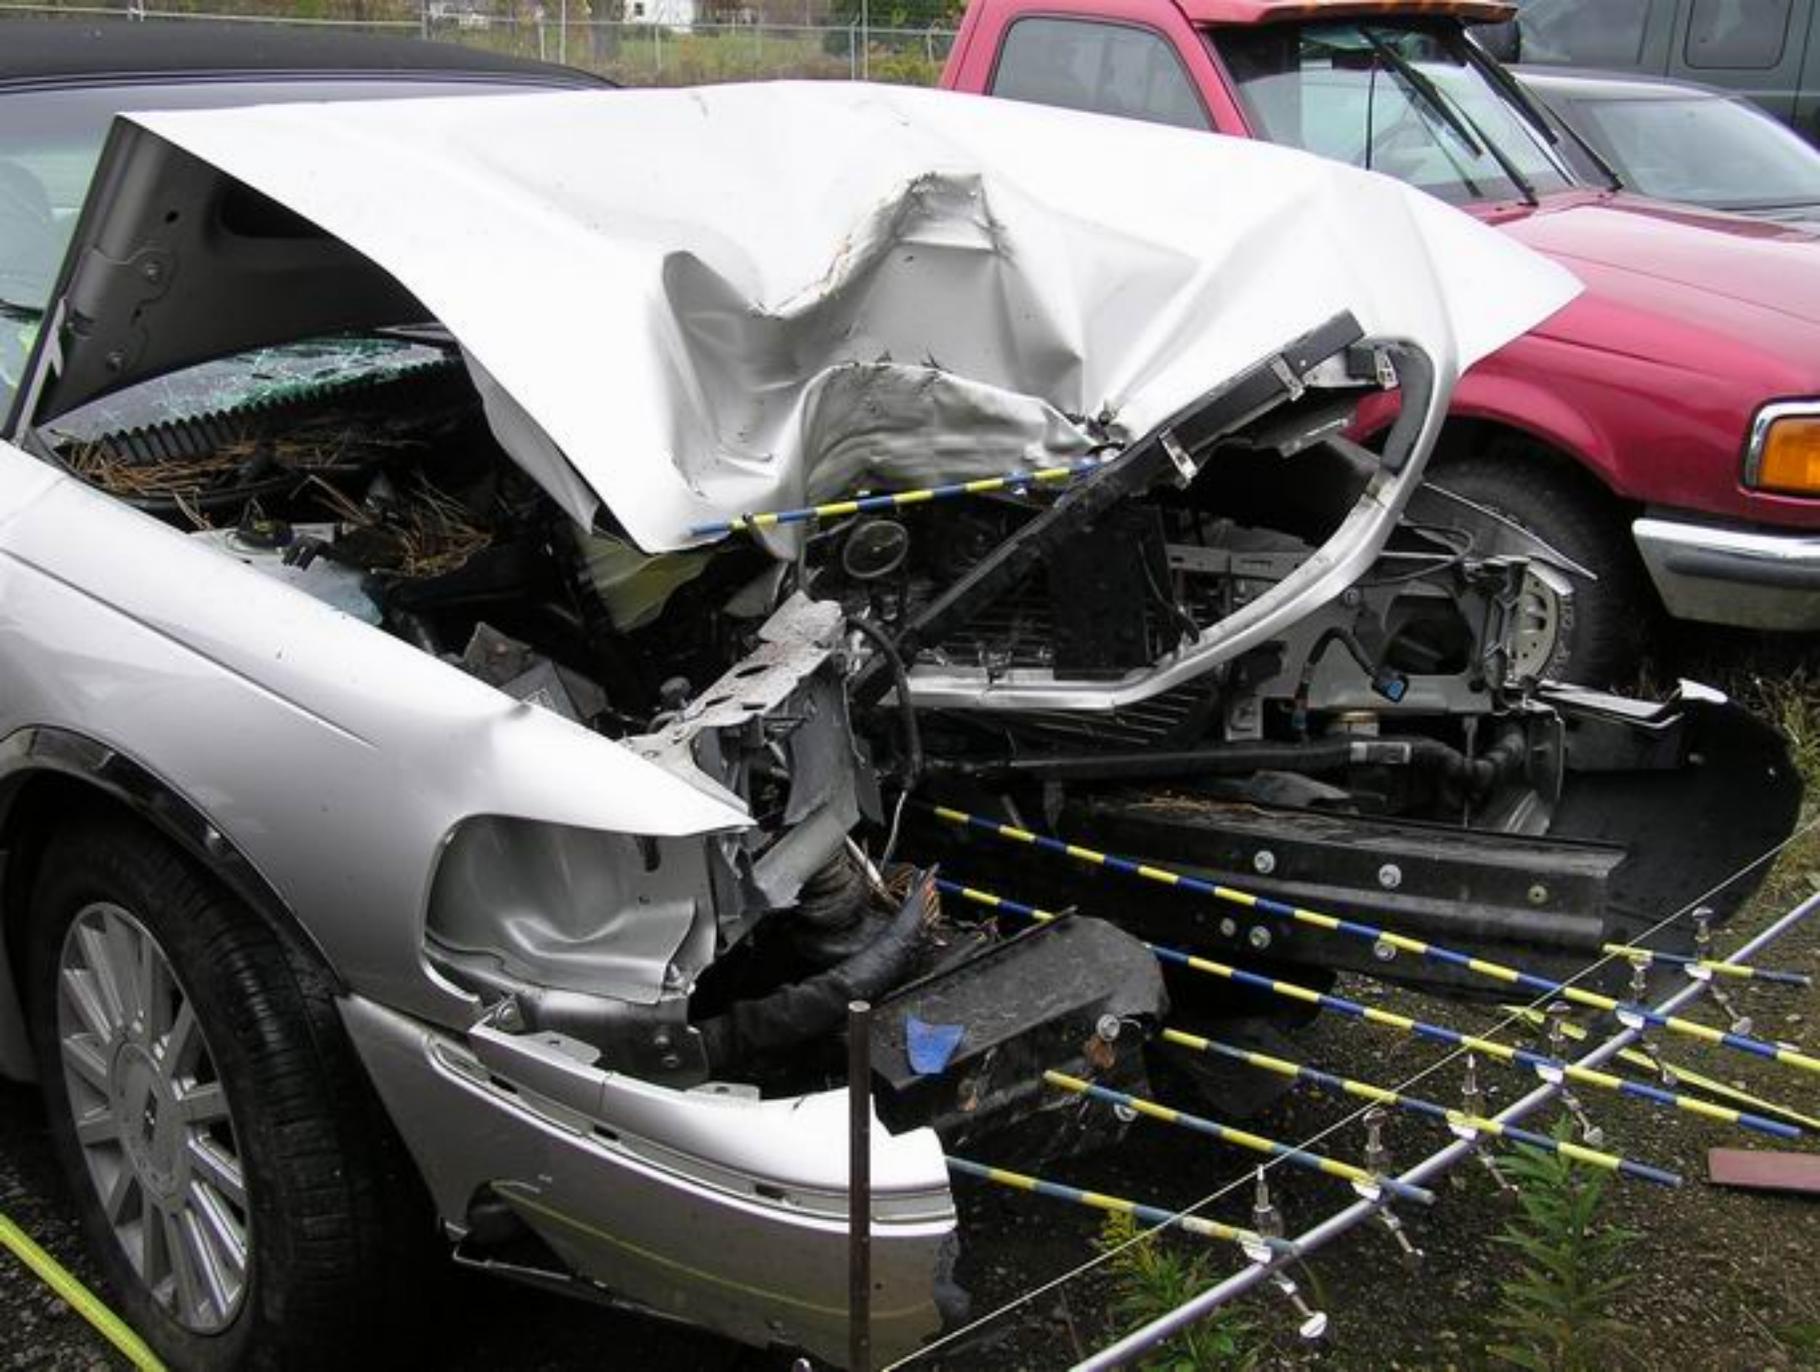
[68](#) The 163-cm, 48-kg (5-ft 4-in, 105-lb) 79-year-old female right-front passenger was using the three-point belt [69](#) [70](#) equipped with an after-market belt extender and pretensioner that was activated, and [35](#) the dash-mounted airbag deployed during the frontal impact with the tree. [37](#) Also, the seatback head/thorax side-impact airbag deployed. [71](#) [72](#) [75](#) Although there were no loading marks on the D-ring, loading marks on the continuous loop of the latch plate and [73](#) [74](#) cutting of the belt webbing by rescue personnel indicate belt use by the right-front passenger.
