Case 502 : Narrative

Case Vehicle (A): 2005 Pontiac	Vehicle (B): 1993 Chevrolet
Type: Grand Prix GT, 4-door sedan	Type: C1500, 2-door pickup, 4x2
Driver: 30-year-old female	Driver: 68-year-old male
CDC: 11-FDEW-2	CDC: 99-0000-0

502: Vehicle Report

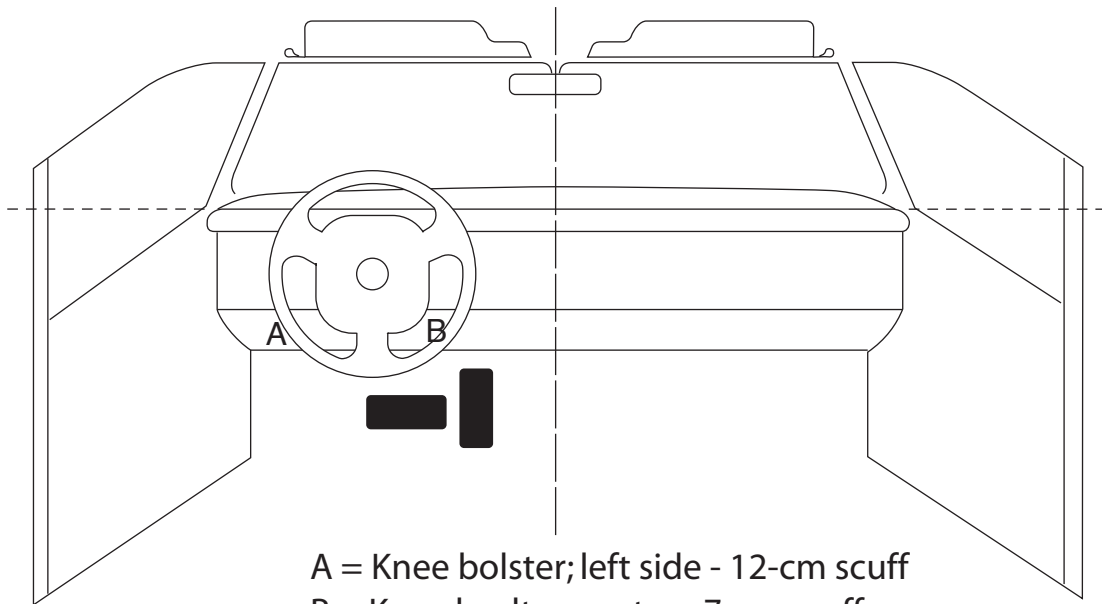
A = Knee bolster; left side - 12-cm scuff
B = Knee bolster; center - 7-cm scuff
C = Center console/armrest - scuff

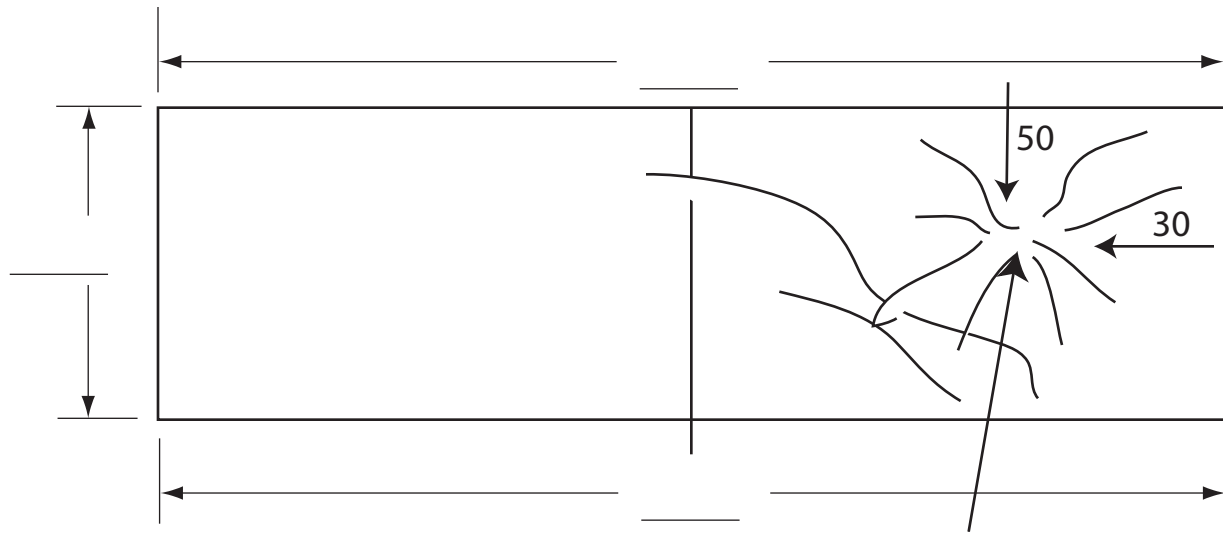
WINDSHIELD MARK ON CASE VEHICLE:

contact by dash-mounted airbag cover

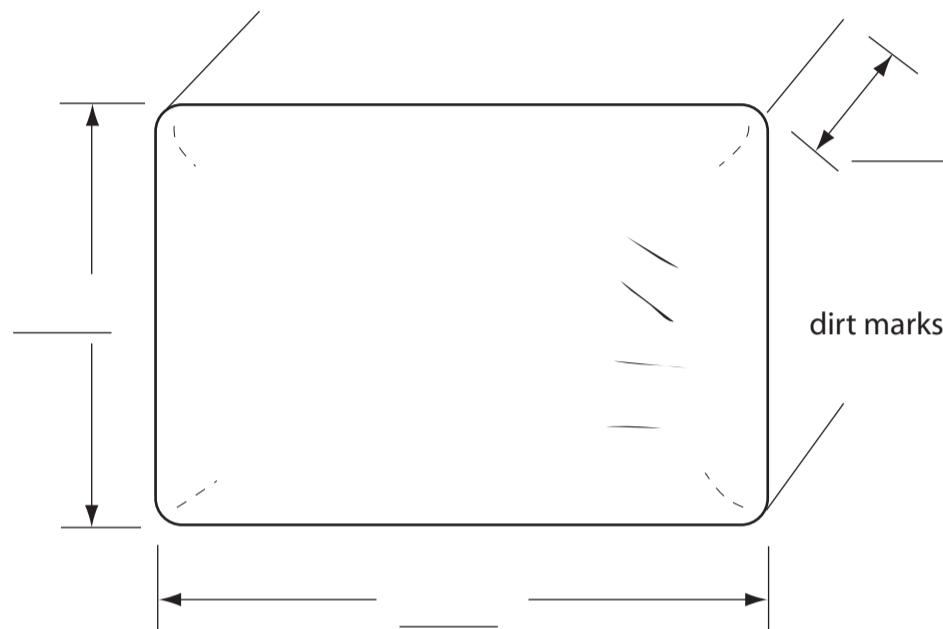
Passenger Airbag

cover hit/cracked windshield
