FRC REMOTE AIR BAG DEPLOYMENT INVESTIGATION

CASE NO. 90-9

FLEET - 1990 MERCURY GRAND MARQUIS

TECHNICAL REPORT STANDARD TITLE PAGE

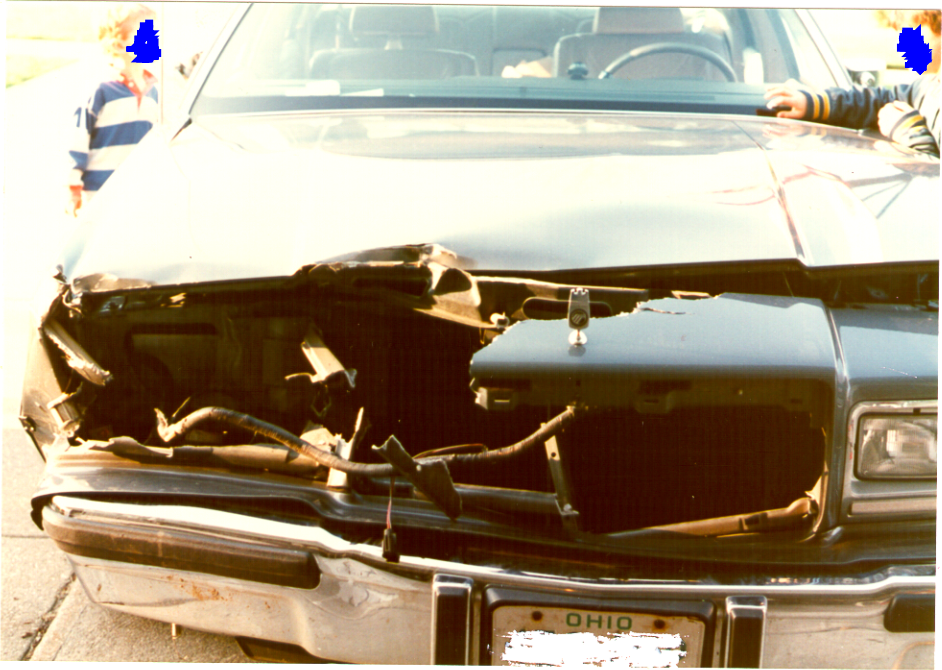
Frontal View Of The Mercury Grand Marquis

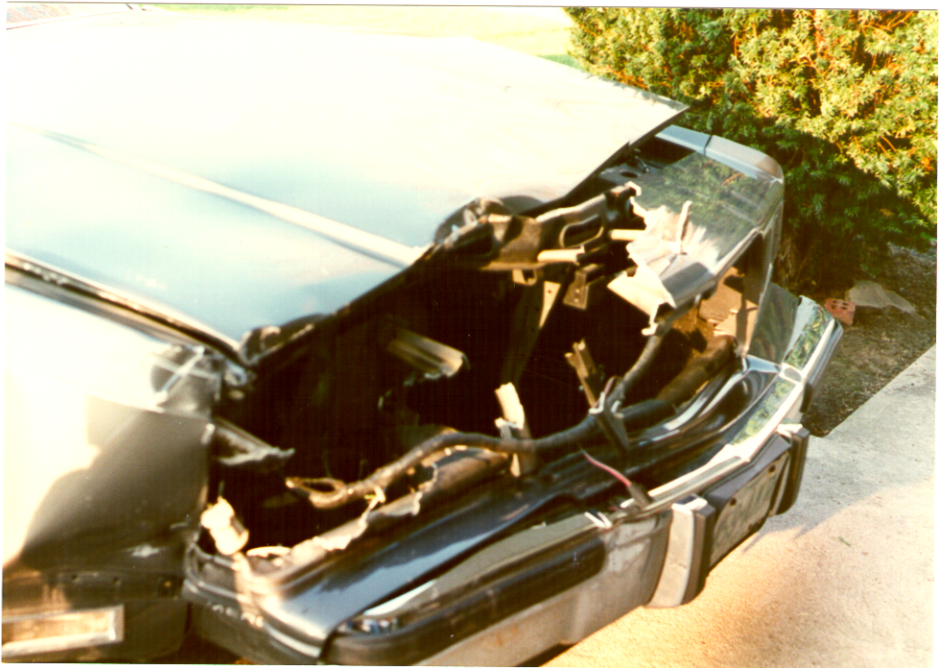
<u>Air Bag Vehicle</u>	<u>Vehicle #2</u>
Estimated Maximum Crush:	3-5" at the right corner of the front bumper	Unknown
Damaged Components:	Front bumper, grille, header panel, right headlight assembly, hood, right front fender (for a detailed listing refer to Appendix B, vehicle damage estimate).	
Repair Estimate:	\$4611.87	Total loss

Closeup View Of The Impact Damage

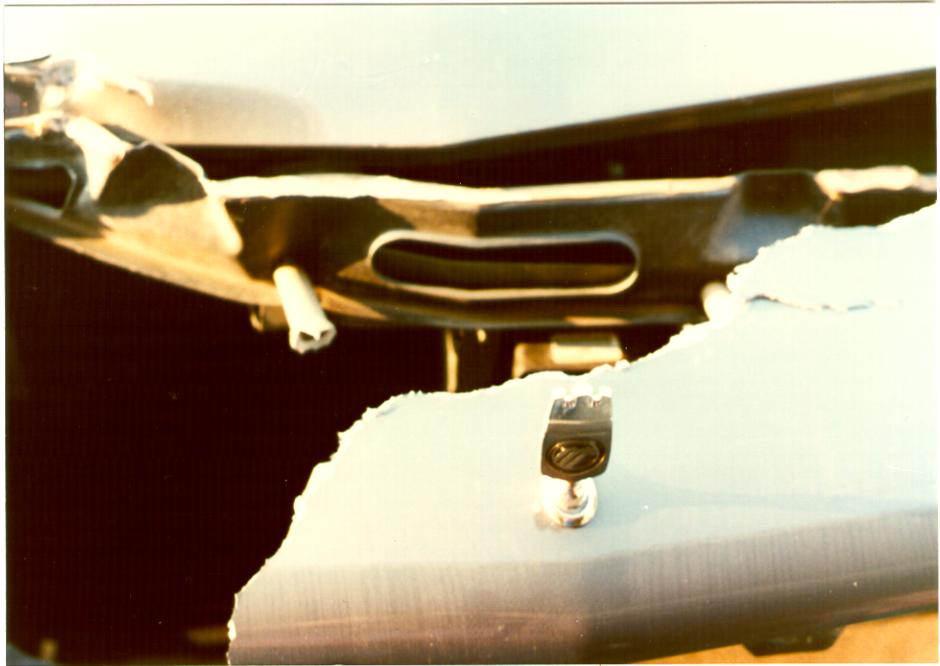
Radiator Support Mounted Air Bag Crash Sensor

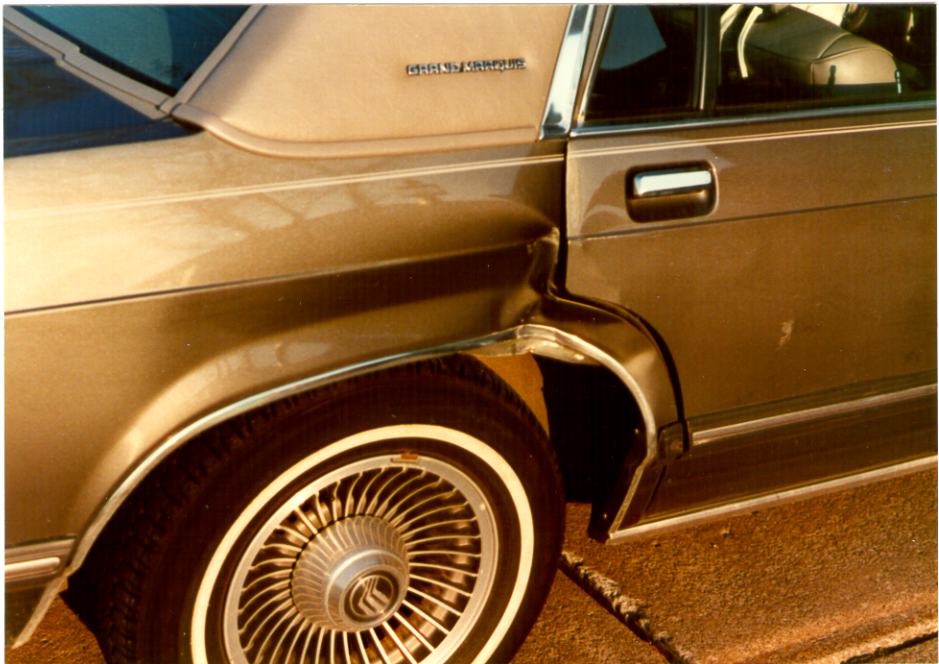
Object Struck:	Vehicle #2	
Event Number:	2	
Damage Location:	Right rear door and quarter panel	Left rear corner area
CDC:	03-RPMN-1	09-LBEN-1 (estimated)
Estimated Maximum Crush:	2" at lower right C-pillar	Unknown
Damaged Components:	Right rear quarter panel, right rear door, and wheel opening molding	
Interior (Air Bag Vehicle):	None reported

Sideslap Damage To The Right Rear Quarter Panel

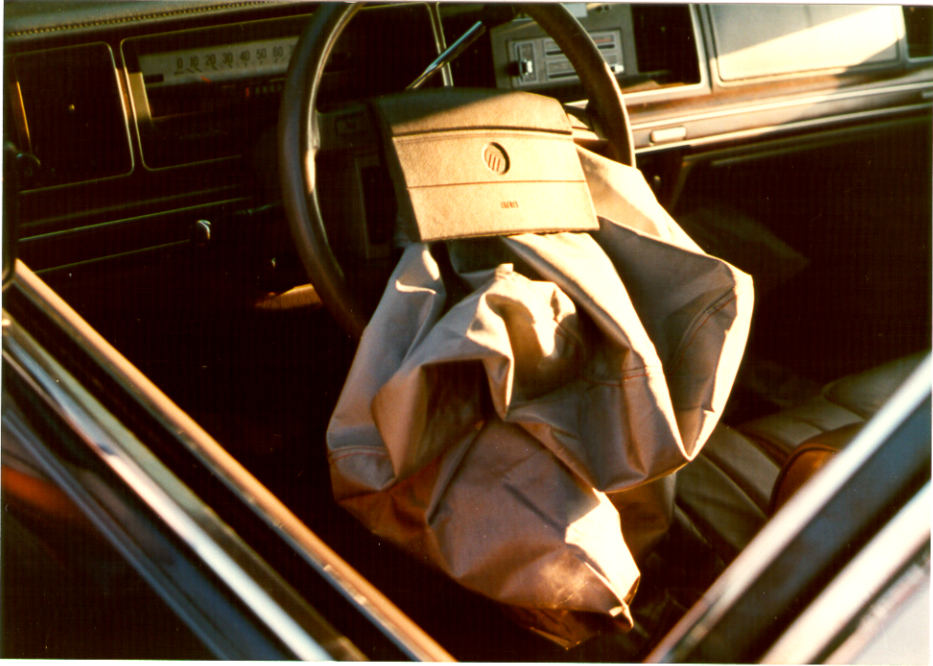
The driver/owner contacted the NHTSA Auto Safety Hotline and reported the alleged air bag failure. He also shipped the deployed air bag and module assembly to FRC. The bag was fully deployed from the module and was intact with no tears or ruptures other than the 1" diameter venting ports located on the back side of the bag at the 3 and 9 o'clock positions.

The driver air bag is designed to deflate immediately following deployment. The bag is vented by two 1 inch diameter ports located on the back side of the bag at the 3 and 9 o'clock positions. Typically, by the time a driver notices a deployed air bag, the bag has deflated. The driver of the Mercury understands the deployment and venting of the air bag; however, he still insists that the bag failed to inflate.

Deployed Driver Air Bag
