CALSPAN ON-SITE AIR BAG DEPLOYMENT INVESTIGATION

CALSPAN CASE NO. 93-19

VEHICLE - 1990 MERCEDES-BENZ 300E

ACCIDENT DATE - [REDACTED] 1993

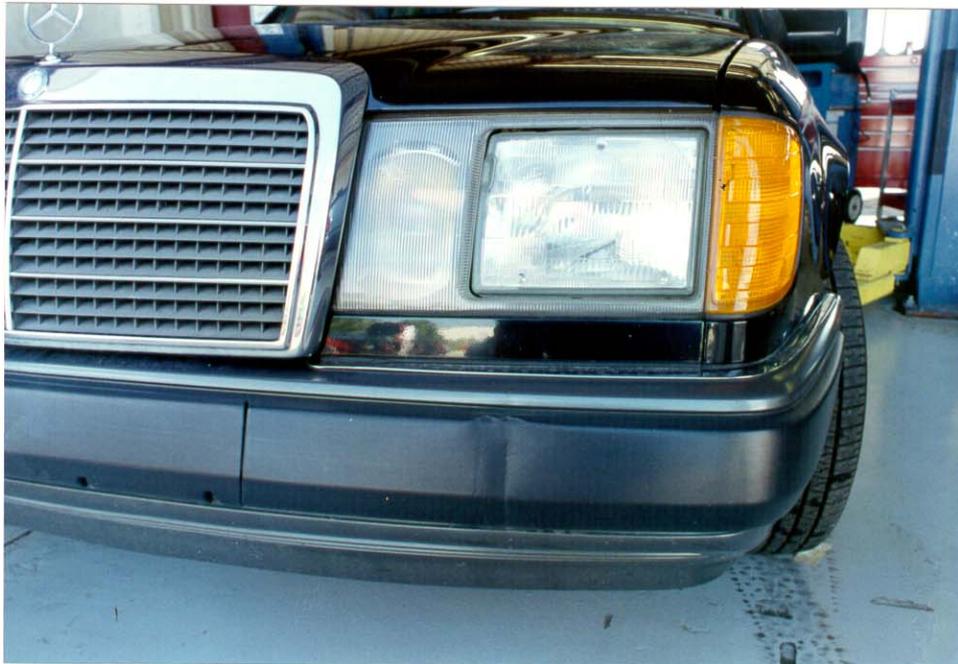
The Mercedes-Benz sustained minor frontal damage as a result of the front-to-rear impact sequence with the stopped Volvo station wagon. The direct contact damage on the bumper fascia consisted of a vertically orientated deformed area that resembled the rear bumper guard of the Volvo. The damage extended 49.4 - 54.6 cm (19 7/16" - 21.5") left of center and was 3 mm (1/8") in depth. The direct contact damage was isolated to the bumper face as the impact involved bumper-to-bumper contact. There was minimal residual crush at the left front corner that was estimated at 0.6 cm (0.25").

Direct Contact Damage On The Front Left Bumper Facia

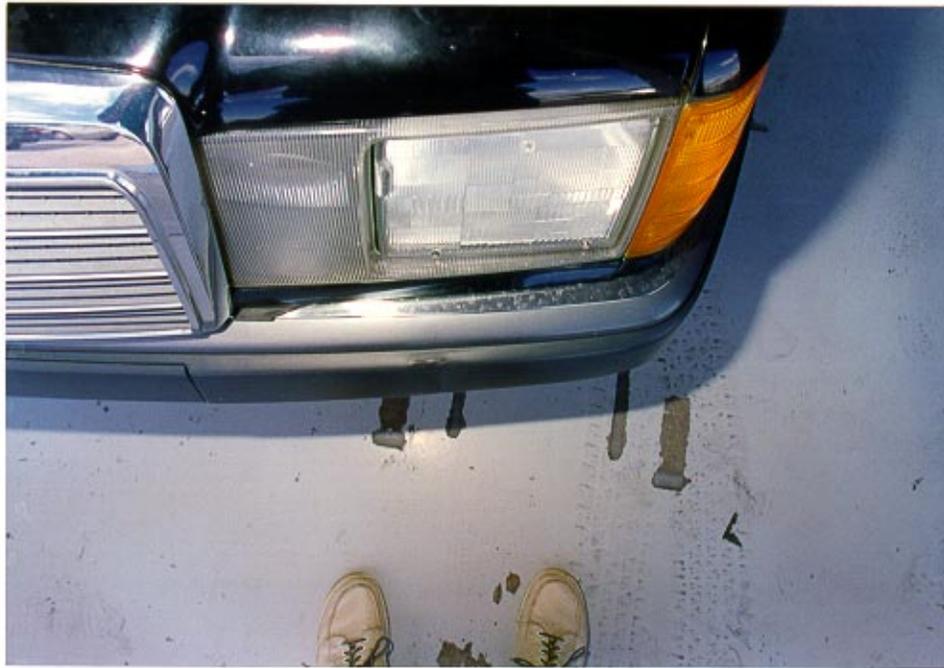
Overhead View Of The Compression To The Bumper Facia

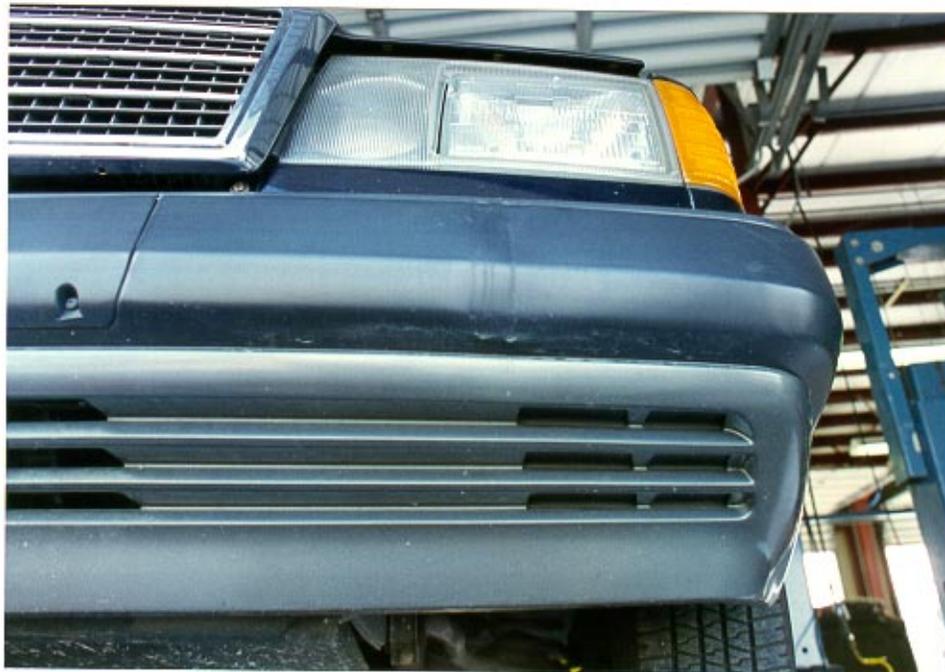
View Looking Upward At The Bumper Facia Deformation

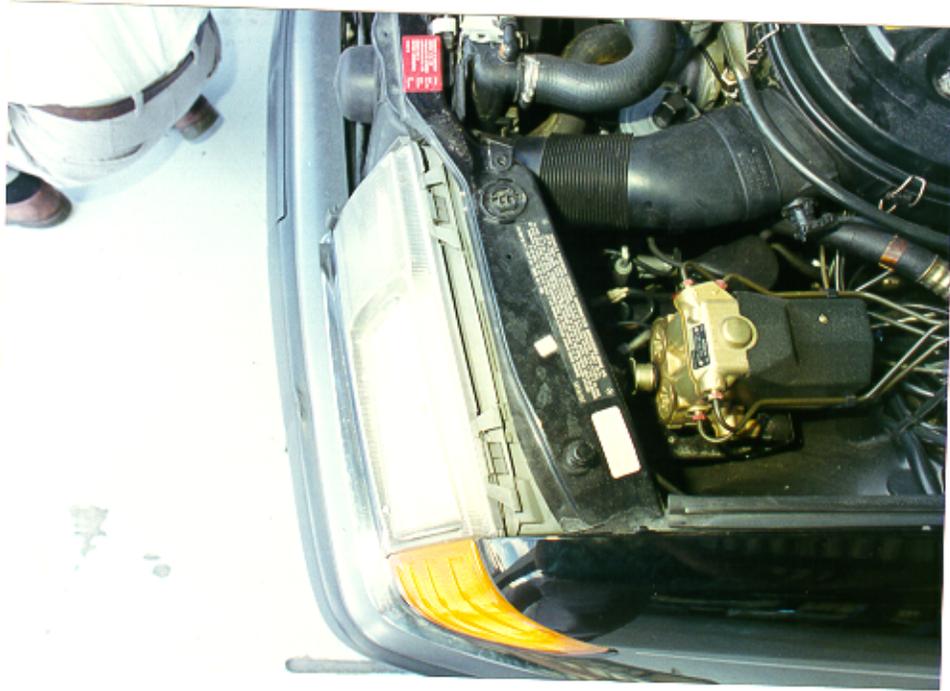
Overhead View Of The Bumper Facia Deformation

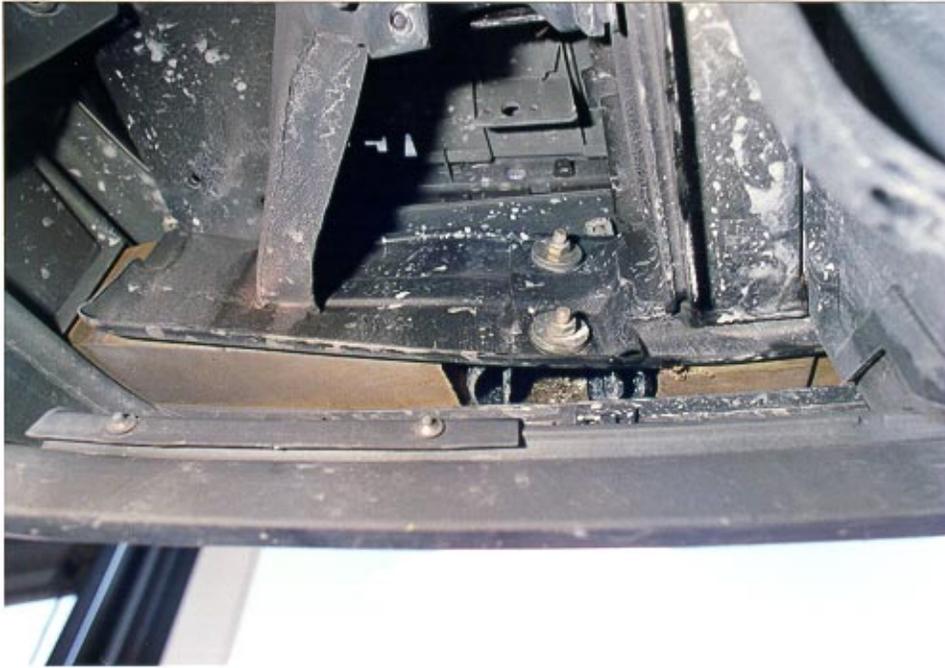
The Mercedes-Benz 300E bumper system did not utilize a hydraulic type energy absorbing unit. There was a rubberized type mount that was affixed to the bumper reinforcement bar and bolted to a heavy gauge sheetmetal backer plate which was welded to the frame rails and an outboard bracket. The left rubberized mount was slightly compressed due to the impact while the right side was not damaged. The backer plate was displaced approximately 1.3 cm (0.5") rearward at the left corner area. There was no visible deformation to the frame rail or adjoining undercarriage components; however, the left wheelbase measured 3 cm (1/8") less than the right wheelbase.

Undercarriage View Of The Backer Panel At The Left Front Corner
(Arrows Indicate Deformation)

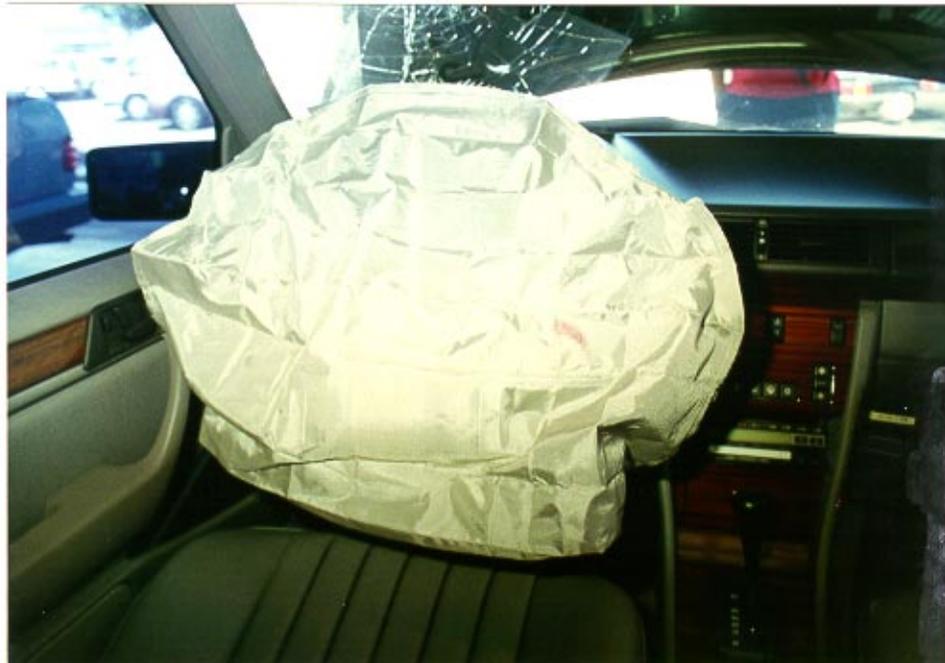
The driver's side air bag of the Mercedes-Benz deployed as designed with no damage to the bag or associated components. The module cover opened at the designated tear points in an H-configuration. The upper flap measured 23 cm (9.25") horizontally x 6 cm (2 3/8") while the lower flap was 23 cm (9.25") x 7 cm (2.75"). The air bag was constructed of a woven nylon-type fabric and was approximately 69 cm (27") in diameter. The tethered air bag was sewn with an external peripheral seam. Venting of the air bag gases was accomplished through a porous panel that was yellowish in color and extended from the 9:30 - 2:30 o'clock positions along the upper back side of the bag.

Deployed Driver's Side Air Bag

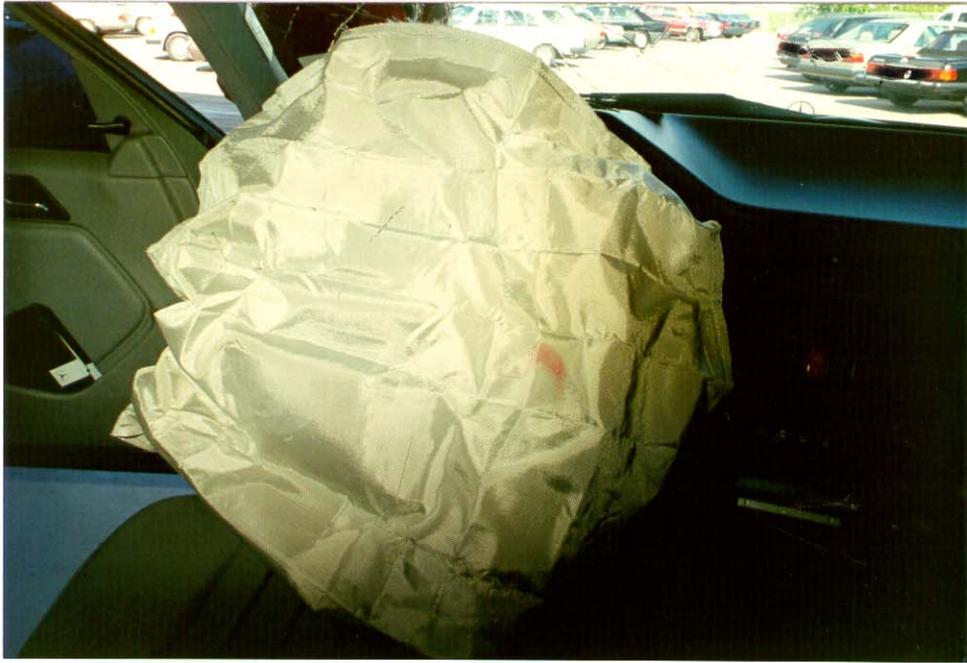
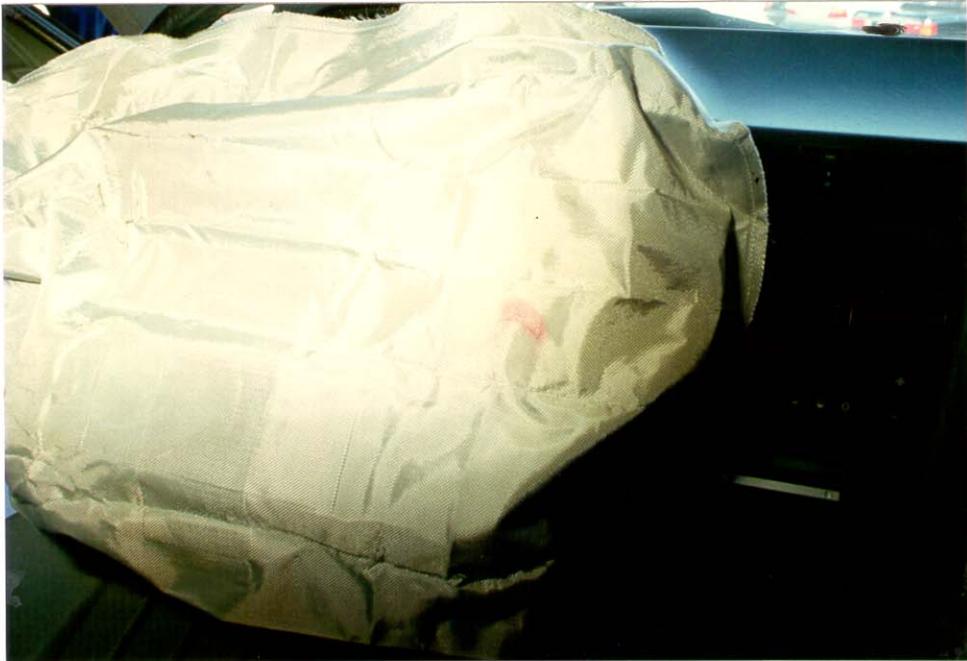
The driver's face contacted the right center area of the air bag. A 4 cm (1.75") diameter upper lipstick transfer was noted to the bag 11-16 cm (4.5 - 6.25") right of center and 5-10 cm (2.1-3.9") above the horizontal centerline. There was no injury or additional contact evidence from her involvement with the air bag.

Lipstick Transfers On The Deployed Driver's Side Air Bag

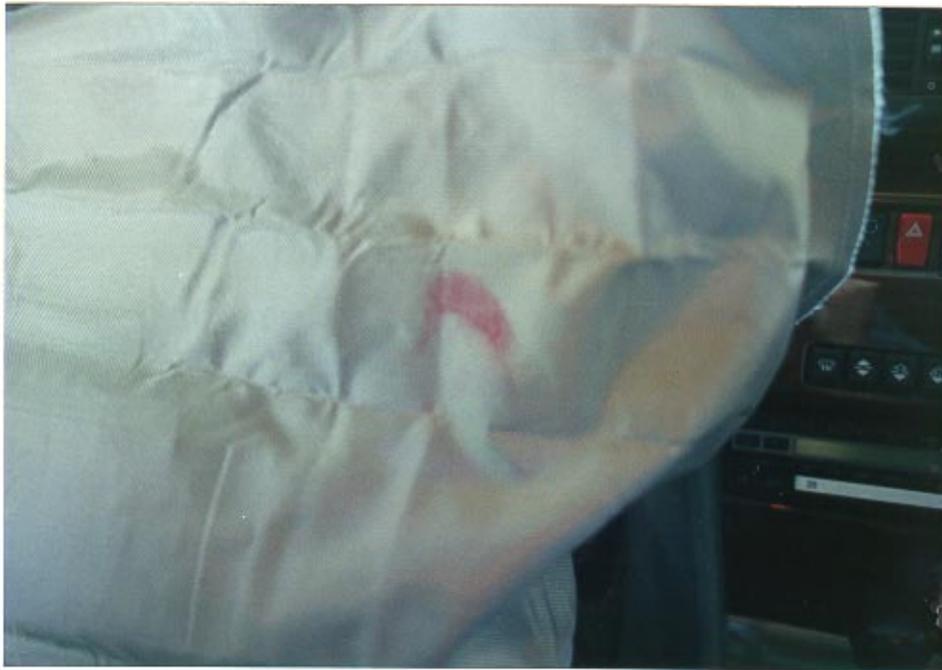
Close-up View Of The Lipstick Transfer

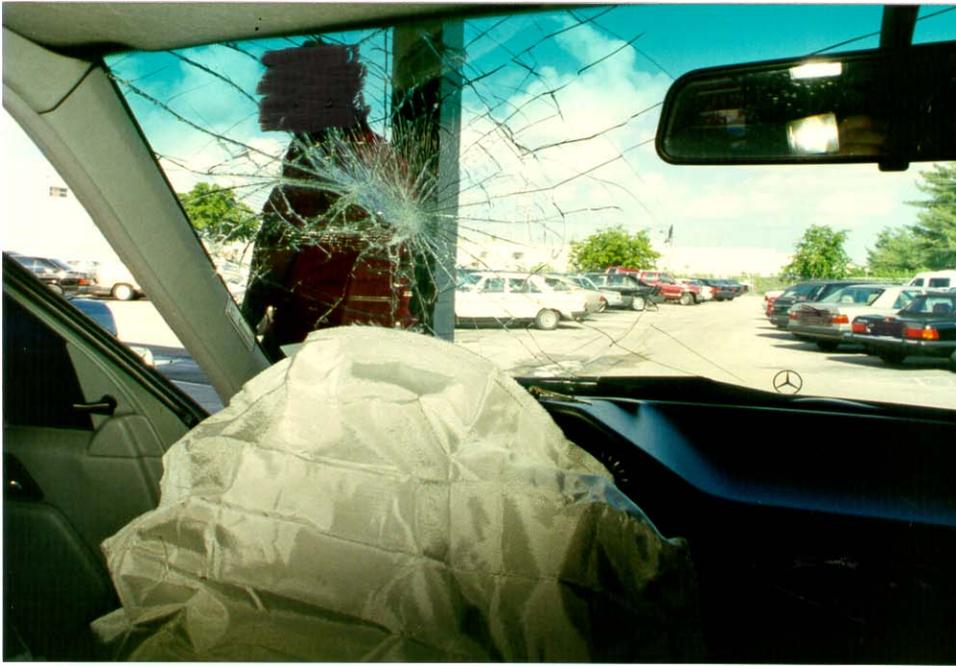
The medial dorsal aspect of the driver's left hand impacted the windshield as the hand separated from the steering wheel following air bag expansion against the left anterior area. The hand contact fractured the laminated glass 38.7 cm (15.25") left of center and 17.8 cm (7") above the upper instrument panel. The dorsal aspect of the driver's left wrist subsequently impacted the windshield adjacent to the hand contact, which further cracked the glass. The contacts bowed the windshield outward approximately 6 mm (.25").

Driver's Left Hand/Wrist Contact To The Windshield

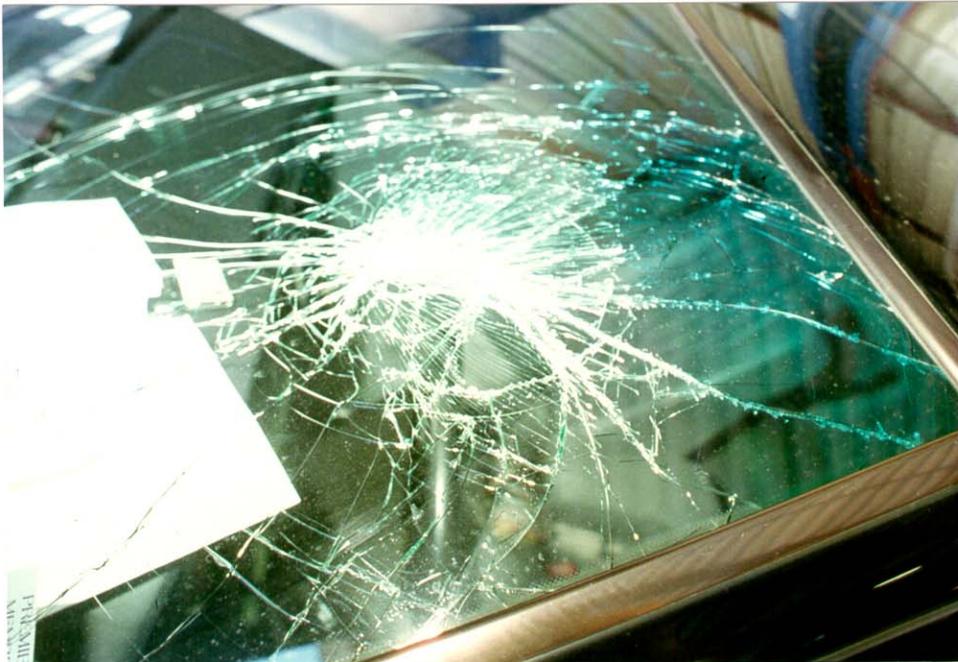
Closeup View Of The Hand/Wrist Contact

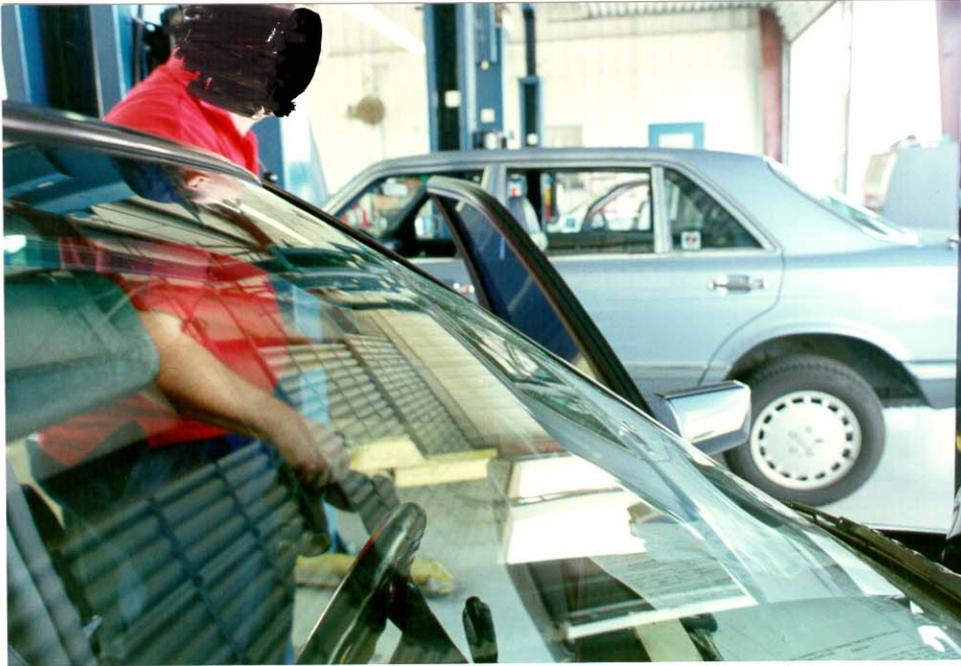
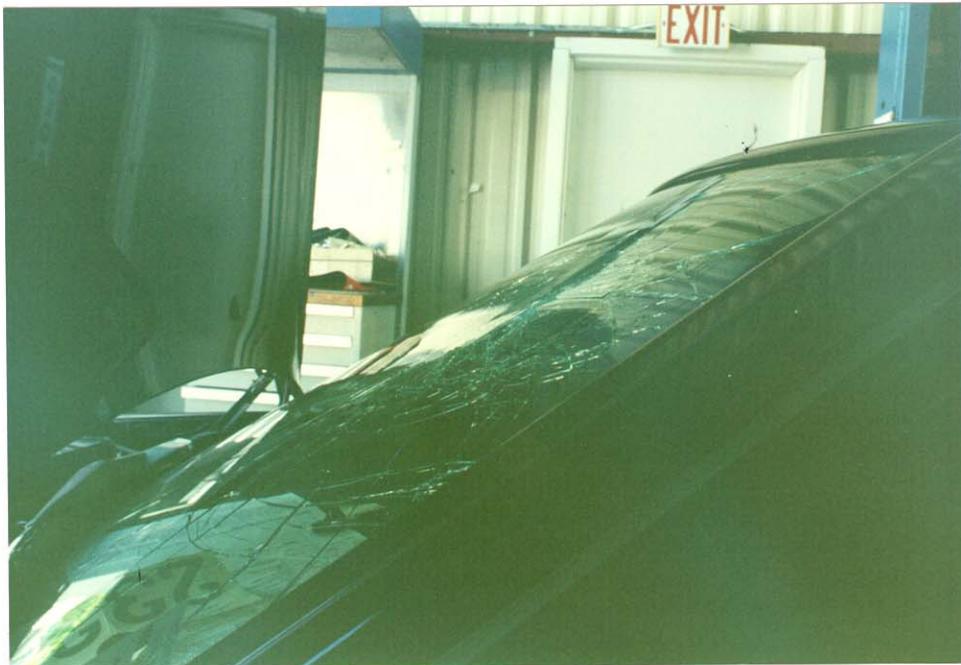
Outward Bowing Of The Windshield From Driver's Hand/Wrist Contact

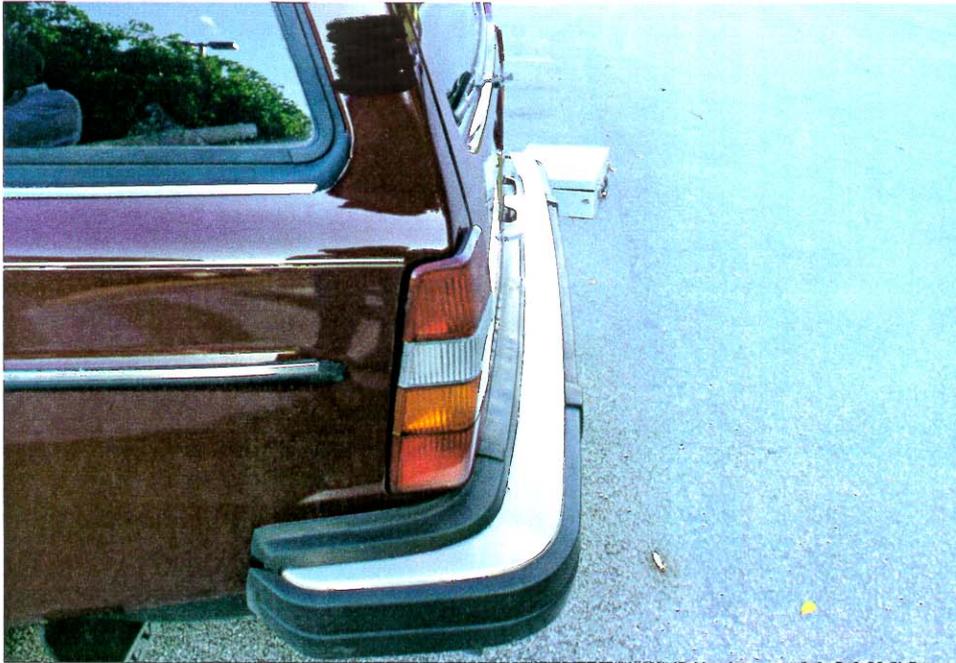
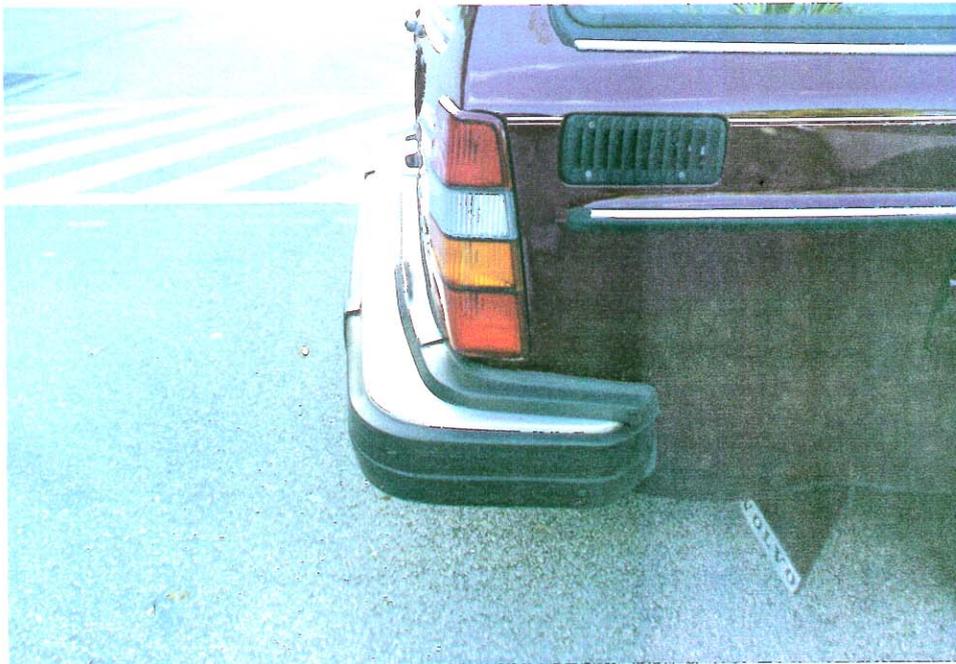
The rear of the 1982 Volvo station wagon sustained minor damage from its impact sequence with the Mercedes-Benz 300E. There was no direct contact evidence on the rear bumper rub strip. The left front bumper area of the Mercedes-Benz impacted the right bumper guard area of the rear bumper and fully compressed the bumper energy absorbing devices (EADs). The bumper guard was 5.3 cm (2.1") in width and was located 39.4 cm (15.5") outboard of the centerline of the vehicle. The guard protruded 1.6 mm (5/16") from the rub strip. The male end of the rear EADs was covered with a rubber jacket which interfered with the measurement of the units. It appeared that both EADs compressed approximately 8.9 cm (3.5") then returned to their original pre-crash positions.

Perpendicular Views Of The Rear Bumper

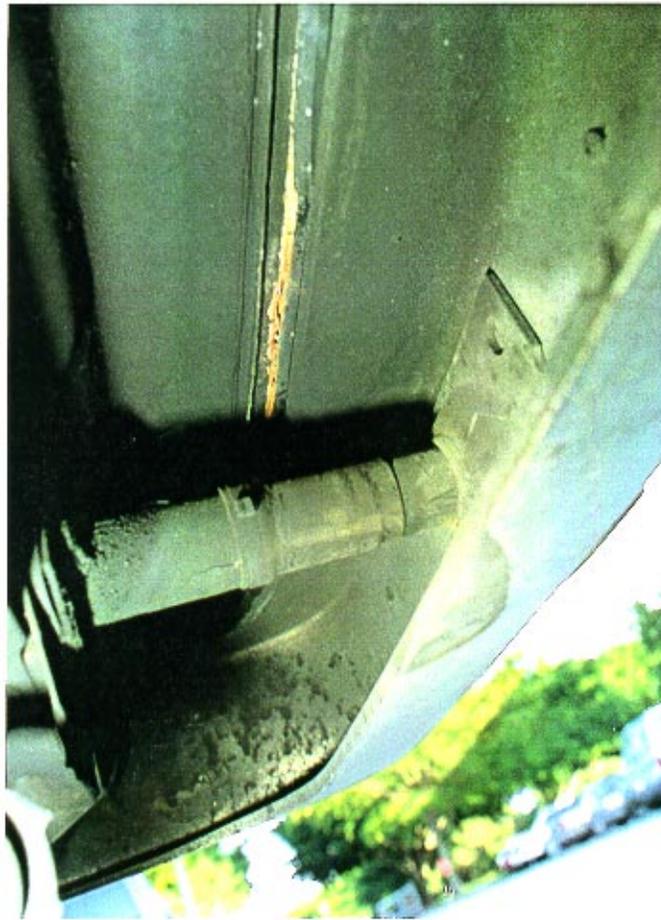
The right side of the undercarriage sheetmetal seam at the rear edge of the trunk floor was partially separated due to the full compression of the right EAD. The seam was sealed with a caulk-like material that was disrupted, revealing the minimal deformation of the sheetmetal juncture. There was no additional damage to the undercarriage area of the vehicle.

Compression/Stroke Of The Right Rear Bumper Energy Absorbing Unit

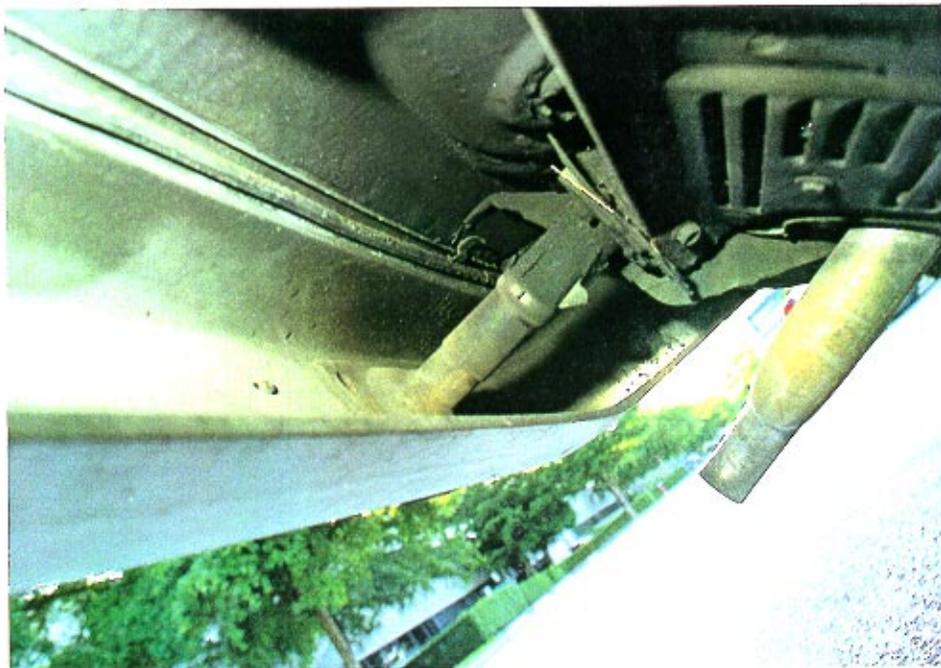
Compression/Stroke Of The Left Rear Bumper Energy Absorbing Unit

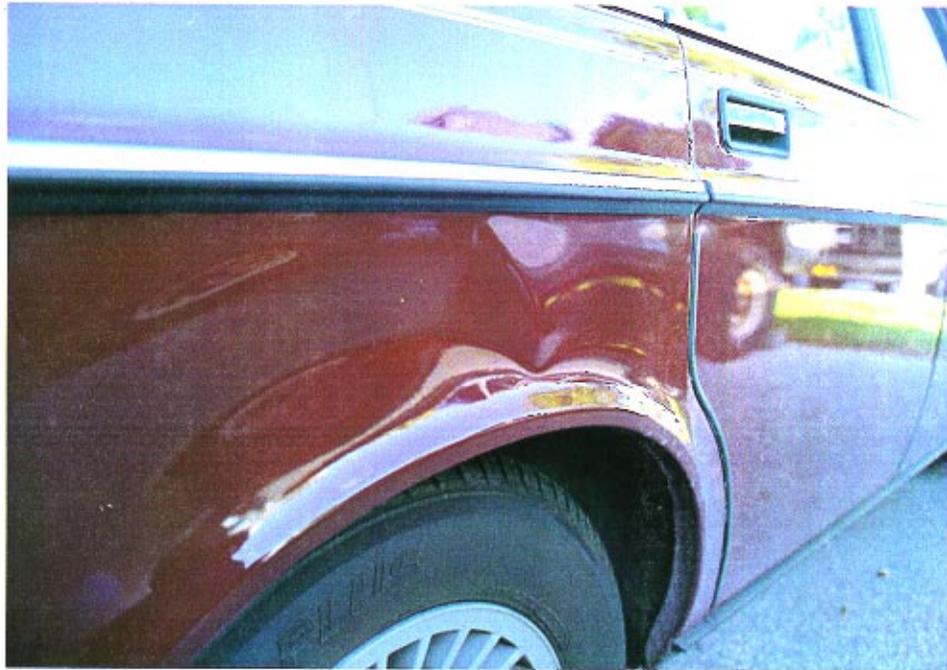
The compression of the rear bumper area was transmitted through the unibody construction of the vehicle. A small diameter outward buckling of the right quarter panel was visible directly above the right axle position. There was no reduction noted to the 264 cm (104") wheelbases.

Remote Buckling To The Right Rear Quarter Panel
Directly Over the Axle Position

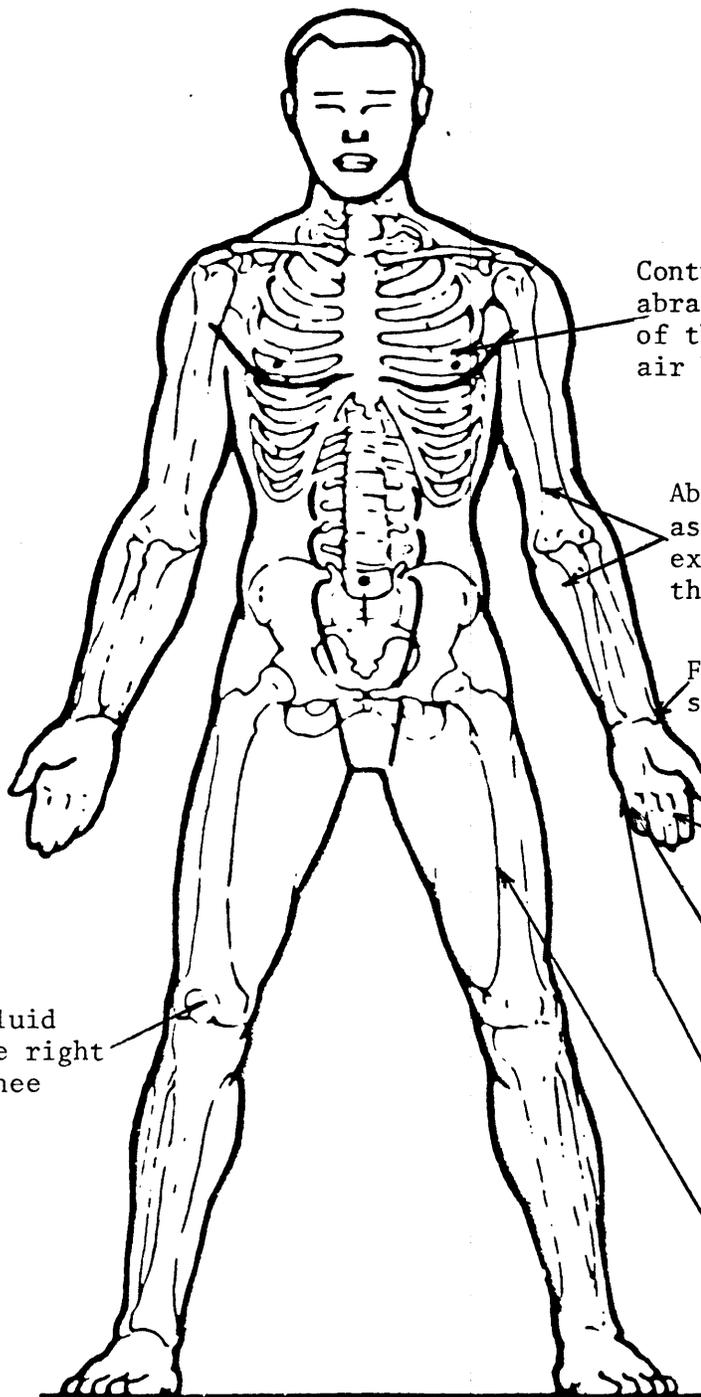
Contusion with superficial abrasion of the lateral aspect of the left breast (AIS-1), air bag

Abrasion of the anterior aspect of the left arm that extended above and below the elbow (AIS-1), air bag
