CALSPAN POWER WINDOW INVESTIGATION

CALSPAN CASE NO. 94-11

VEHICLE: 1991 TOYOTA CAMRY DX

14. Sponsoring Agency Code	
15. Supplementary Notes On-site investigation of a power window incident that resulted in a fatality to a 3 year old child occupant.

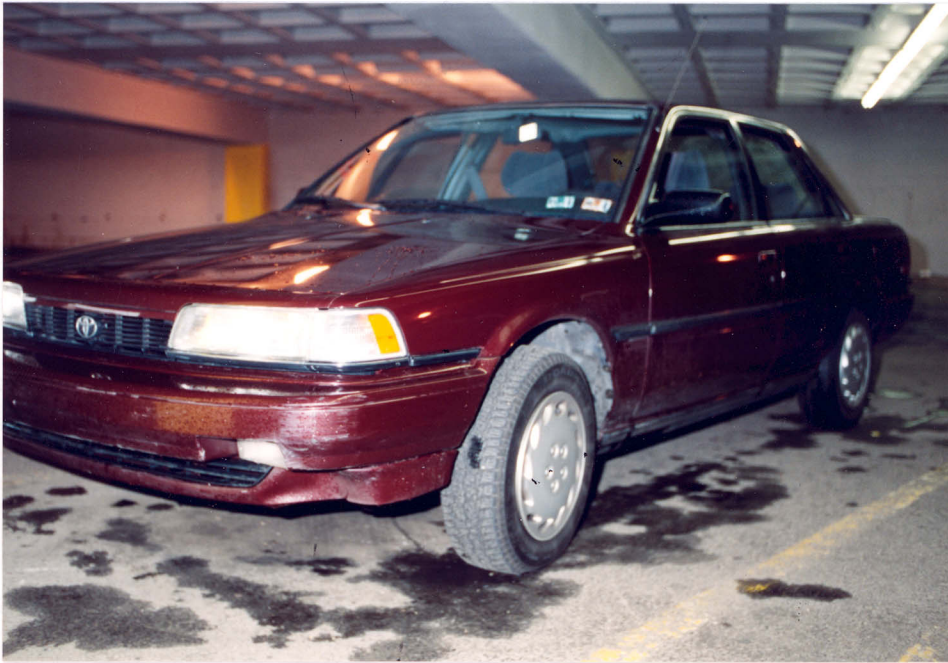
1. Left front three-quarter view of the Toyota Camry.

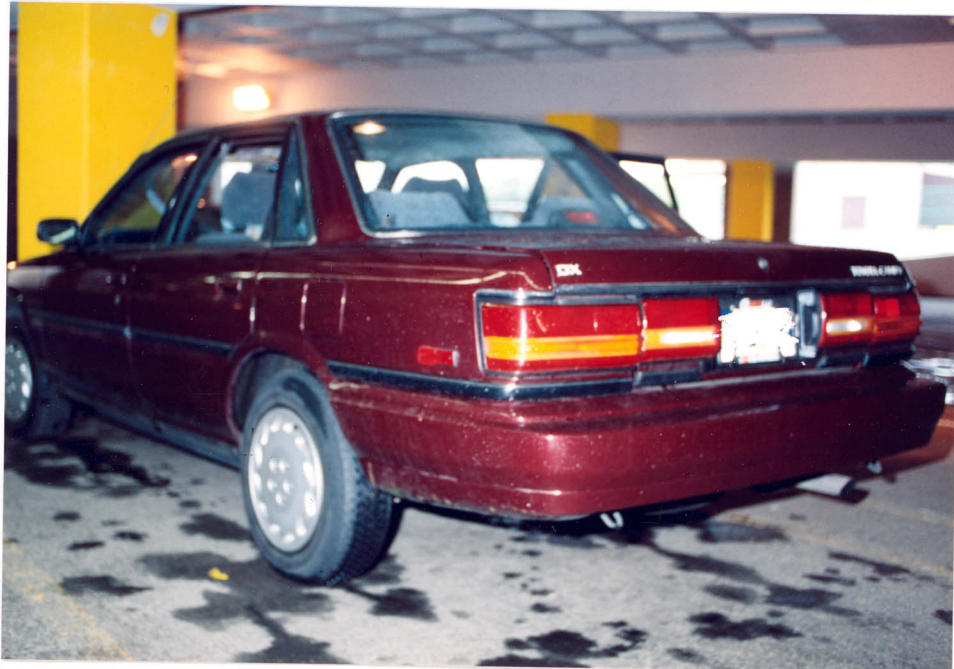
2. Left rear three-quarter view of the Toyota Camry.

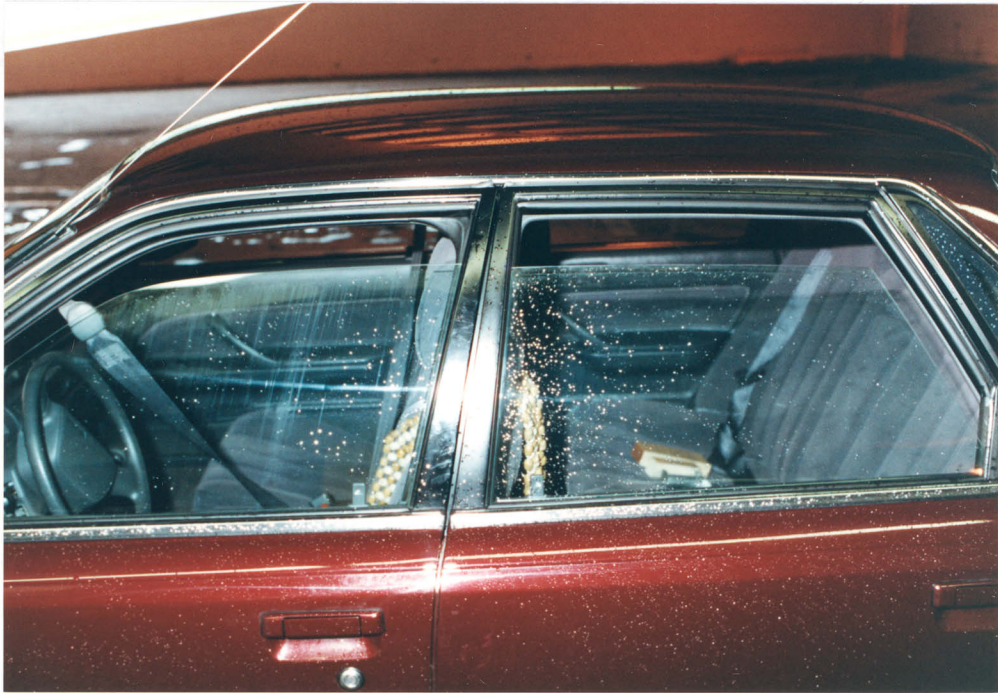
The driver stated that due to the warm weather, he had partially opened all four power door windows during the drive. He estimated that each window was opened approximately 7.6 cm (3.0"). The power windows were controlled by a master switch panel that was integrated into the left front door armrest, forward of the pull handle. The switch panel contained four rocker type switches that were positioned in two rows for the four door windows. The driver's window had an automatic down mode that powered the window to the full down-position when the switch was depressed and momentarily held in that position. The right front and rear door windows required constant switch pressure to fully open the windows. To return all the windows to their up-positions, the driver must lift the forward edge of each switch and hold the switch in the up-position until the window is fully closed or at the desired height. Located forward of the cluster of window switches was a detent type

3. Approximate opened positions of all four door windows.

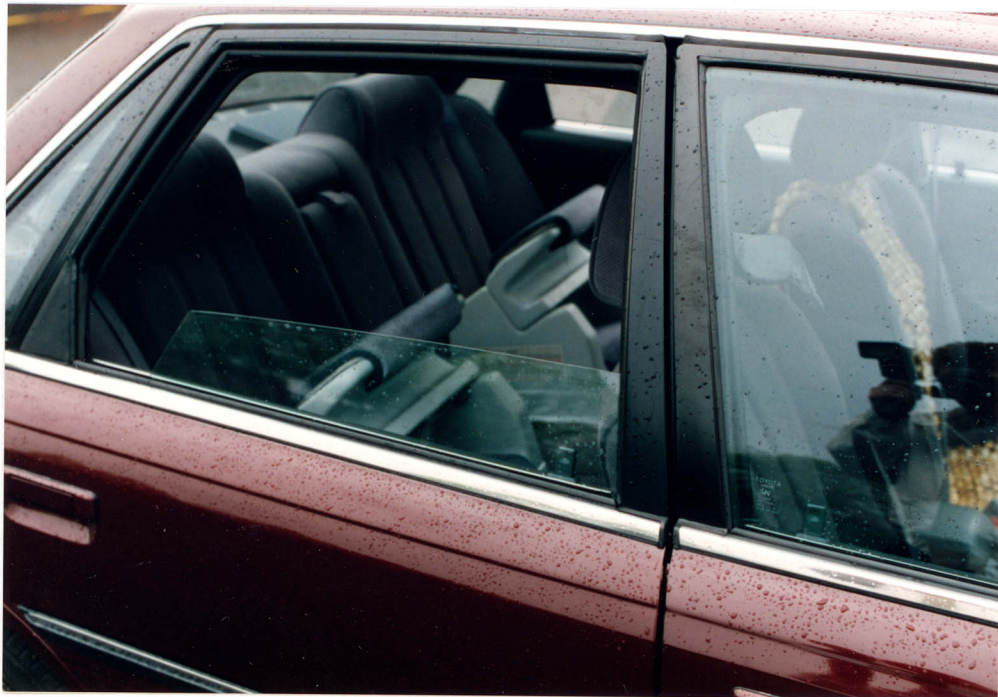
4. Exterior view of the right rear window in the full down-position.

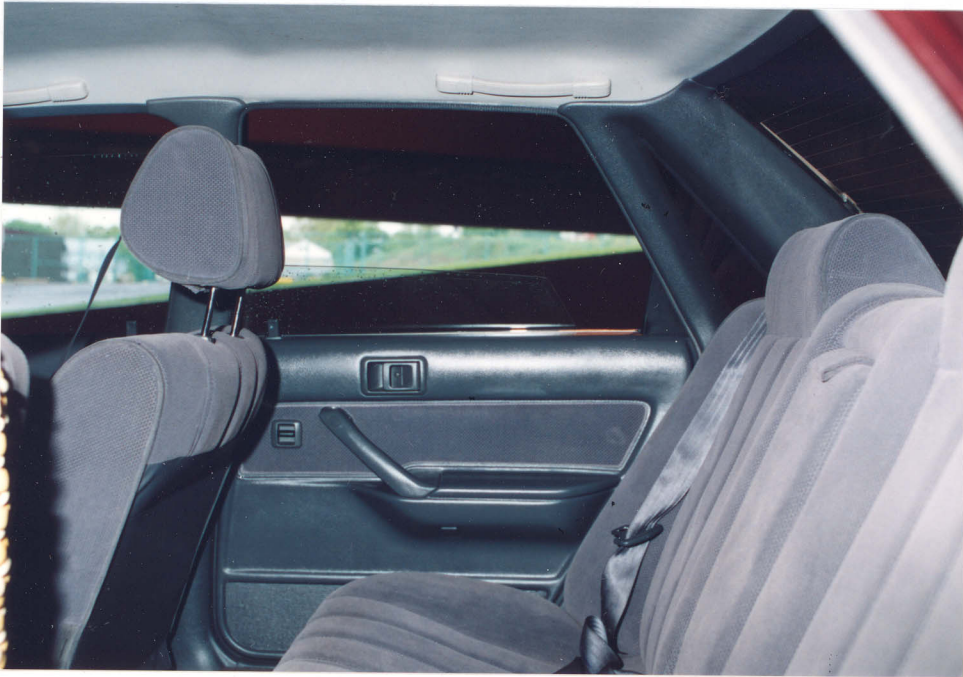
5. Interior view of the fully opened right rear window.

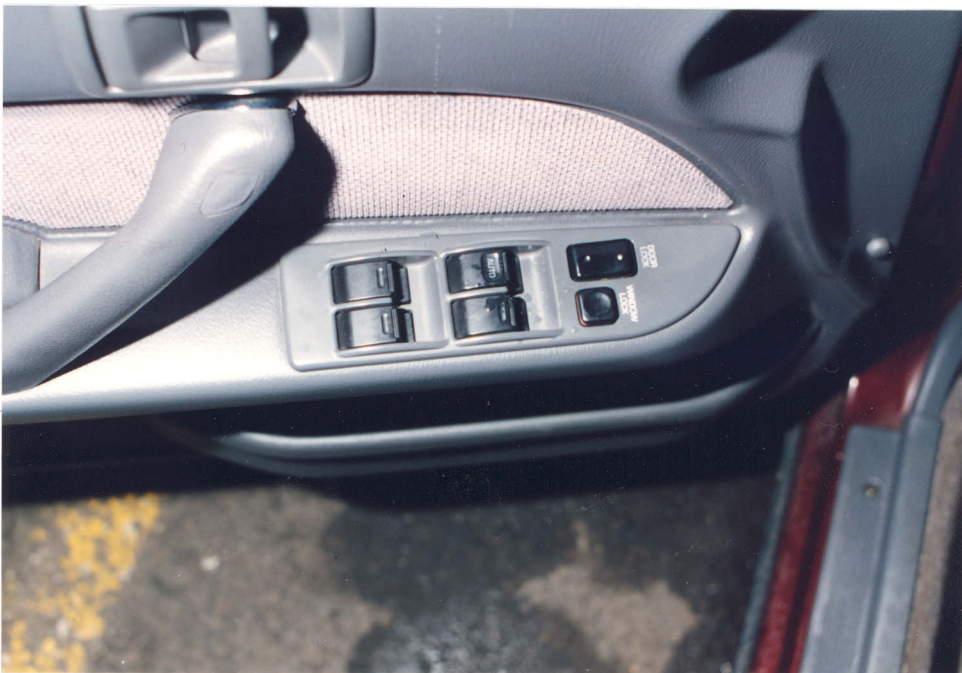
lock-out switch for the right front and rear door power windows. The lock-out mode was activated by depressing the square switch and released by depressing the switch again, which returned the switch to the up and off-position. The lock-out mode could lock-out the power window operation of the right front and rear doors with the windows in any position, from the full up to the full down position.

6. Power window switch console on the driver's side door armrest.

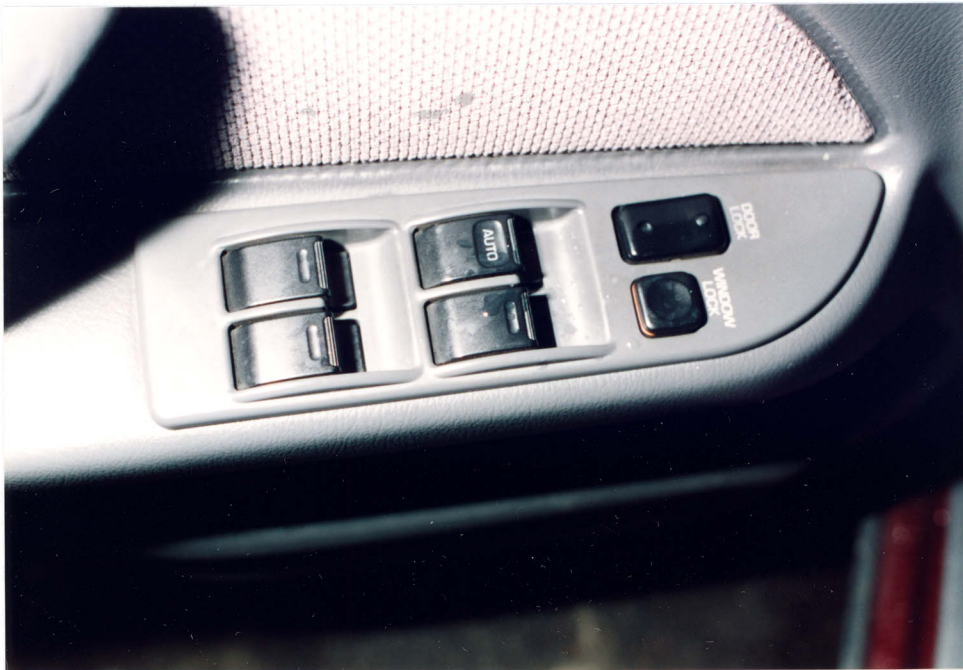
7. Close-up view of the power window switch console.

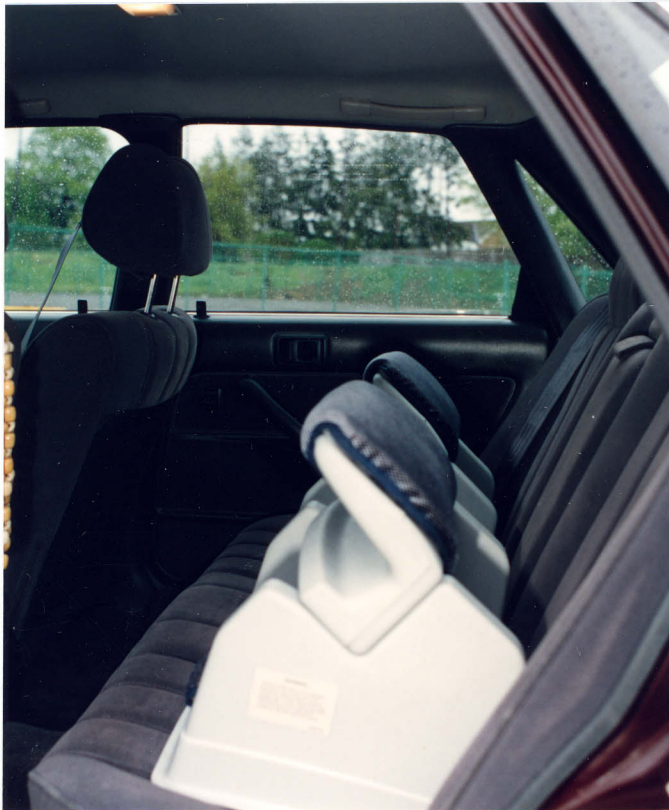
8. View across the rear seat area toward the right rear door.

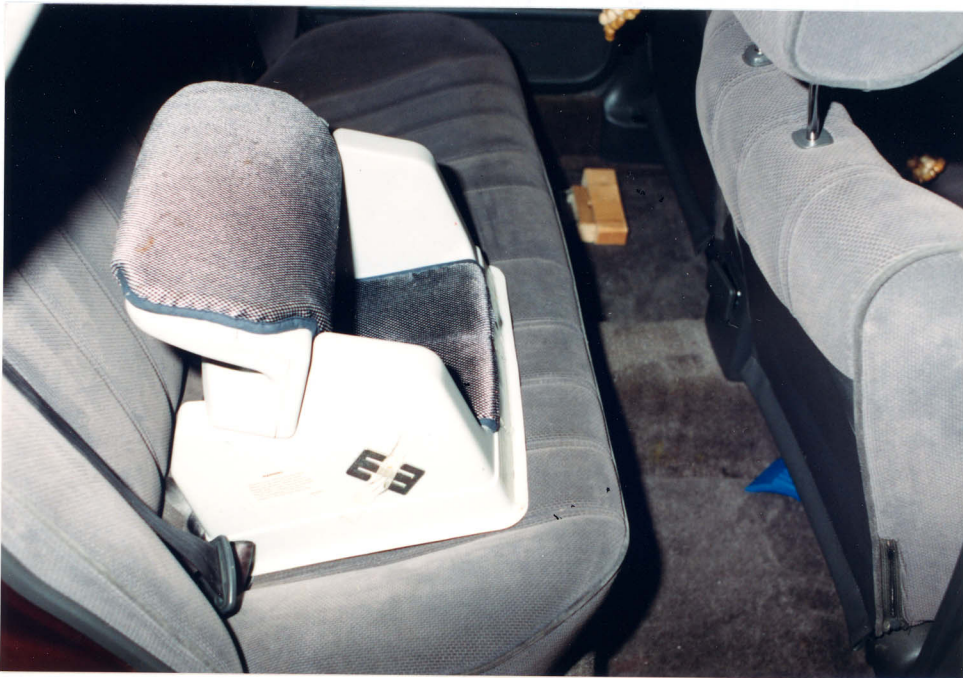
9. Evenflo Sightseer booster seat (reversed position on seat).

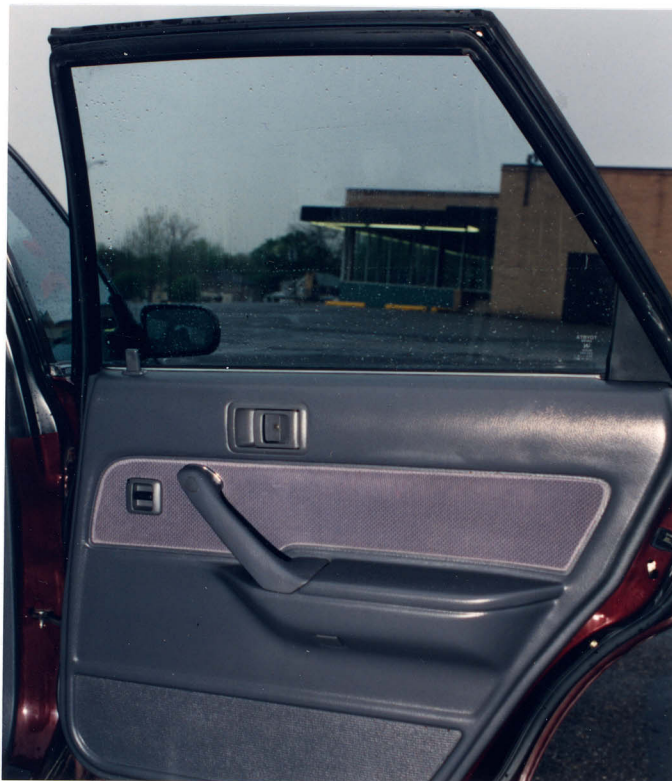
10. Overall view of the right rear interior door panel.

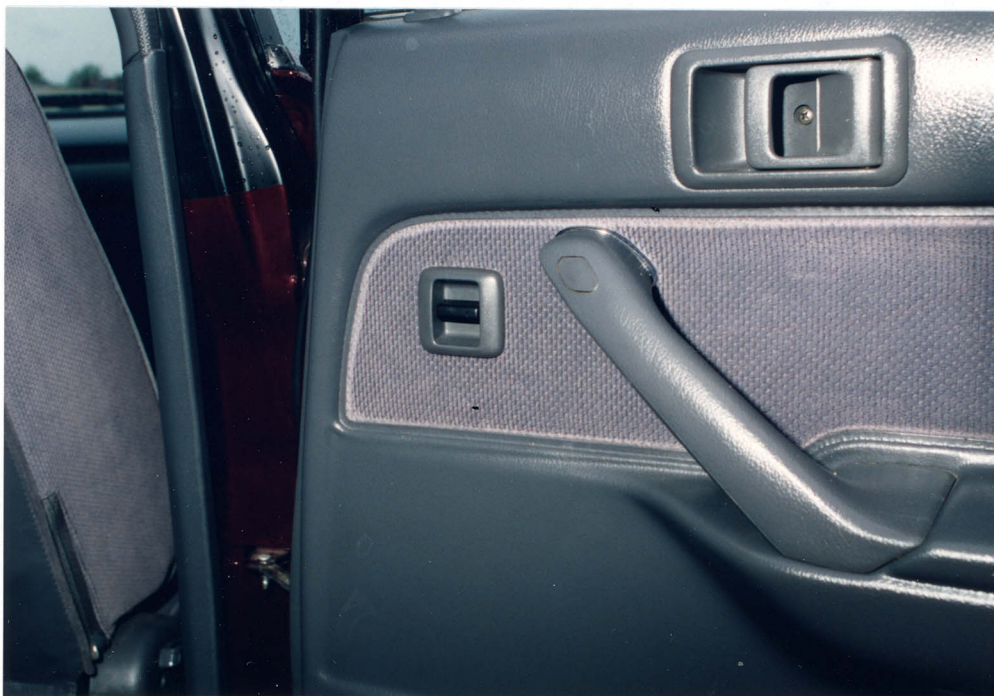
The right front and rear doors were equipped with separate switches to operate the power window for the specific door only. These switches were mounted flush with the door panel and were located 15 cm (6") below the beltline and 9.50 cm (3.75") rearward of the leading edge of the door panel. The toggle-type switches were vertically operated which required constant pressure in the up and down positions to power the window. When pressure was released from the switch, the switch automatically returned to the center (neutral) off-position. The rear door windows were polygonal in shape with horizontal measurements of 66 cm (26") at the base and 48.5 cm (19.1") at the roof side rail, and vertical measurements of 40 cm (15.75") at the B-pillar and 36.6 cm (14.4") at the C-pillar. The rear windows did not retract fully into the door panel. In the full down position, the center of the glass extended 10.80 cm (4.25") above the beltline. As the rear windows were lowered, the rear edge of the glazing disengaged from the window track along the C-pillar while the forward edge remained engaged with the B-pillar track.

11. Close-up view of the right rear door power window switch.

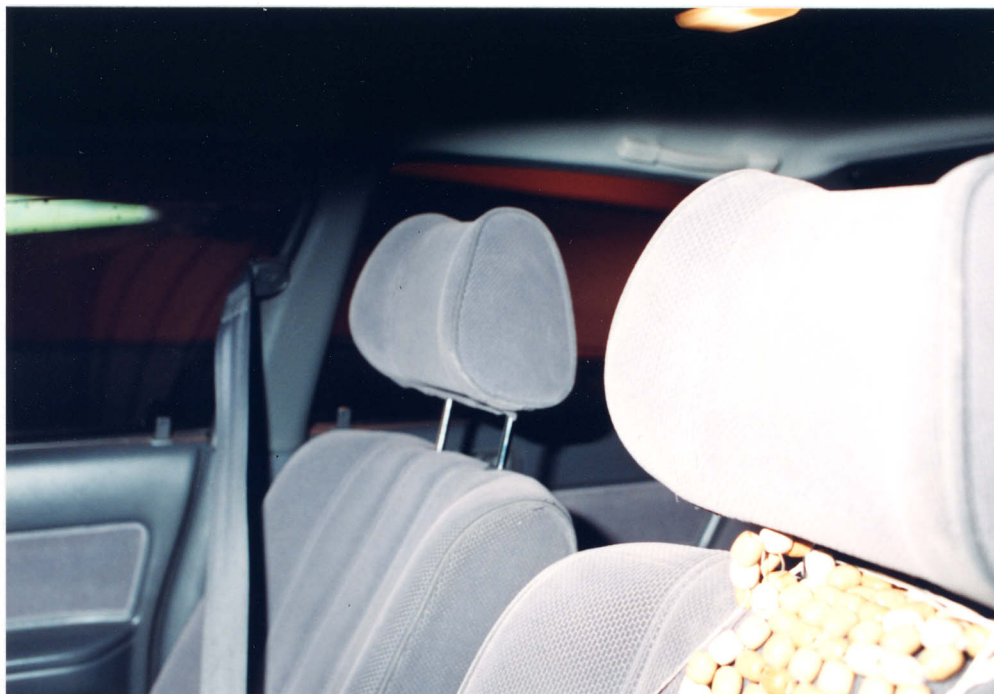
12. Right front seat back and head restraint obstruction of driver's view toward the right rear area.

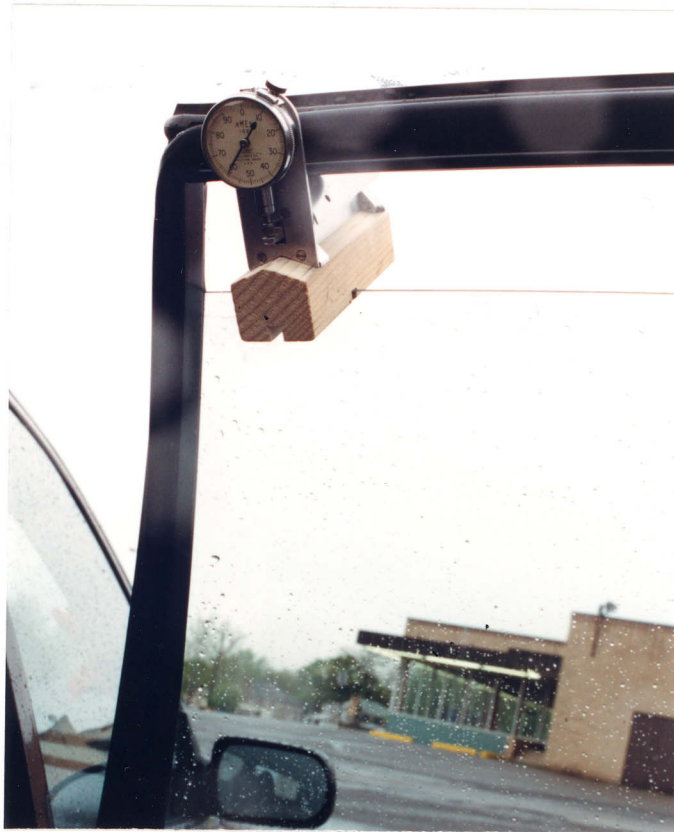
The power windows were not equipped with force limiters or a load sensing type reversal mechanism. When the switches were held in the up modes, the windows continued to close until a resisting force was encountered that would stall the door mounted electric motor. A hand-held force gauge was used to measure the closing force of the right rear window. The gauge was Calspan property and was purchased and calibrated by our Equipment Standards Laboratory (ESL). The stick force indicator gauge was manufactured by [REDACTED] and [REDACTED]. The gauge was identified by [REDACTED] and was calibrated on [REDACTED] 93. The gauge is due for recalibration on [REDACTED] 94. The face gauge was a dial indicator gauge that was calibrated to read in pounds and was capable of measuring from 0-100 pounds of force. A wooden block was fabricated to fit in the base of the gauge with a slot cut in the base of the block to accommodate the glazing.

The gauge and block were placed at various points along the right rear window as the window was powered-up, compressing the gauge between the top edge of the glazing and the window frame. This procedure was performed with the ignition in the on-position and with the engine running. The window was also raised against the force gauge from various levels, from the full down position which allowed the glazing and internal mechanism to travel approximately 19.70 cm (7.75") to less than 2.5 cm (1.0") of travel before stalling against the force gauge. These procedures were repeated several times to ensure consistent results. The results are as follows:

13. Force gauge positioned between the right rear window and the window frame adjacent to the B-pillar.

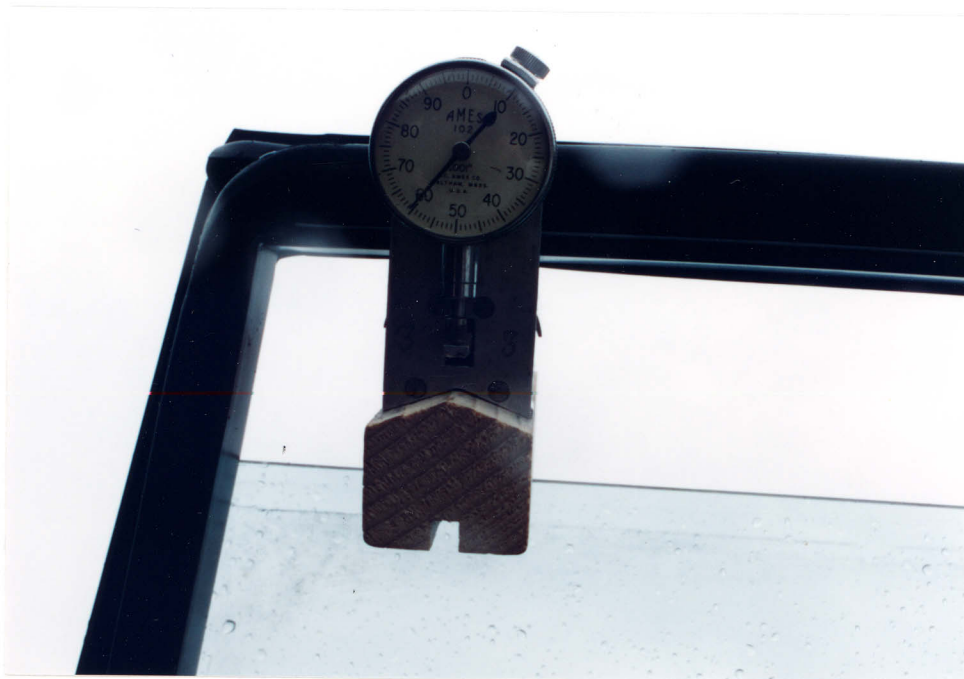
<u>Ignition Switch In On-Position</u> (Engine Off)	<u>Engine Running</u>
Gauge Location		
Forward Edge of Glazing	43-45 lbs. of Force	60 lbs. of Force
Mid Glazing	43-45 lbs. of Force	60 lbs. of Force
Rear Edge	40-43 lbs. of Force	50 lbs. of Force

The force exerted by the Toyota Camry's power window system was substantial to not only asphyxiate an occupant, but to also cause severe injury due to crushing. There was insufficient evidence to determine direct fault in this incident. The fatally injured child could have inadvertently closed the window on himself, or the father could have attempted to close the window without realizing the child was extended outside the passenger compartment. The most likely scenario involves the other child who probably attempted to prevent his brother from throwing his candy Easter eggs out the vehicle's window. It was obvious that the power windows were not in the lock-out mode and that the father allowed the children to play with the windows and not remain in their child restraints.

14. Gauge reading of 60 lbs. of force.

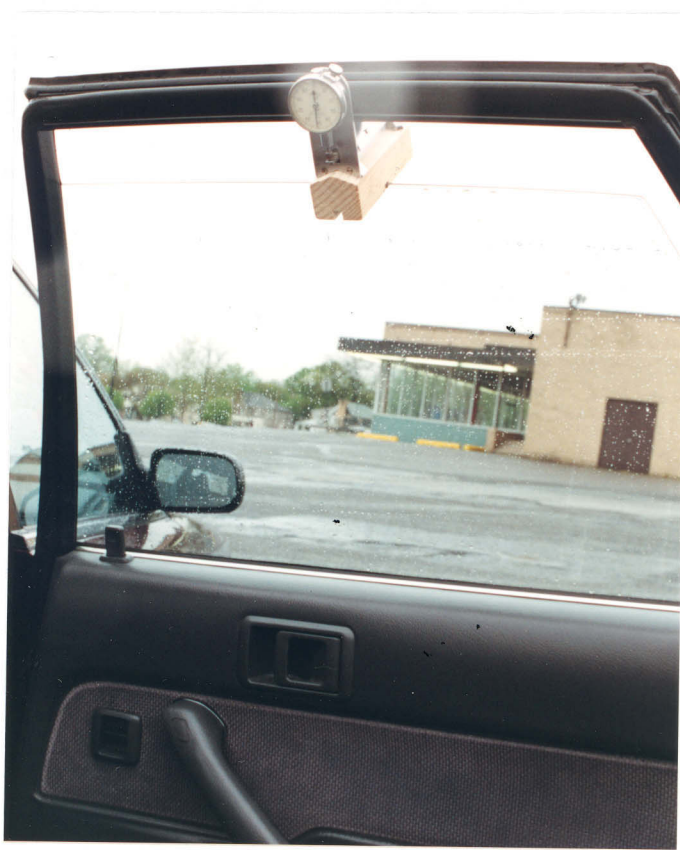
15. Gauge positioned at the mid portion of the right rear window.

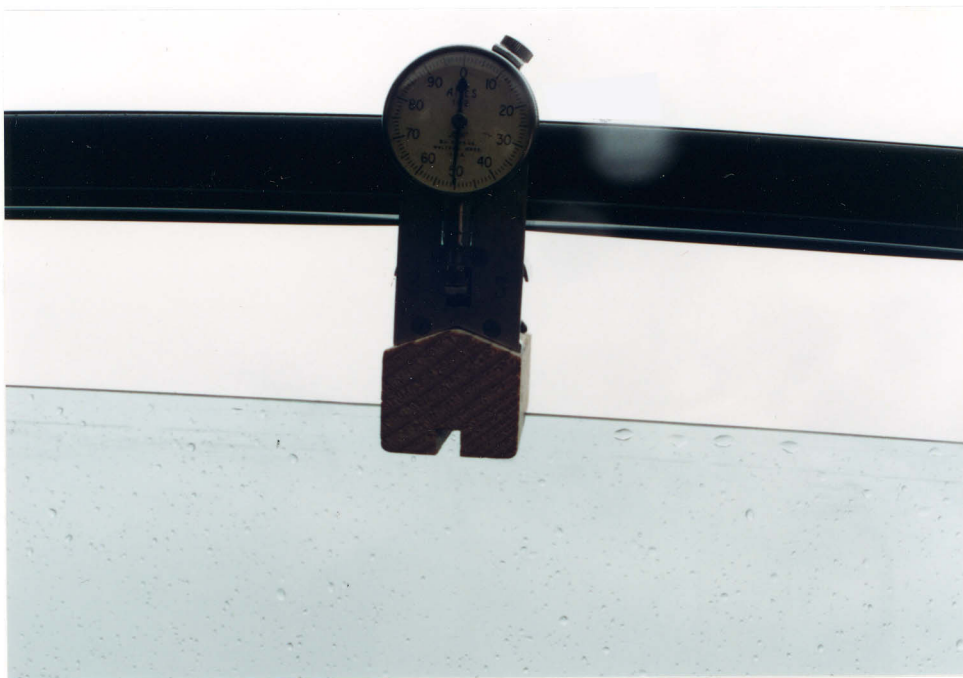
The force levels were lower at the rear edge of the glazing due to the design of the door and window

frame which allowed the glazing to disengage from the rear vertical window frame as the window was lowered. As the glazing was raised against the gauge, the glazing was subsequently deflected outward, thus rotating the force gauge between the glazing and the upper window frame.

16. Gauge reading of 50 lbs. of force at mid window.
