**CALSPAN ON-SITE EVALUATION OF NCAP TEST VEHICLE FIRE  
CALSPAN CASE NO. 94-37  
VEHICLE: 1995 FORD CONTOUR  
TEST LOCATION: [REDACTED] OH  
DATE [REDACTED] 1994**

14. Sponsoring Agency Code	
15. Supplementary Notes On-site evaluation of an NCAP test vehicle to determine the root cause of flames which vented through the deployed passenger side air bag module assembly.

**CALSPAN ON-SITE EVALUATION OF NCAP TEST VEHICLE FIRE**  
**CALSPAN CASE NO. 94-37**  
**VEHICLE: 1995 FORD CONTOUR**  
**TEST LOCATION: TRC (REDACTED), OH)**

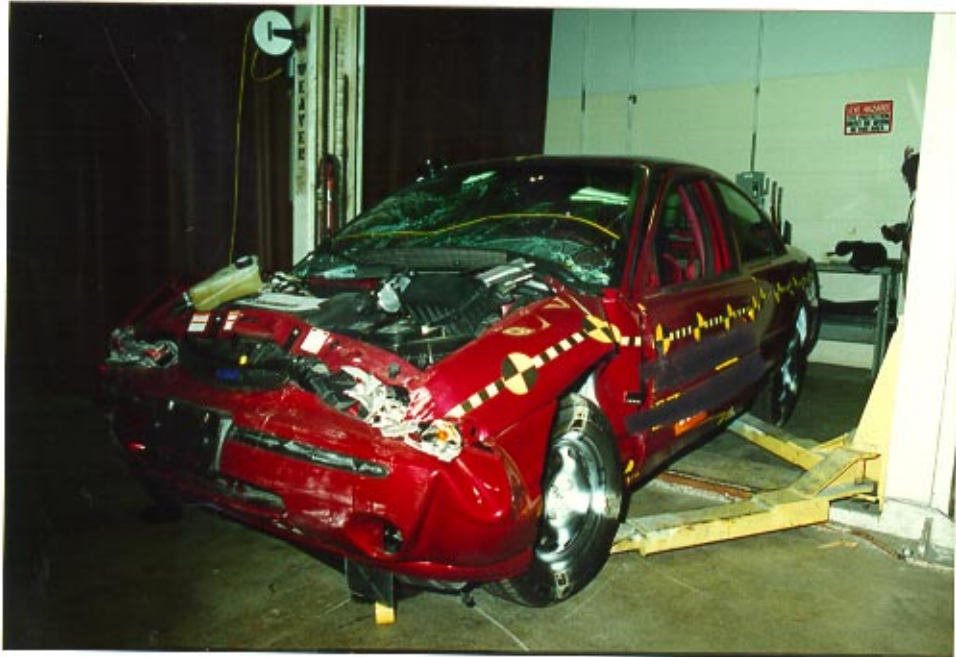
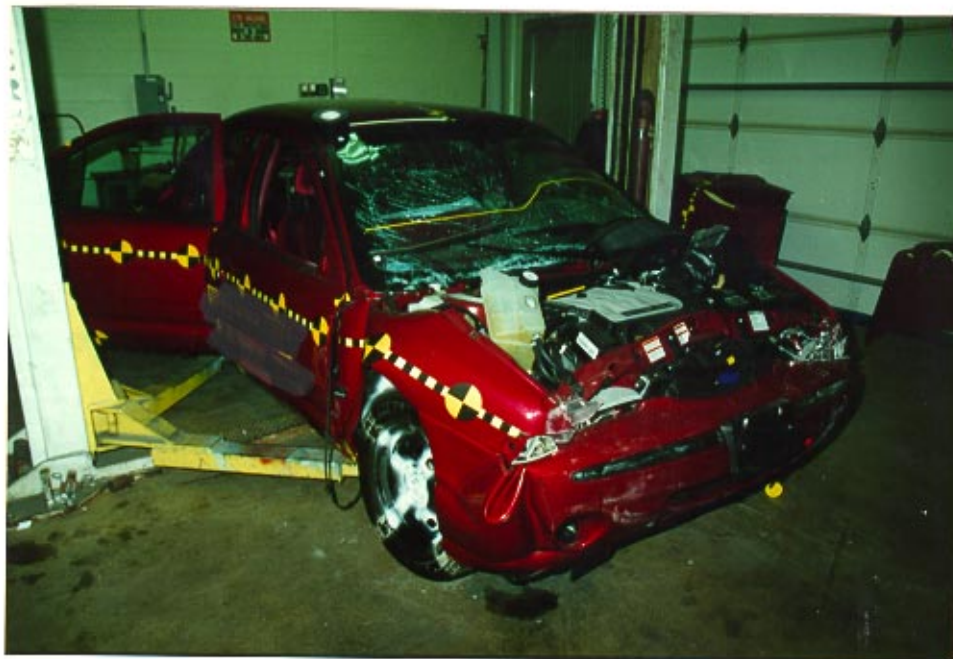
1. & 2. Post-test front three-quarter views of the 1995 Ford Contour.

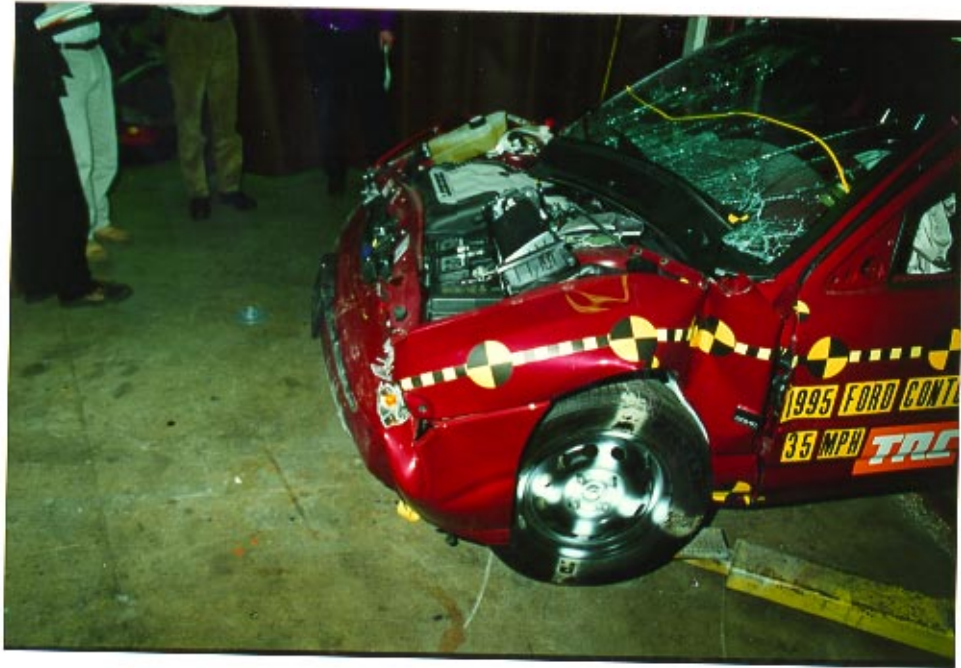
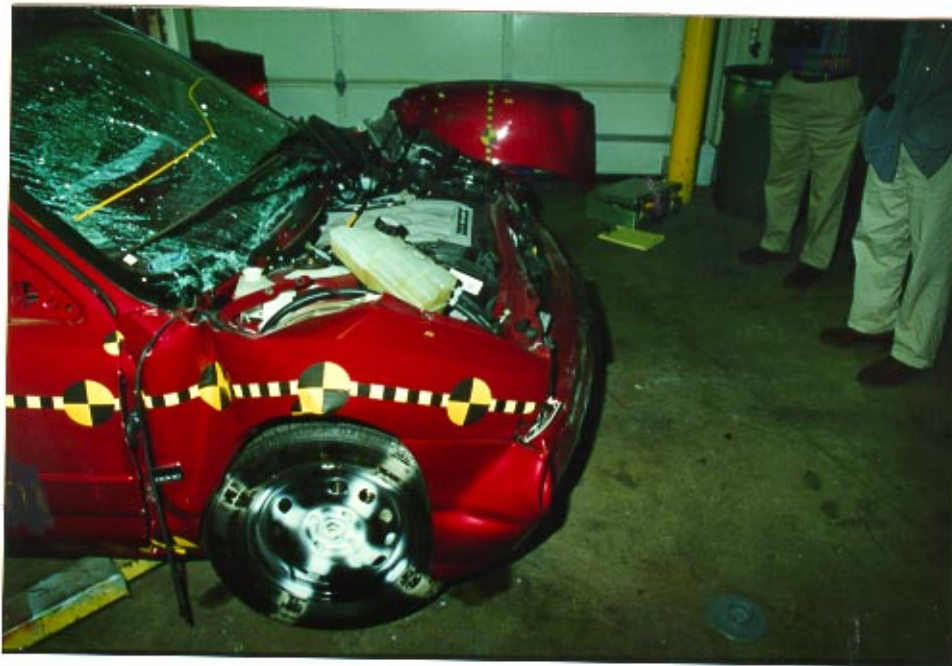
TRC personnel measured the maximum crush to the Ford Contour at 40.2 cm (15.8") located on the bumper fascia right of the vehicle's centerline. Crush values across the full frontal width of the vehicle were as follows: L = 152.4 cm (60"), C<sub>1</sub> = 31.5 cm (12.4"), C<sub>2</sub> = 36.2 cm (14.3"), C<sub>3</sub> = 39.7 cm (15.6"), C<sub>4</sub> = 40.2 cm (15.8"), C<sub>5</sub> = 39.4 cm (15.5"), C<sub>6</sub> = 36.5 cm (14.4"). The transverse mounted Duratec 2.5 liter DOHC V-6 cylinder engine was displaced rearward into the engine/passenger compartment cowl which intruded into the passenger compartment.

3. & 4. Perpendicular views showing the extent of frontal crush.

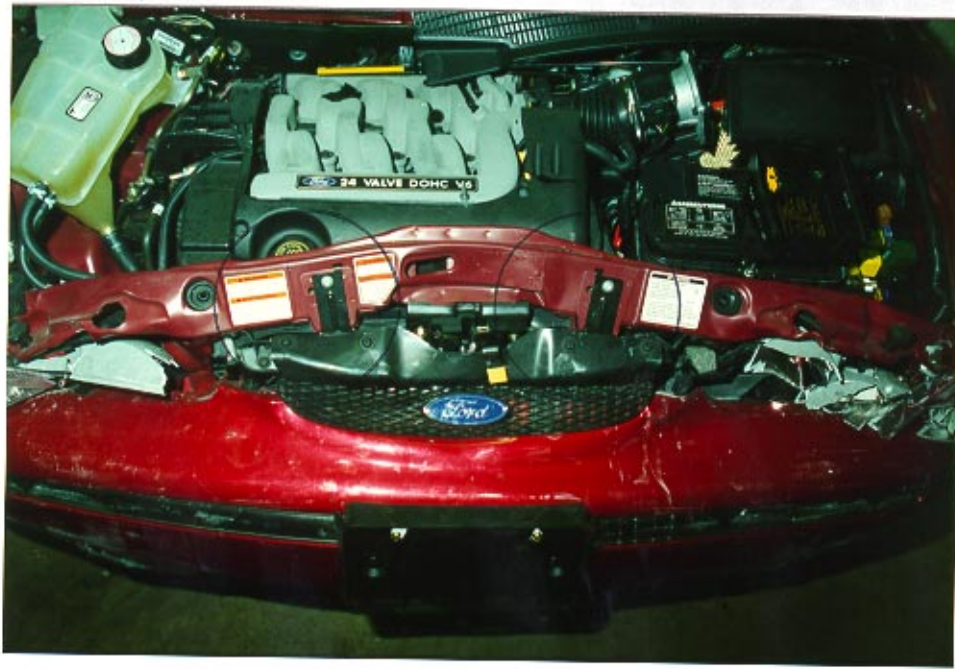
5. Circles represent location of front mounted air bag crash sensors.

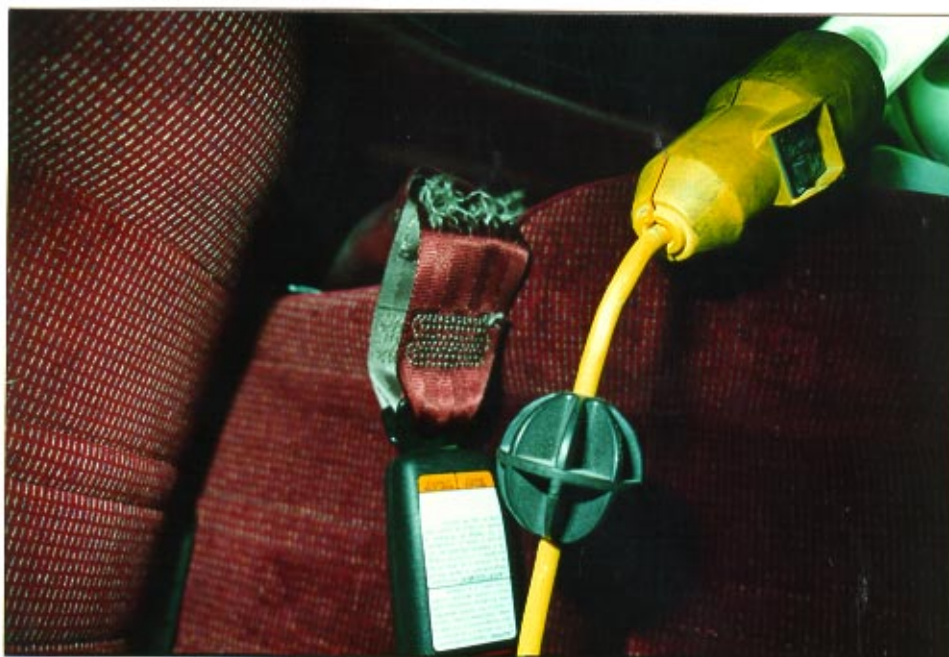
10. Separated energy management stitching in the right front belt buckle assembly.

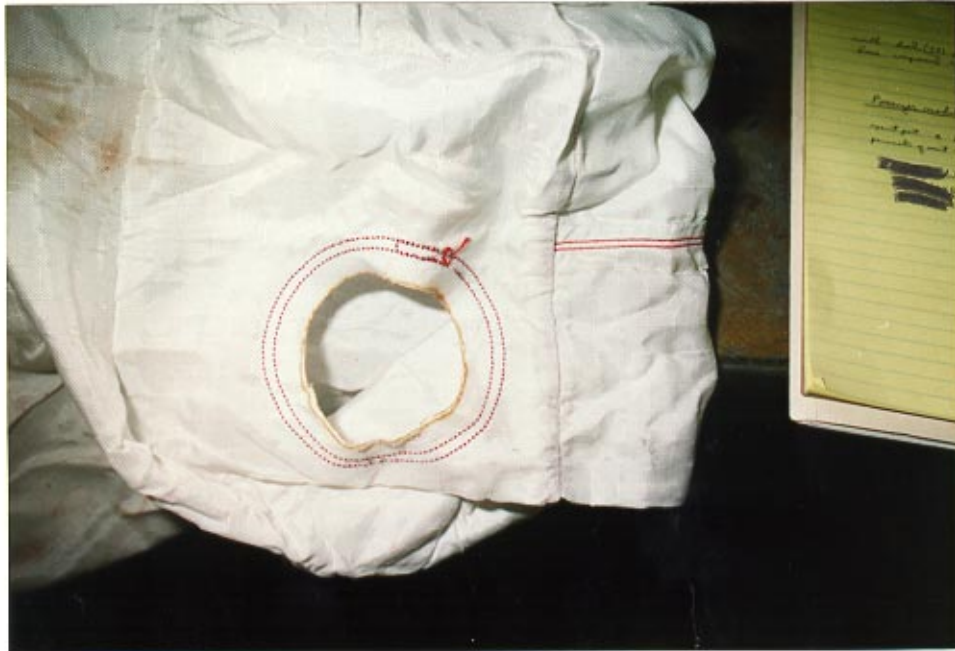
13. Passenger side vent ports; superficial singeing around port.

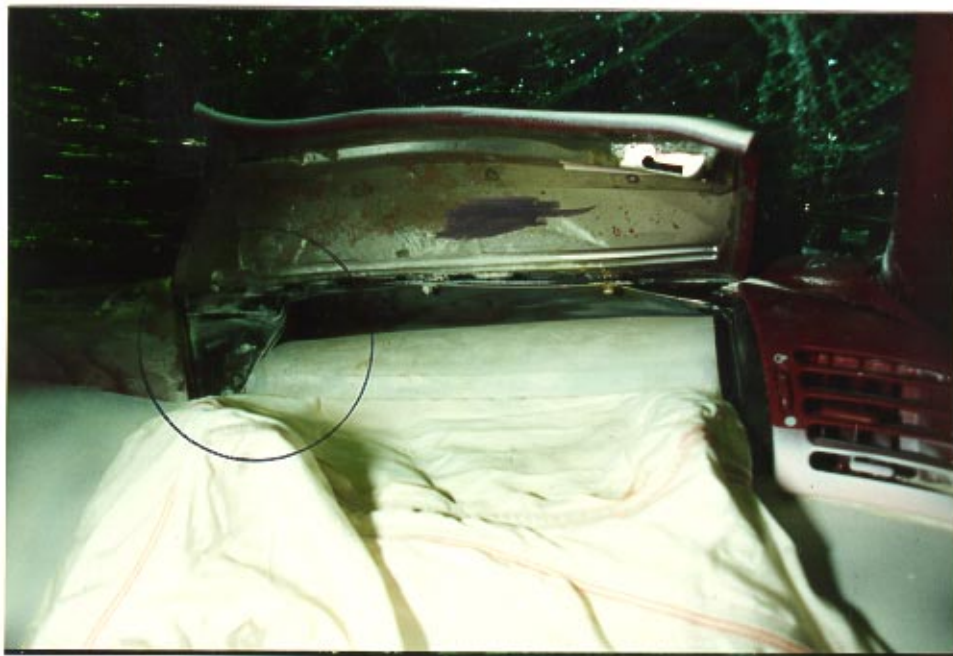
of the vehicle with a fuel pan retrieving fuel that was leaking out of the fuel tank/filler tube area. A second technician approached the vehicle from the right side. Simultaneously, both technicians detected flames extending from the upper left quadrant of the deployed passenger side air bag module. They immediately called for assistance and technicians responded with fire extinguishers that were available at the test site. The technicians sprayed the area of flames with a dry chemical-type fire extinguisher which rapidly extinguished the flames. The rapid detection and response by the technicians prevented the vehicle from sustaining fire damage.

14. Circled area identifies location of the flames.

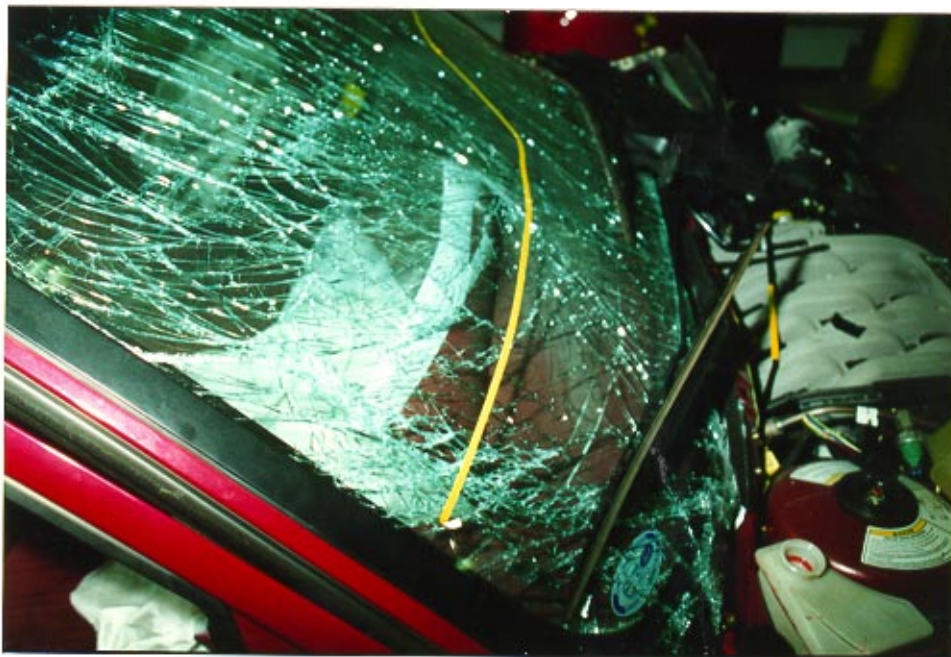
The passenger side air bag module cover flap was constructed of a steel backer panel with a vinyl exterior cover. The flap was found in the full opened position against the windshield. The left corner and center area of the passenger side module cover flap contacted and cracked the windshield.

15. Passenger side module cover flap contact with windshield.

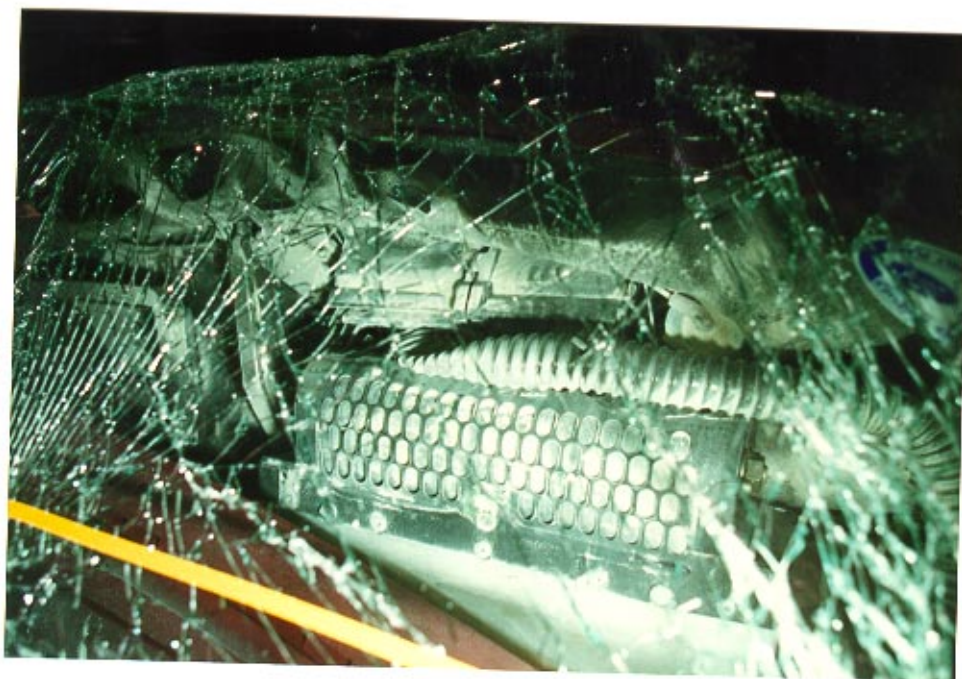
16. Heater tube compressed against the air bag generator.

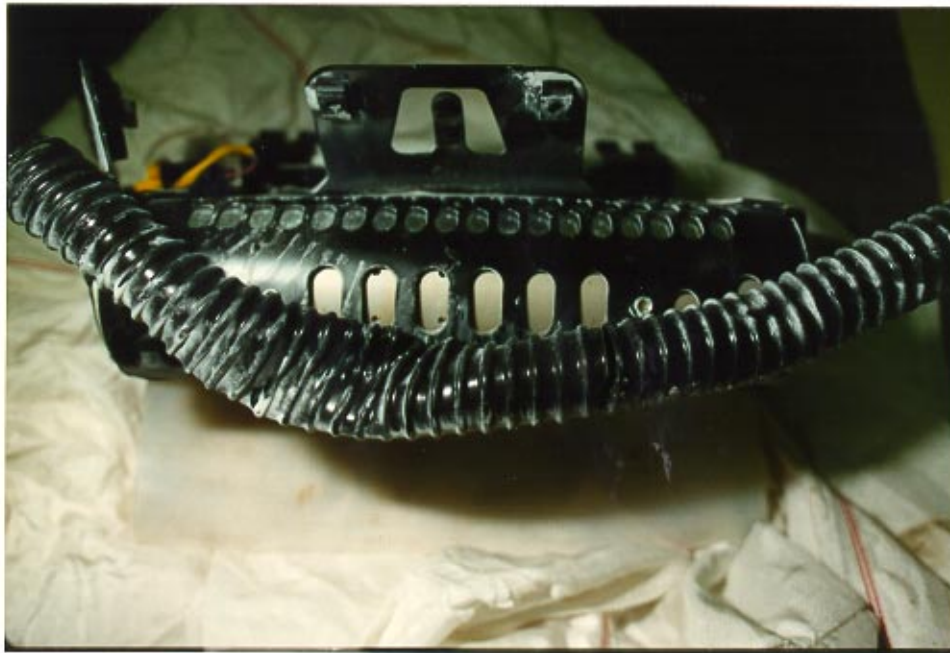
The passenger side air bag module was removed from the vehicle and inspected for evidence of fire. There was no indication of excessive heat of flame to the module assembly. The heater duct tubing that was identified above was fused to the back side of the inflator. This resulted from the heat generated by the inflation process and the compression of the tubing against the module from intrusion. The steel cover (flap) of the passenger side air bag module was stamped with a identification number of [REDACTED]. The module assembly was identified with a bar coded label which contained Ford Part No. [REDACTED] and Module Serial No. [REDACTED].

17. Melted heater tube fused to the heat shield around the generator.

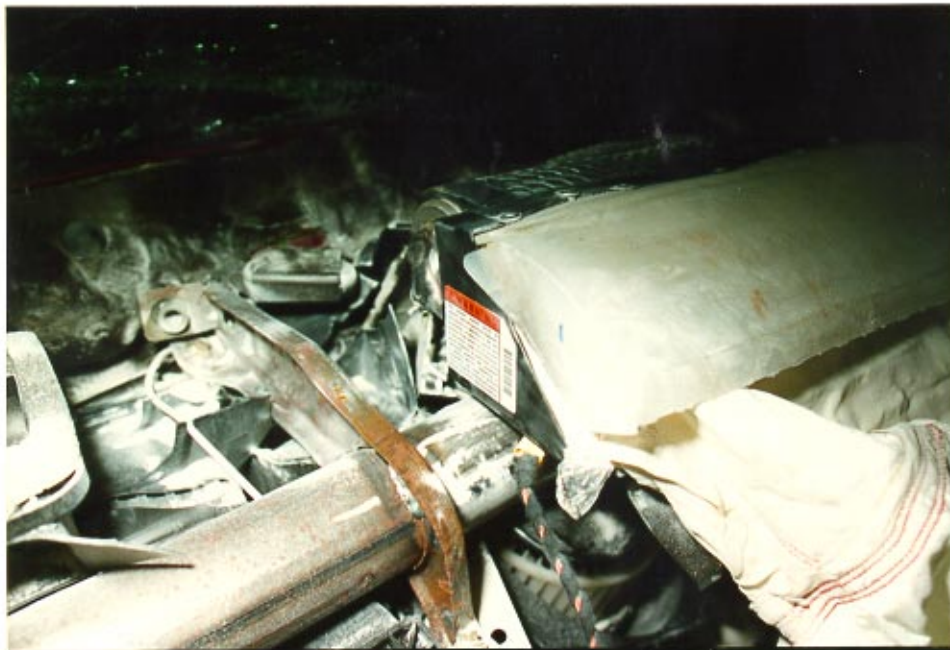
18. Area where the flames vented from the instrument panel.

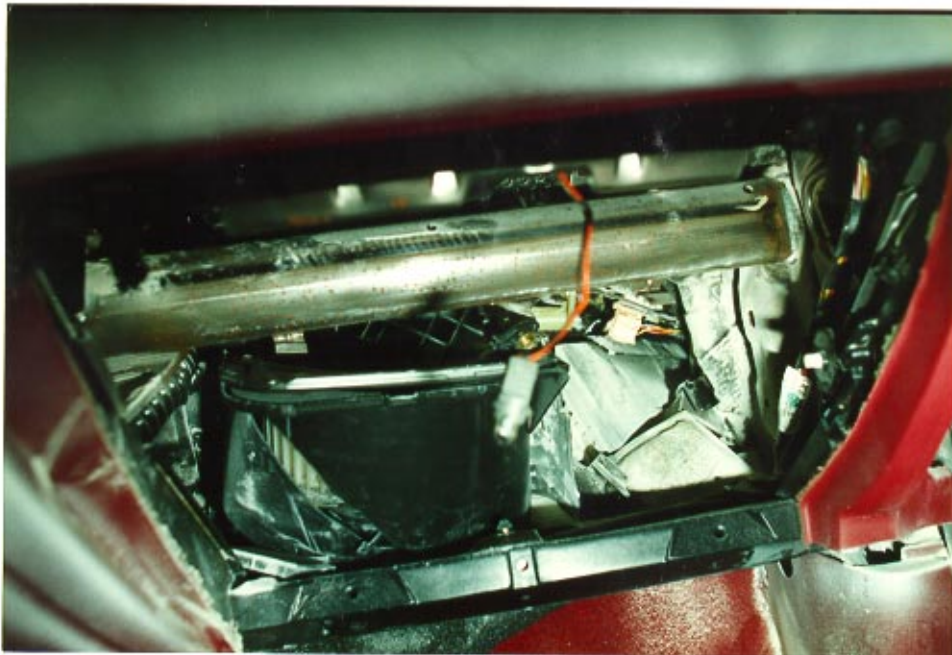
The next step involved the removal of the glove compartment door which provided a view of the lower instrument panel area. The heater/AC fan was located forward and inboard of the glove box. This unit was housed in a plastic-type assembly that was fractured at multiple sites by intrusion of the cowl and toe pan. An inspection of the area forward of the fan assembly revealed evidence of additional fire related damage which consisted of melted plastic and charred type surfaces.

20. View through glove box area of the fractured heater blower motor assembly.

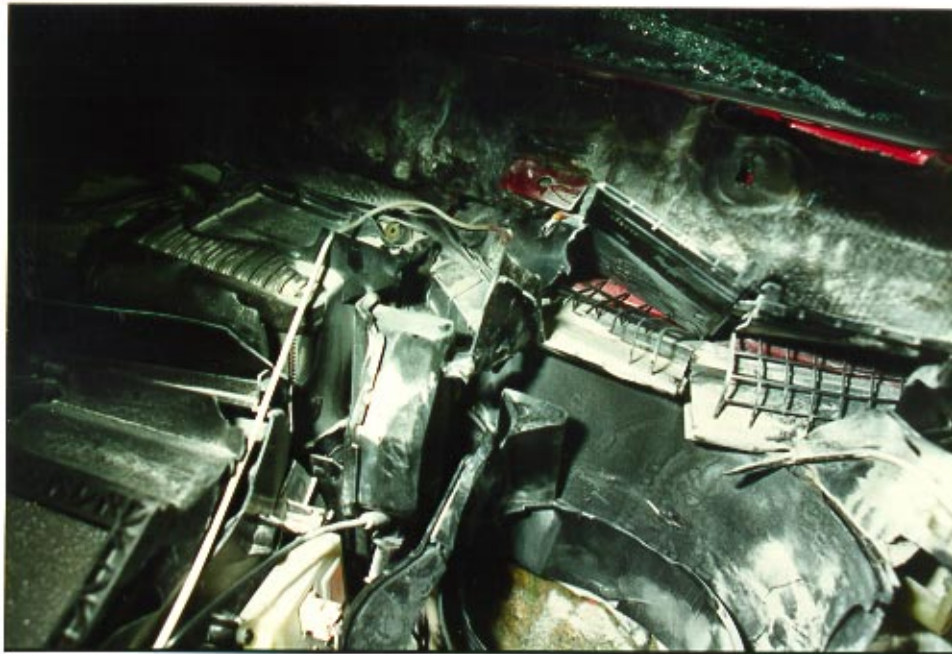
22. Charred and melted path of the flames through the mid panel area.

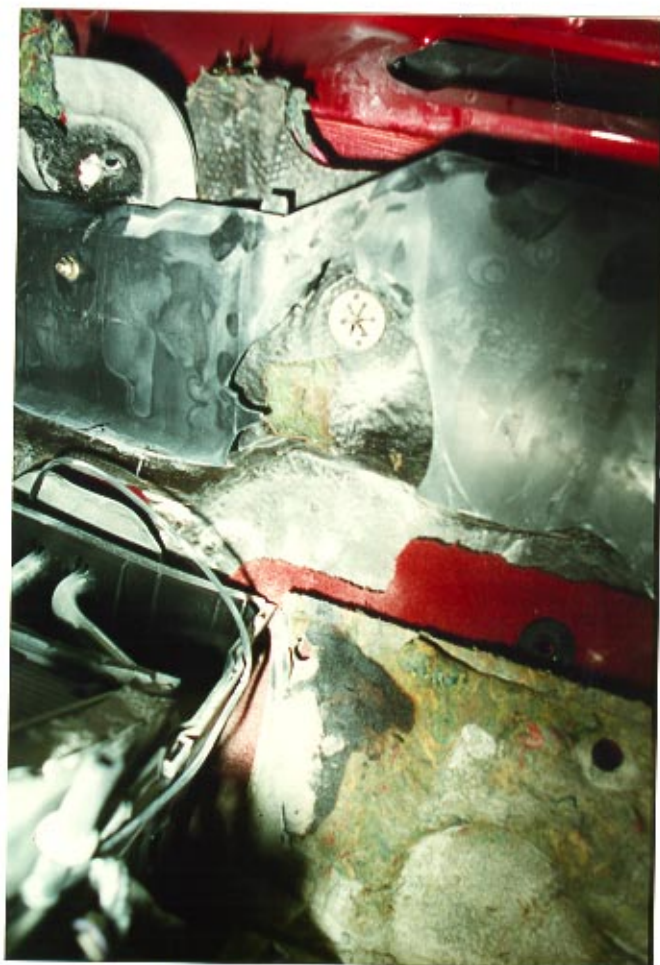
24. Charred insulation adjacent to the A/C core.

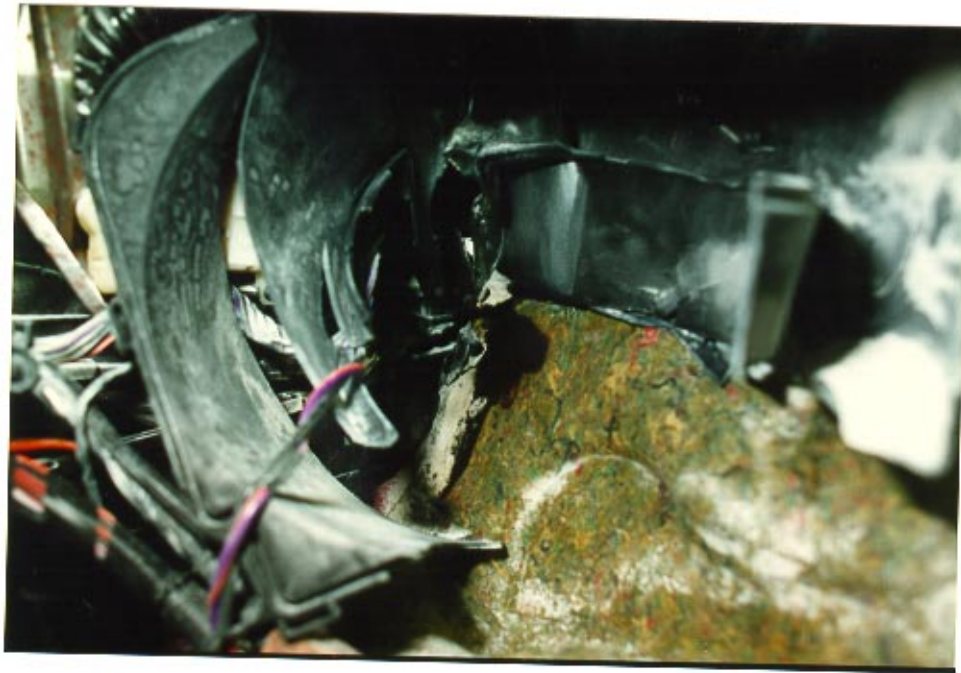
Following removal of this component, the source of the fire was evident. The heater blower switch resistor assembly which regulates the blower motor speed was displaced by the intrusion of the cowl. The plastic-type housing that incorporated the A/C core and the heater blower switch resistor assembly was fractured by the intrusion, thus exposing the resistor coils to the insulation material that was positioned around the A/C core. The insulation was subsequently compressed against the exposed resistor coils. The coils were hot since the instrument panel mounted fan speed switch was turned to the lowest speed position and the ignition switch was turned to the run-position. The heat generated by the resistor coils ignited the insulation and the flames vented through the upper instrument panel at the corner of the passenger side air bag module. The heater blower switch resistor assembly was identified with Ford Part No. [REDACTED]

25. Source of the fire at the heater blower switch resistor assembly.

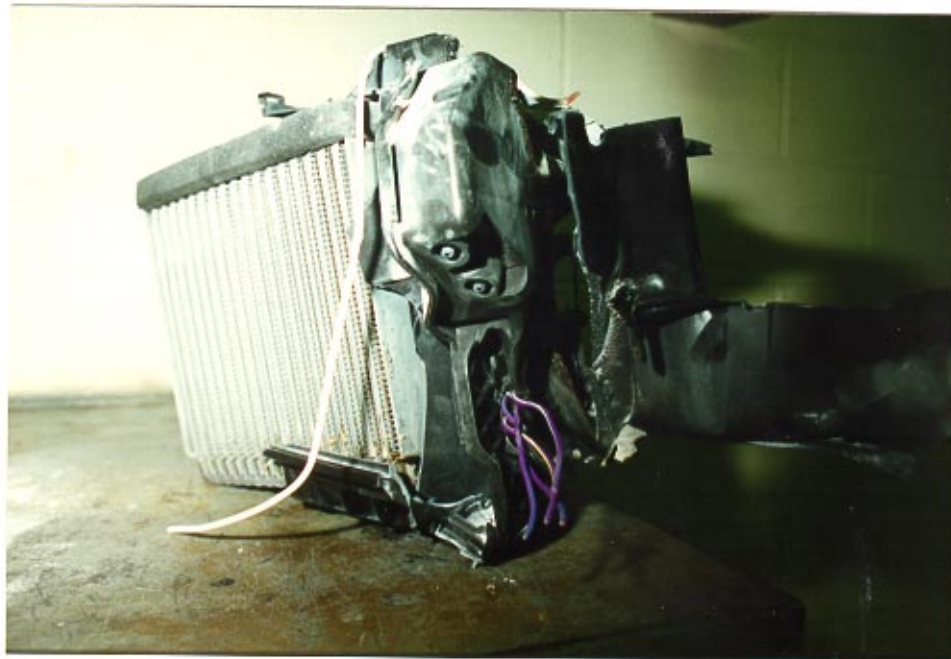
26. A/C core removed with charred and melted area surrounding the switch resistor component.

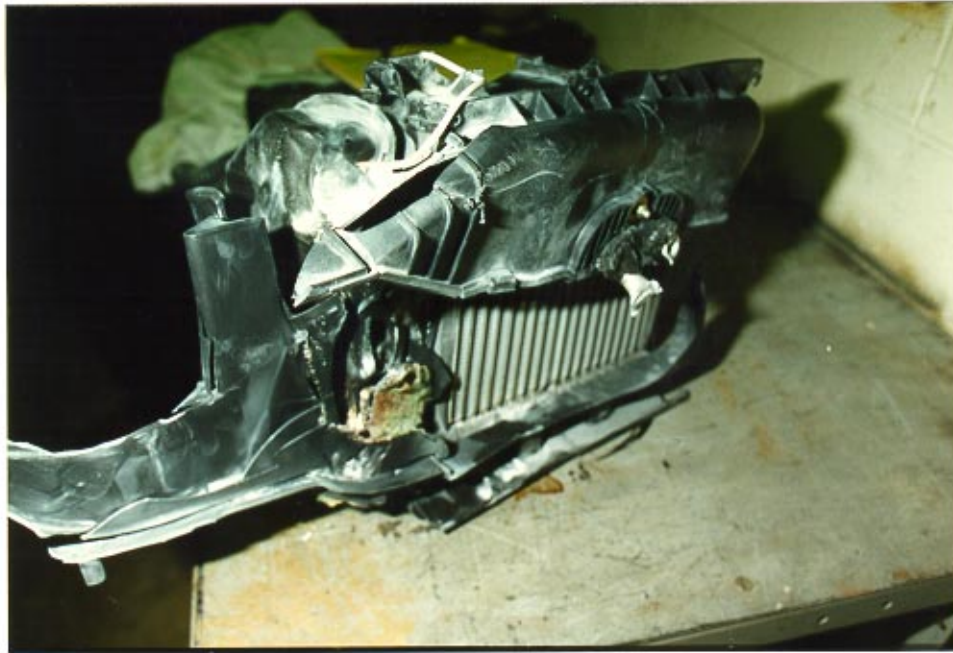
27. Forward aspect of the A/C core assembly with burned insulation at lower left quadrant.

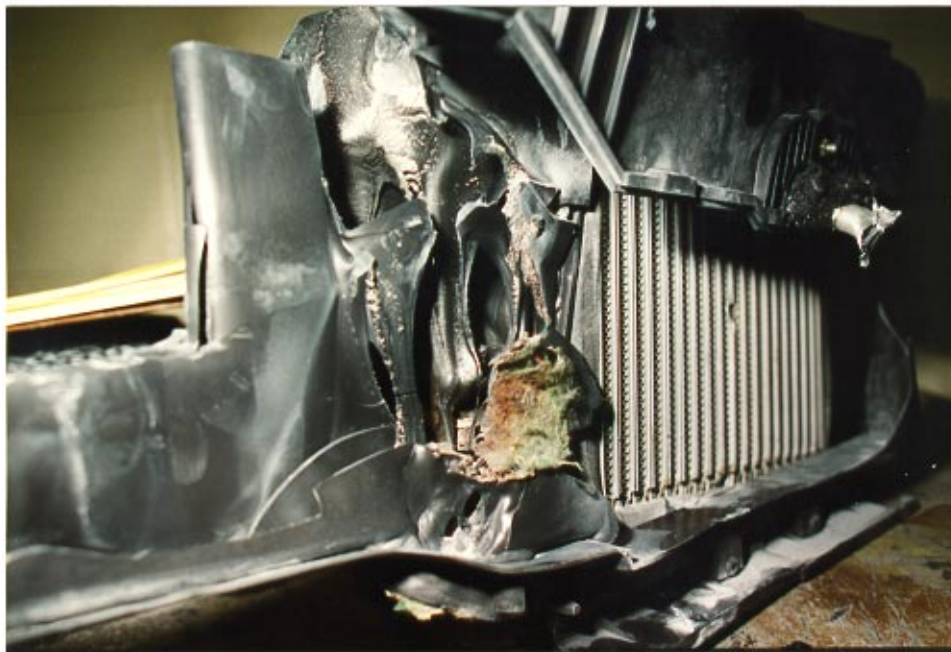
28. Close-up view of the burned insulation.

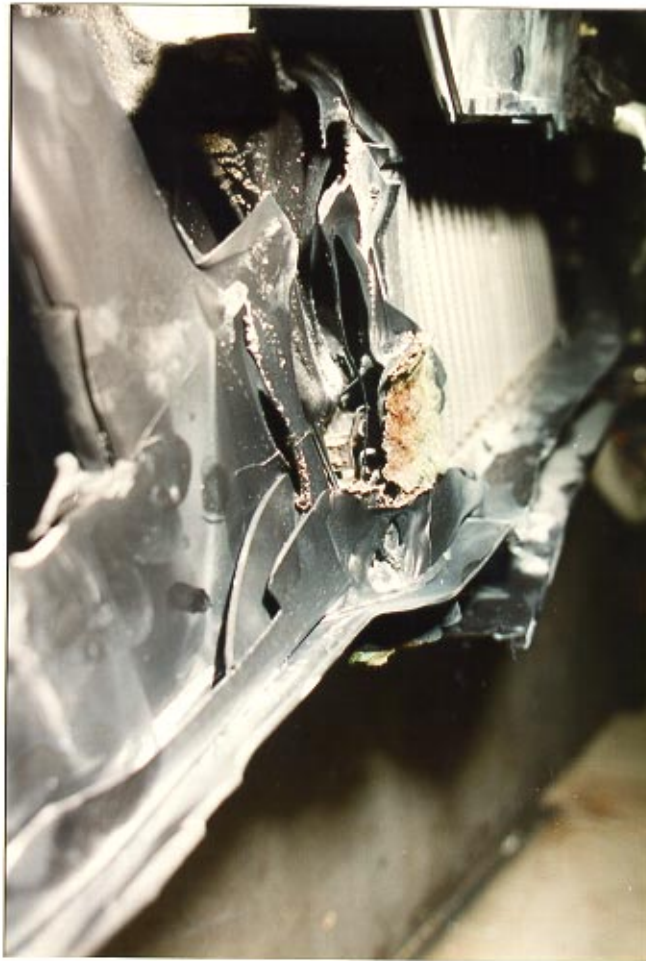
29. Profile view of the insulation and the exposed resistor coils.

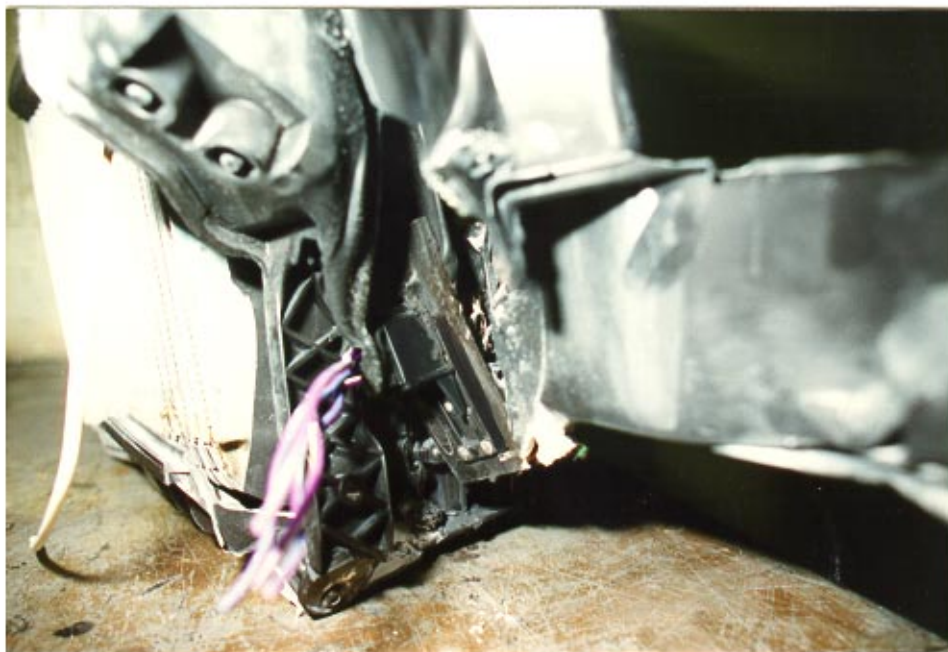
30. Damaged switch with the exposed resistor coils.
