REPORT NUMBER 216-GTL-03-005

**SAFETY COMPLIANCE TESTING FOR  
FMVSS NO. 216  
ROOF CRUSH RESISTANCE**

**FORD MOTOR CO.  
2003 FORD WINDSTAR, MPV  
NHTSA NO. C30208**

**FINAL REPORT**

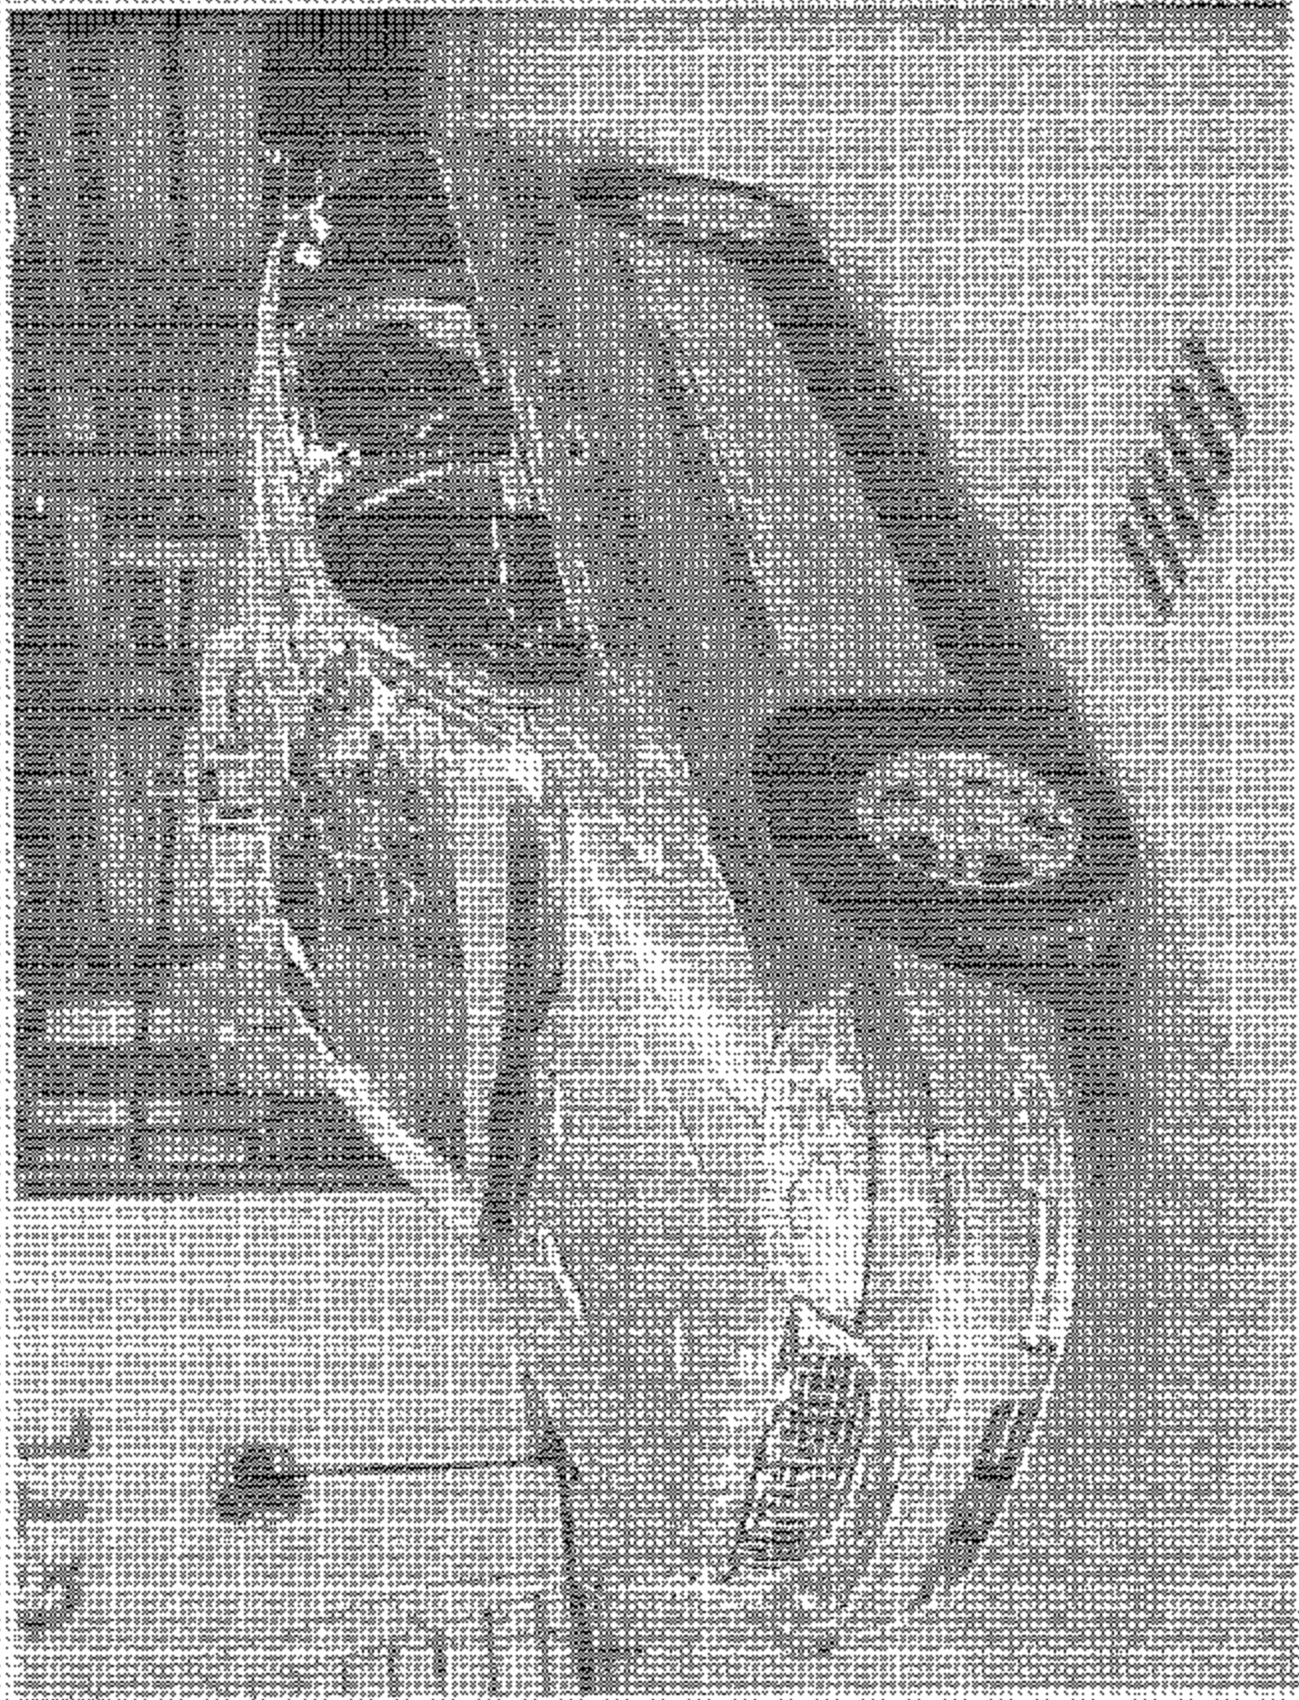
FIGURE 1004  
 1/4 FORWARD VIEW OF VEHICLE ON TESTED SIDE  
 AFTER TESTING

Driver's side roof flattened from "A" pillar rearward approximately 2010 mm and approximately 500 mm wide. "A" pillar, "B" pillar and "C" pillar are bent in and down. Windshield, driver door glass and side door glass are shattered. Driver's door opening pushed down approximately 70 mm.

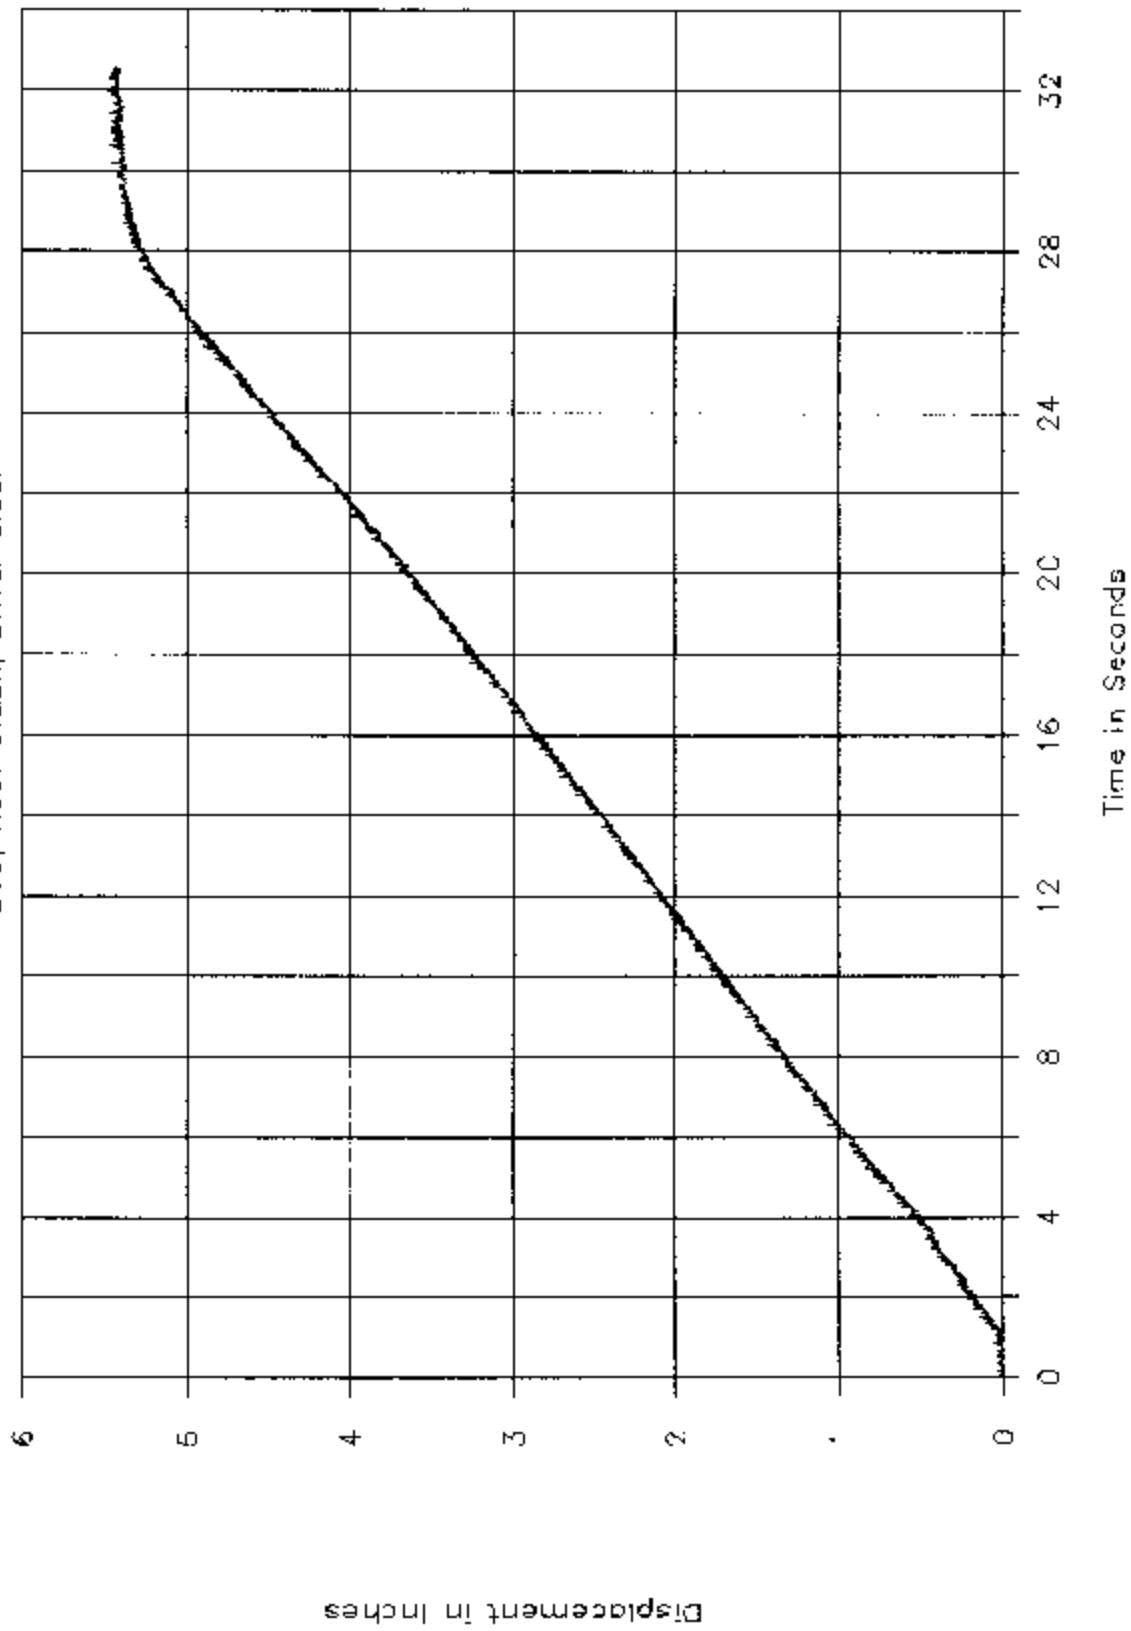
- (1) The maximum roof crush resistance was 42,132 N at 75.7 mm
- (2) The rate of loading was 5.08 mm/sec (.2 in/sec)
- (3) The required roof crush resistance of 28,697 N was at 43.2 mm

216, Root Crush, Driver Side.
