REPORT NUMBER: 201<sup>VER</sup>CAL-03-04

**SAFETY COMPLIANCE TESTING FOR FMVSS 201  
OCCUPANT PROTECTION IN INTERIOR IMPACT**

**HYUNDAI MOTOR COMPANY  
2003 HYUNDAI ELANTRA**

NHTSA NUMBER: C30503

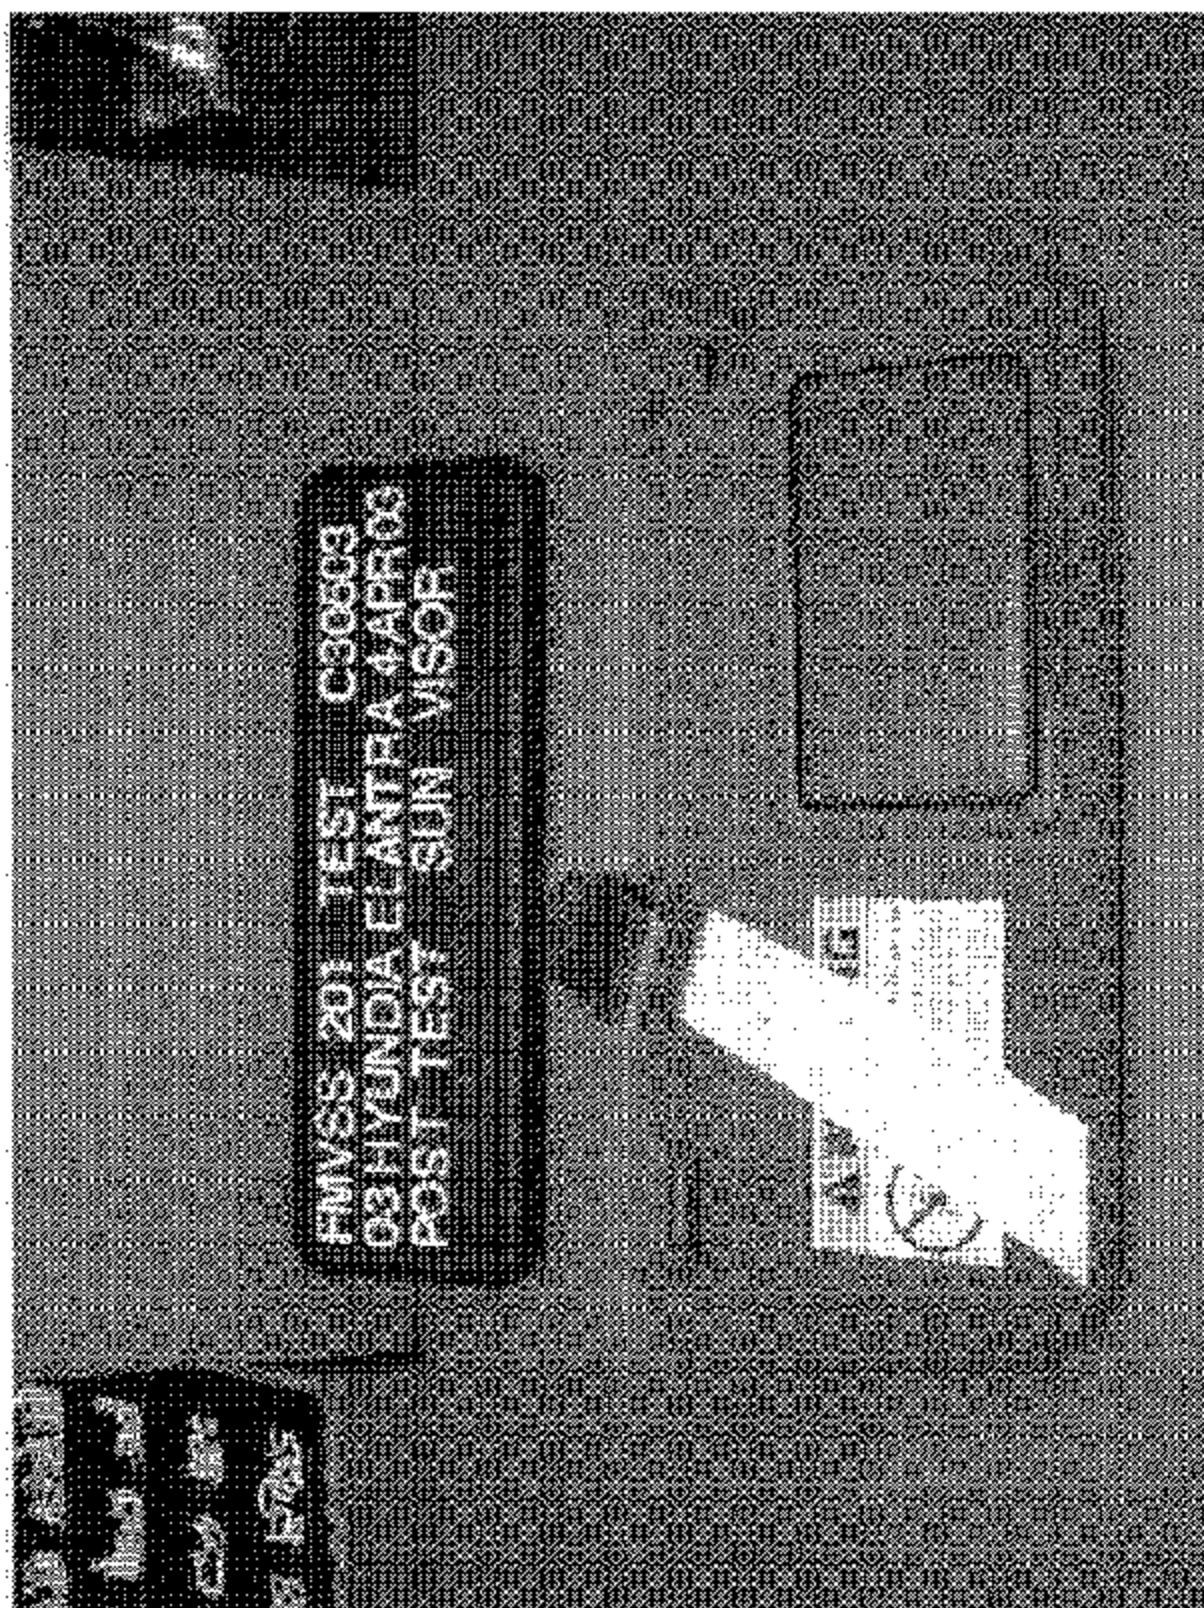
Figure A-7 : SUNVISOR CONSTRUCTION

1. Are sun visors constructed of or covered with energy absorbing material?

YES (PASS): X      NO (FAIL): -

2. Are any edges statically contactable by a spherical 6.5 inch diameter head form of radius less than 0.125 inch?

YES (FAIL): -      NO (PASS): X

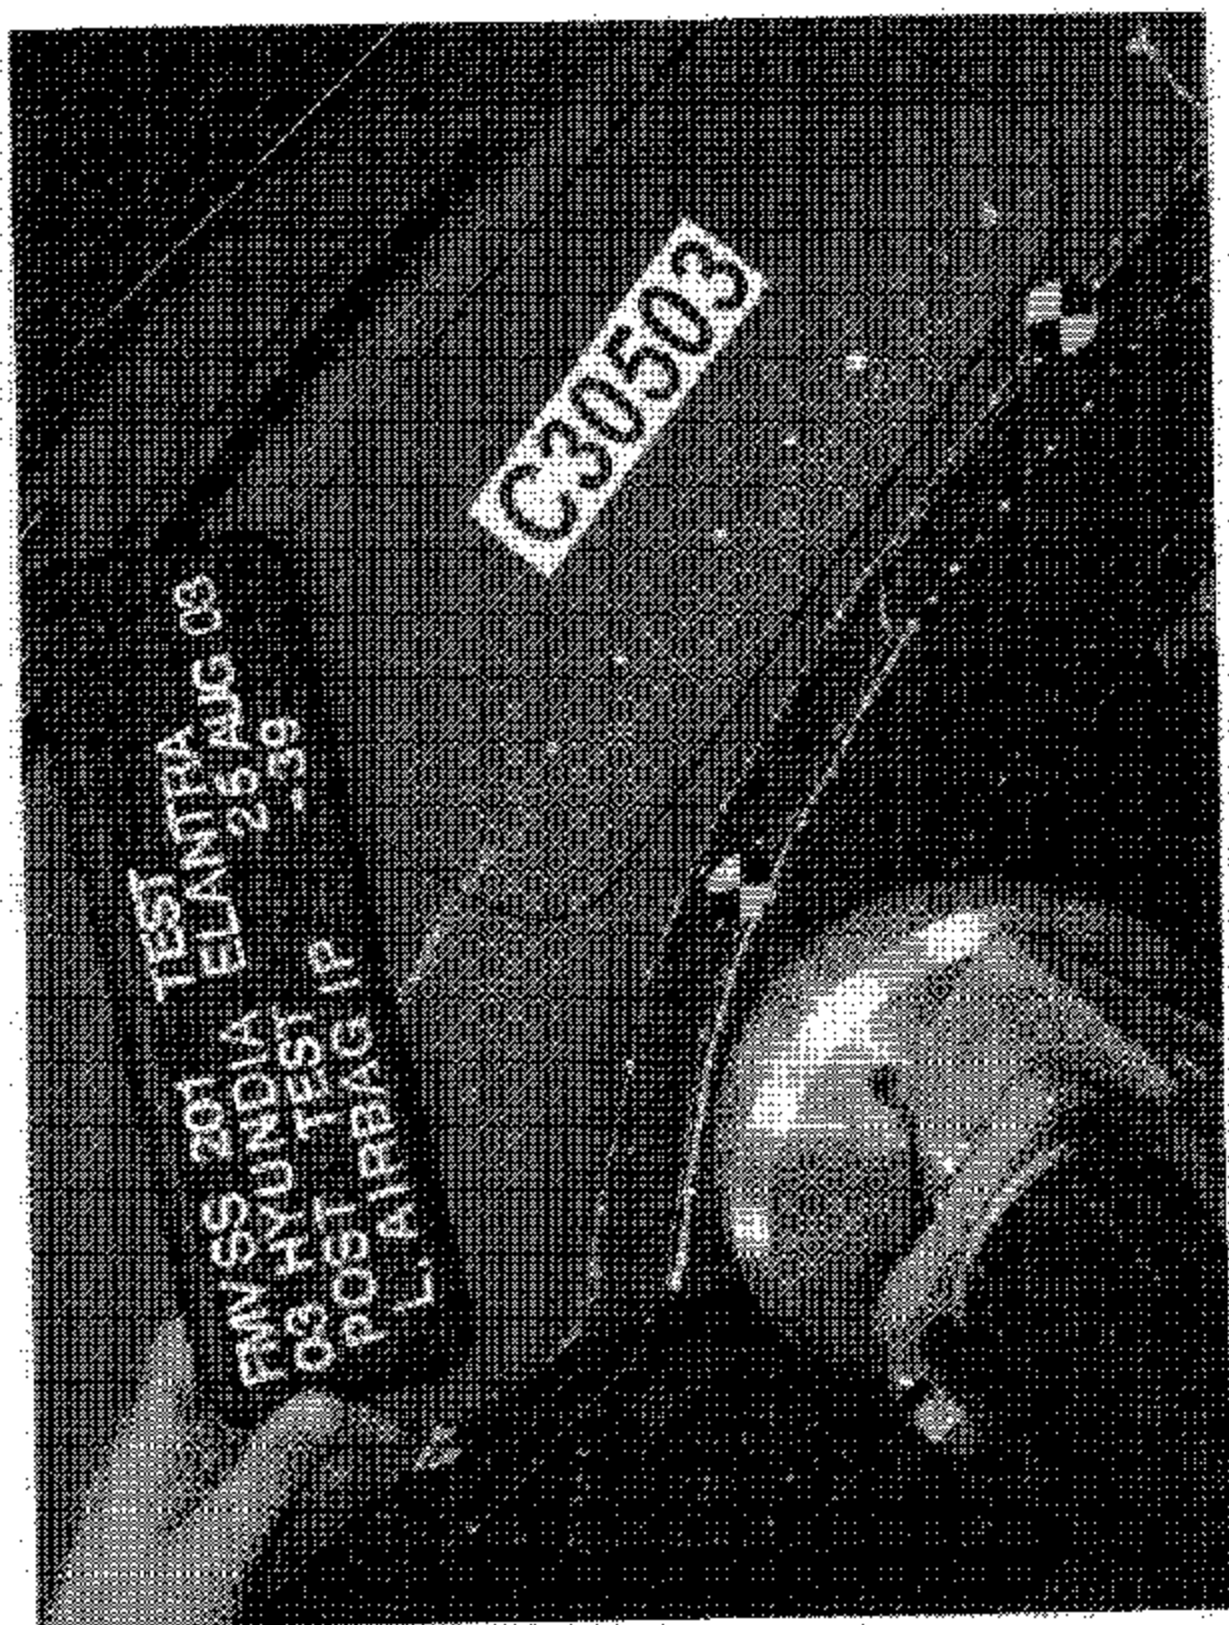
Figure A-15. INSTRUMENT PANEL LEFT SIDE BELOW AIRBAG IMPACT POST-TEST

| IMPACT LOCATION AND NUMBER | | | | VELOCITY<br>(mph) | PEAK<br>ACCELERATION<br>(3 ms Clip) Gs |
|---|---|---|---|---|---|
| 2 IP Lower Left of<br>Airbag | 31.3 | -5.2 | -39 | 11.34 | 60.40 |

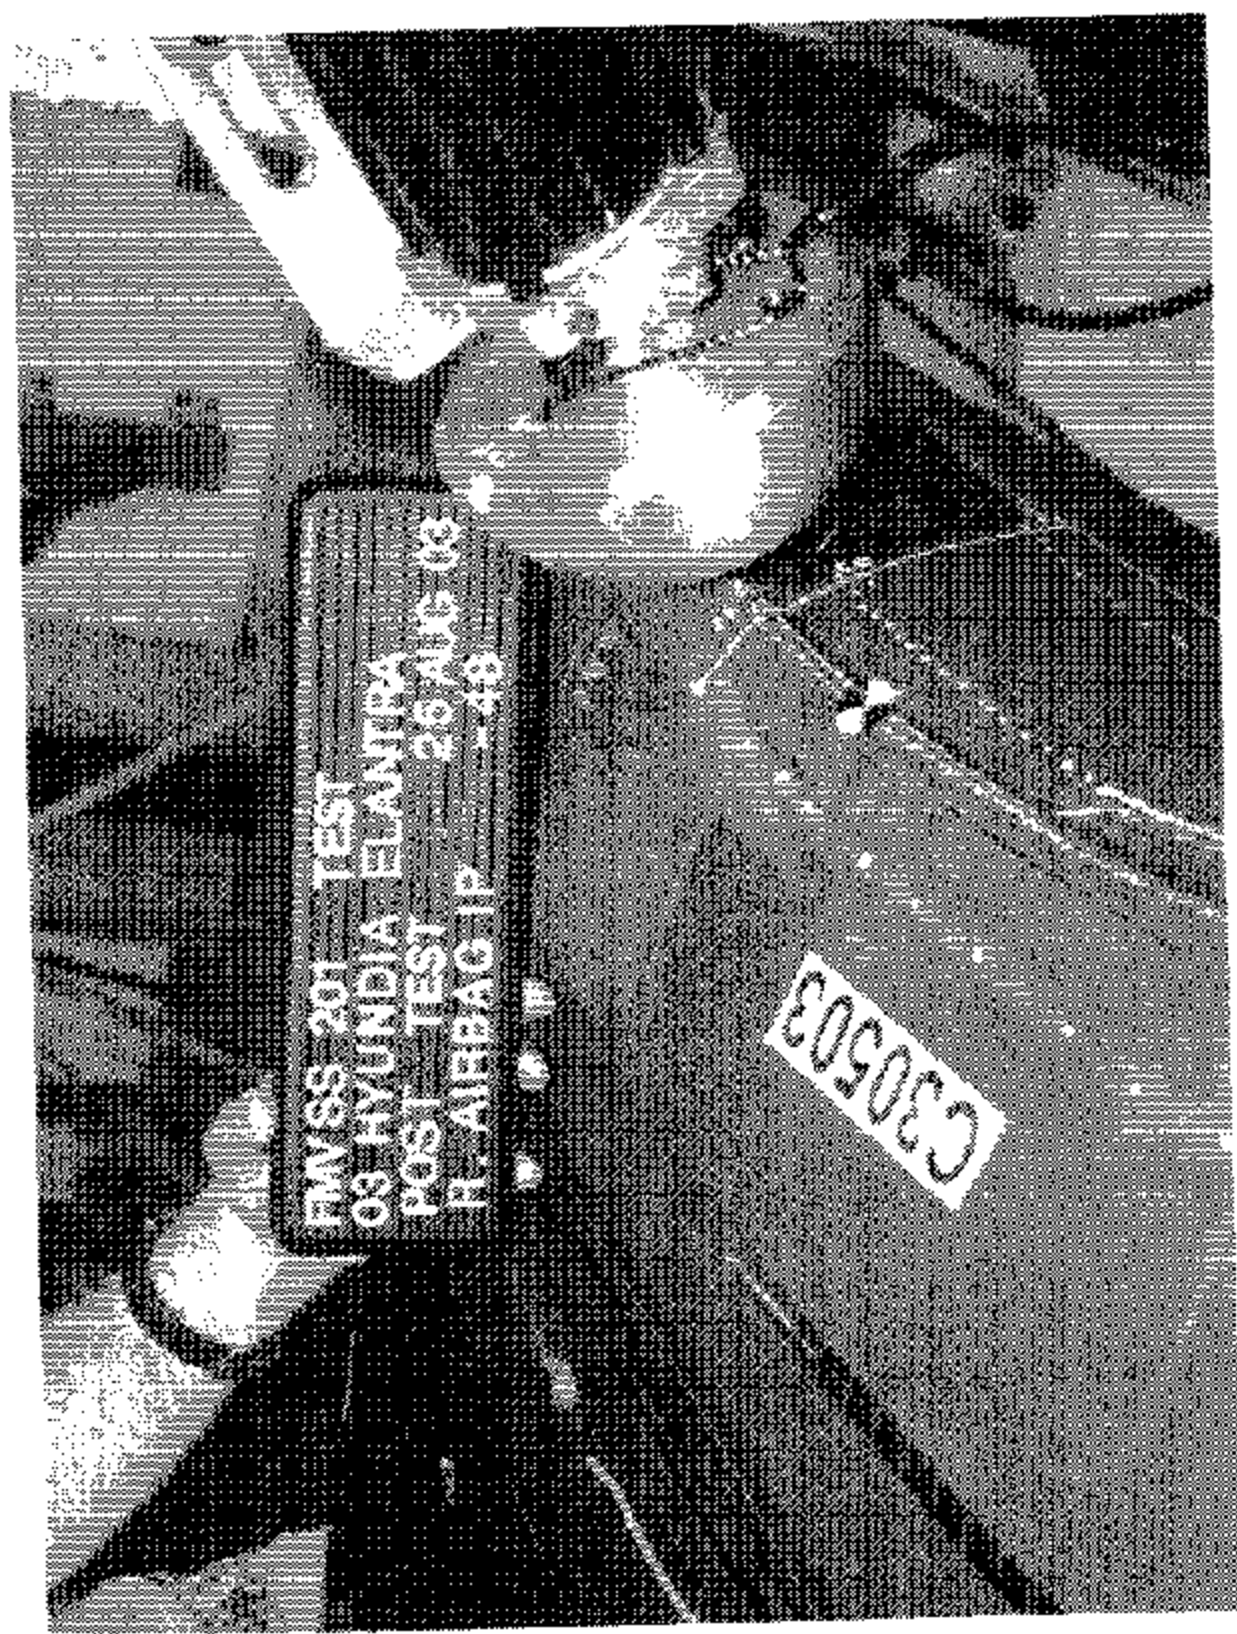
FIGURE 7 INSTRUMENT PANEL RIGHT SIDE BELOW AIRBAG IMPACT POST-TEST

| IMPACT LOCATION AND NUMBER | | | | VELOCITY<br>(mph) | PEAK<br>ACCELERATION<br>(3 ms Clip) Gs |
|---|---|---|---|---|---|
| 3 IP Lower Right of<br>Airbag | 31.6 | 3.4 | -48 | 11.31 | 54.86 |

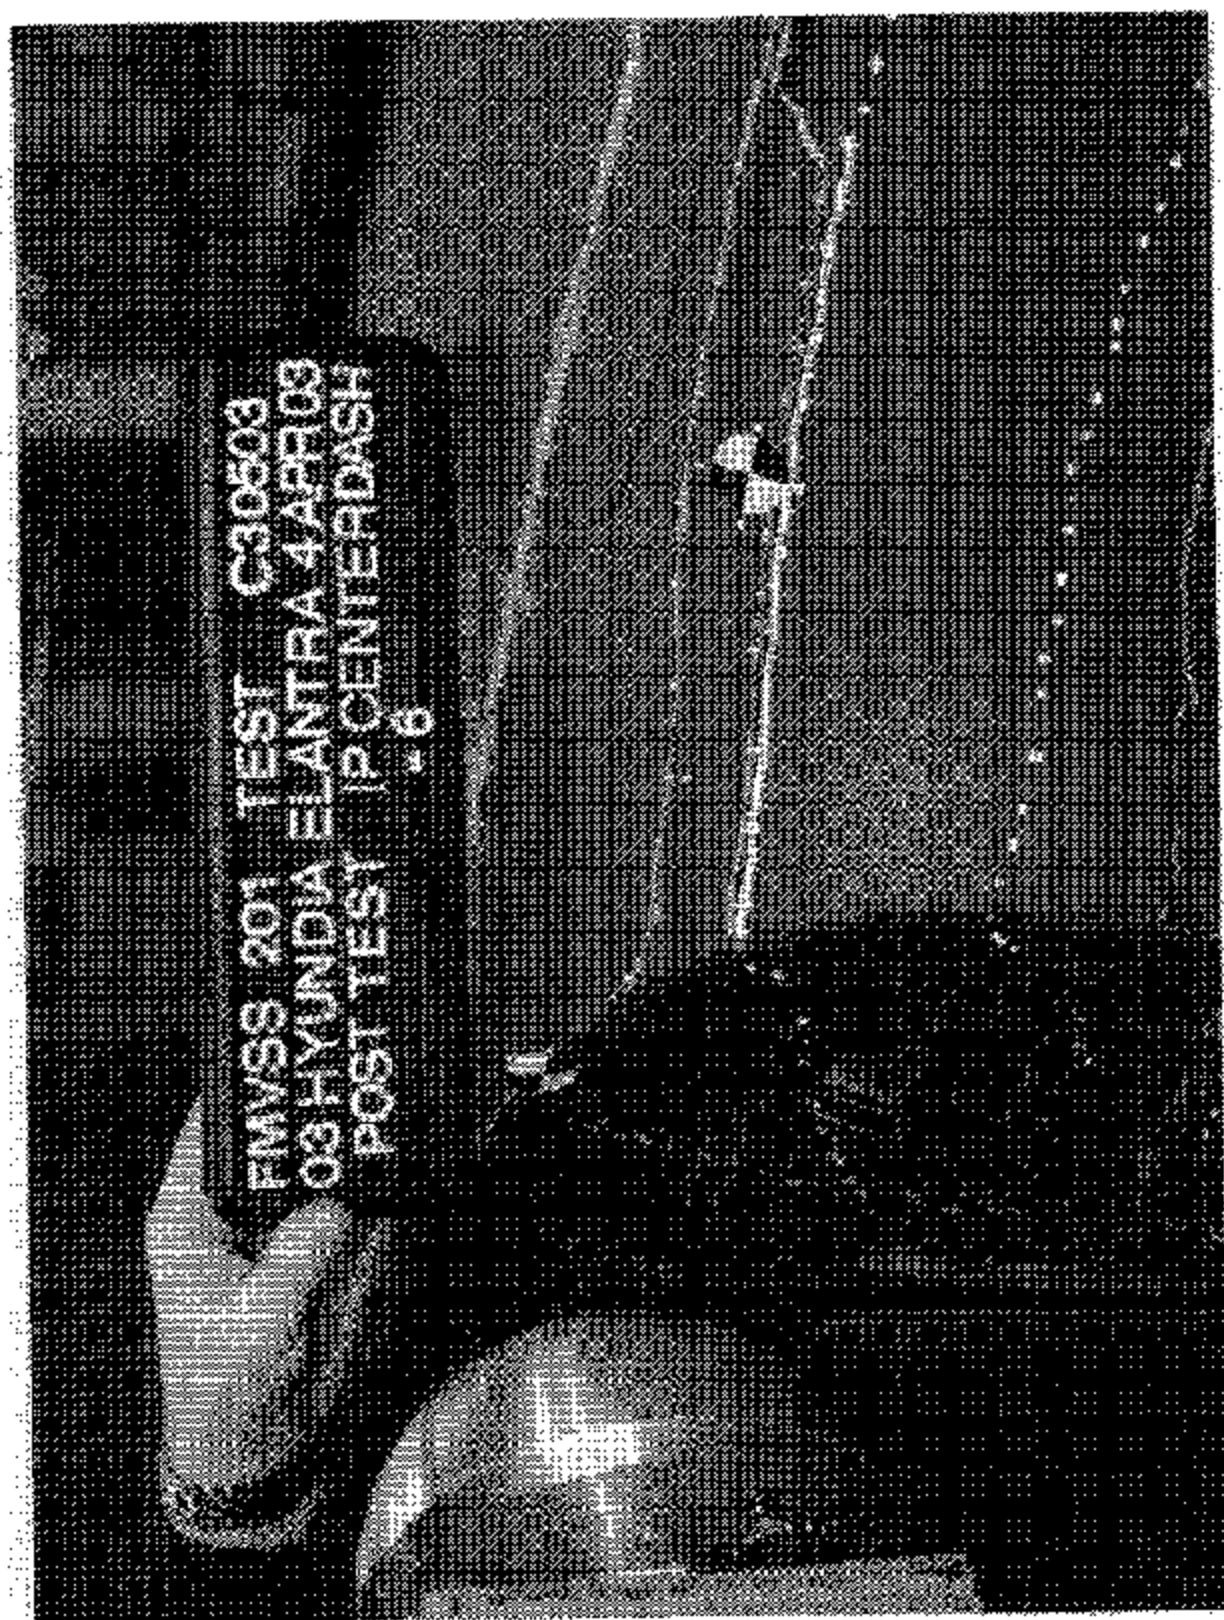
Figure A-19: INSTRUMENT PANEL ABOVE CENTER CLUSTER VENT IMPACT POST-TEST

| IMPACT LOCATION AND NUMBER | | | | VELOCITY<br>(mph) | PEAK<br>ACCELERATION<br>(3 ms Clip) Gs |
|---|---|---|---|---|---|
| 1 IP CenterDash | 29.9 | -14.0 | -6 | 11.42 | 78.54 |

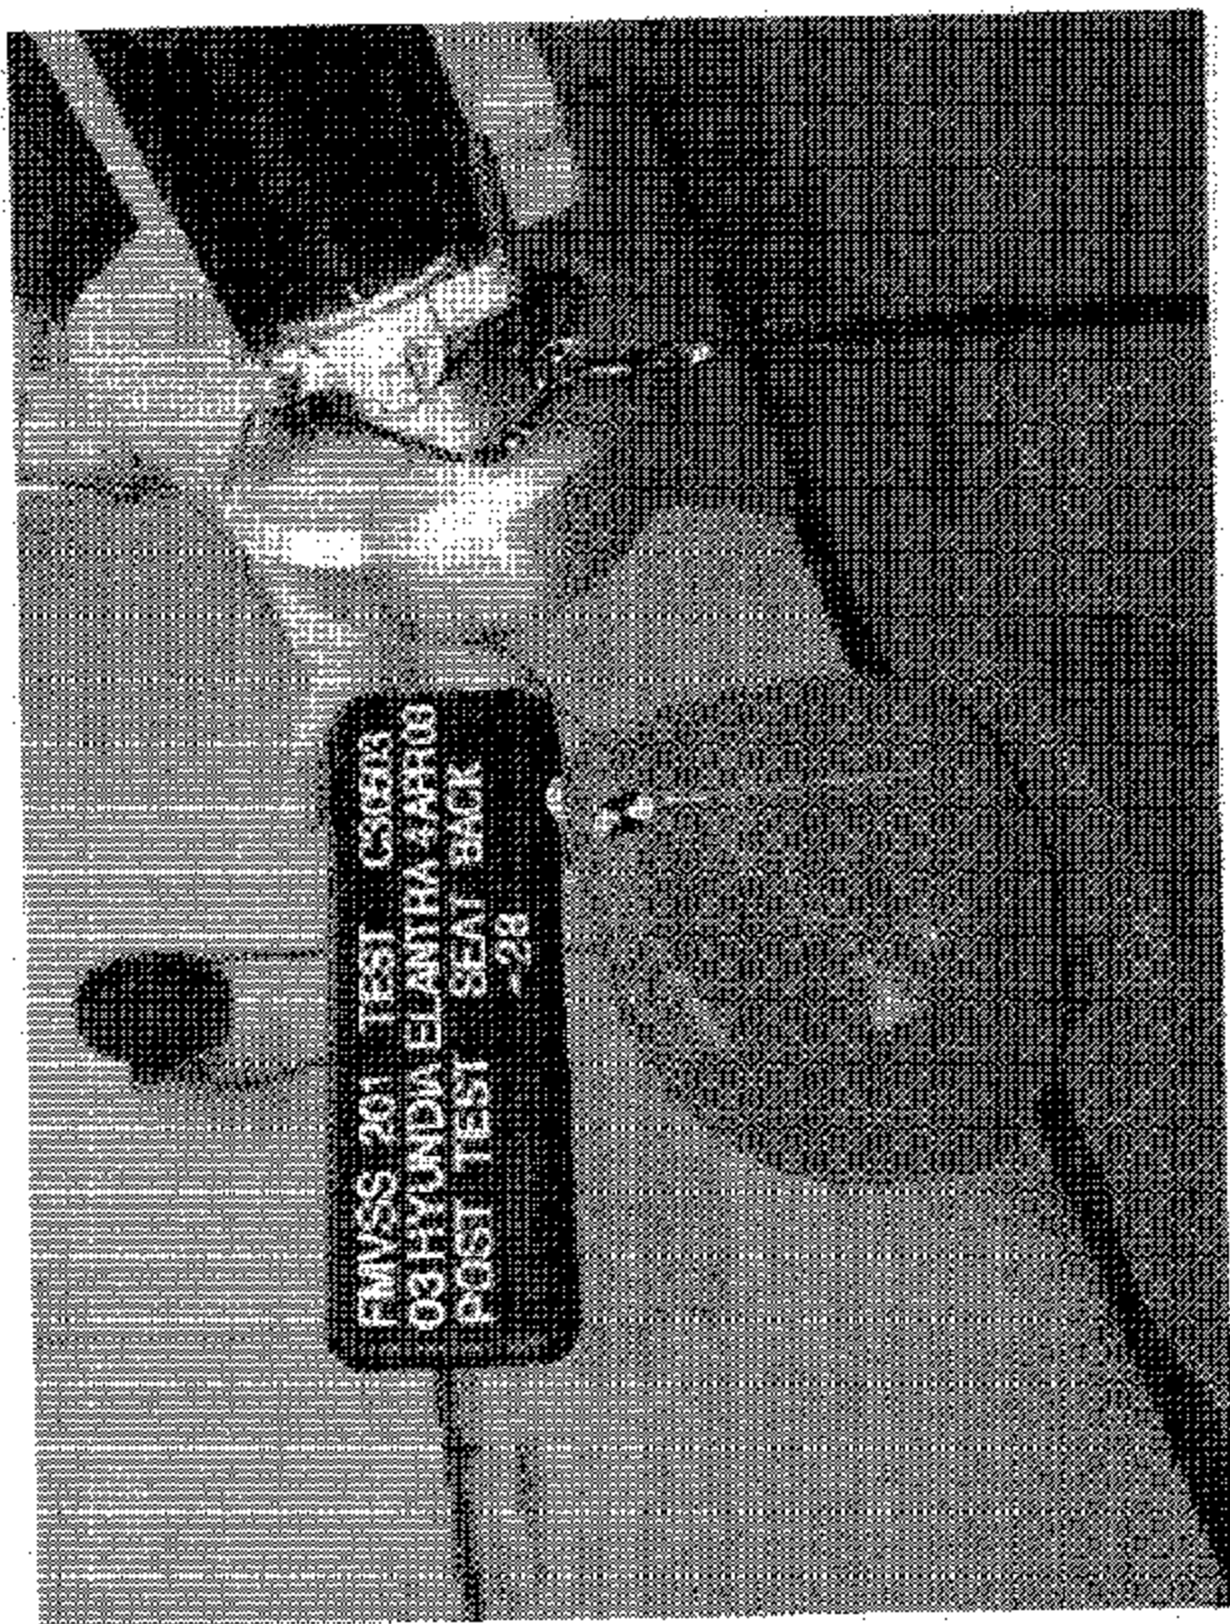
Figure A-22: HEAD RESTRAINT IMPACT AREA POST-TEST

| IMPACT LOCATION AND NUMBER | | | | VELOCITY<br>(mph) | PEAK<br>ACCELERATION<br>(3 ms Clip) Gs |
|---|---|---|---|---|---|
| 1 Seat Back | 3.1 | 0 | -28 | 14.9 | 51.93 |
