REPORT NUMBER TR-P25007-04-NC

FMVSS 301-FUEL SYSTEM INTEGRITY

VOLKSWAGEN DO BRAZIL LTDA  
2005 VOLKSWAGEN GOLF  
4-DOOR HATCHBACK

FINAL REPORT

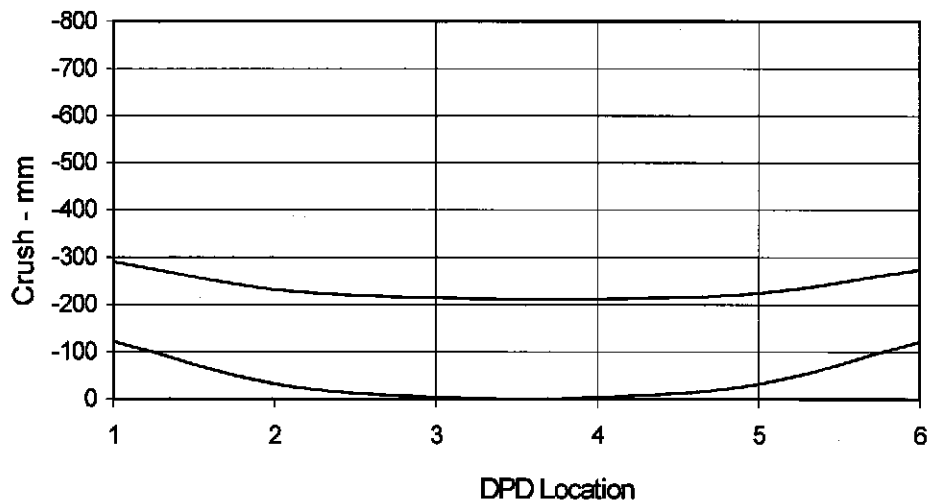
Damage Region Length (mm): 1371 Midpoint of Damage: Centerline

| No. | Measurement Description | Units | Pre-Test | Post-Test | Difference |
|---|---|---|---|---|---|
| C1 | Crush zone 1 at left side | mm | -122 | -290 | 168 |
| C2 | Crush zone 2 on left side | mm | -32 | -231 | 199 |
| C3 | Crush zone 3 on left side | mm | -3 | -214 | 211 |
| C4 | Crush zone 4 on right side | mm | -3 | -212 | 209 |
| C5 | Crush zone 5 on right side | mm | -32 | -224 | 192 |
| C6 | Crush zone 6 at right side | mm | -122 | -274 | 152 |
