REPORT NUMBER TR-P25007-05-NC

FMVSS 301-FUEL SYSTEM INTEGRITY

TOYOTA MOTOR MANUFACTURING, CANADA, INC.  
2005 TOYOTA MATRIX  
5-DOOR SEDAN

NHTSA NUMBER: C55103

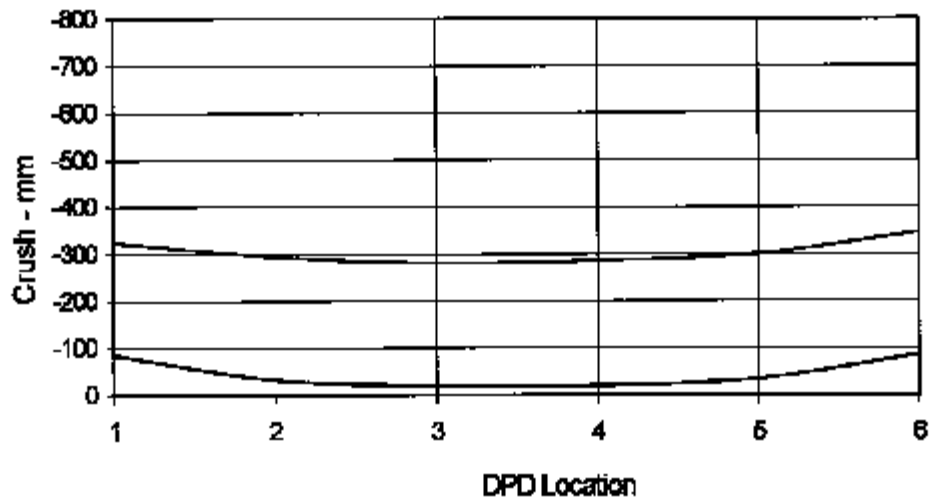
Damage Region Length (mm): 1300      Midpoint of Damage: Centerline  
 Impact Mode: Rear Impact (0 Deg.)

| No. | Measurement Description | Units | Pre-Test | Post-Test | Difference |
|---|---|---|---|---|---|
| C5 | Crush zone 5 on right side | mm | -34 | -300 | 266 |
