SAFETY COMPLIANCE TESTING FOR FMVSS NO. 214S SIDE IMPACT PROTECTION (STATIC)

MITSUBISHI MOTORS NORTH AMERICA, INC. 2006 MITSUBISHI ECLIPSE, PASSENGER CAR NHTSA NO. C65600

GENERAL TESTING LABORATORIES, INC. 1623 LEEDSTOWN ROAD COLONIAL BEACH, VIRGINIA 22443

FINAL REPORT

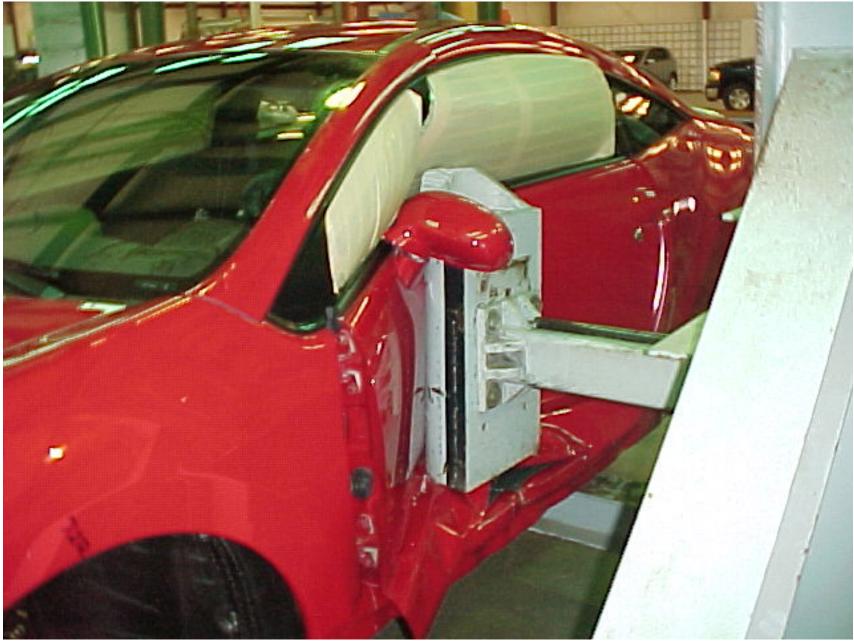
FIGURE 5.14 LOAD DEVICE AGAINST DOOR @ MAX LOAD -TEST 1

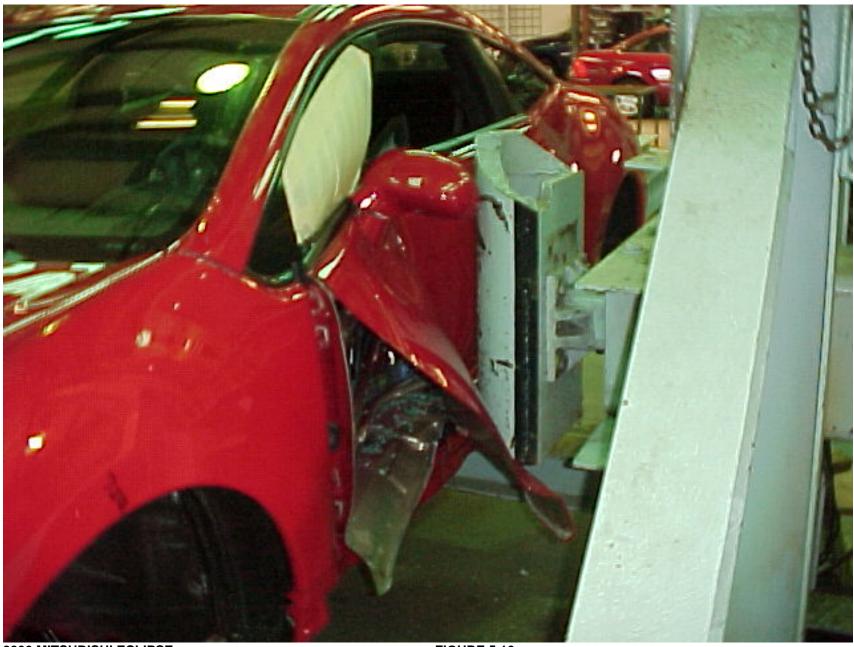
FIGURE 5.16 POST TEST DOOR OUTSIDE – TEST 1

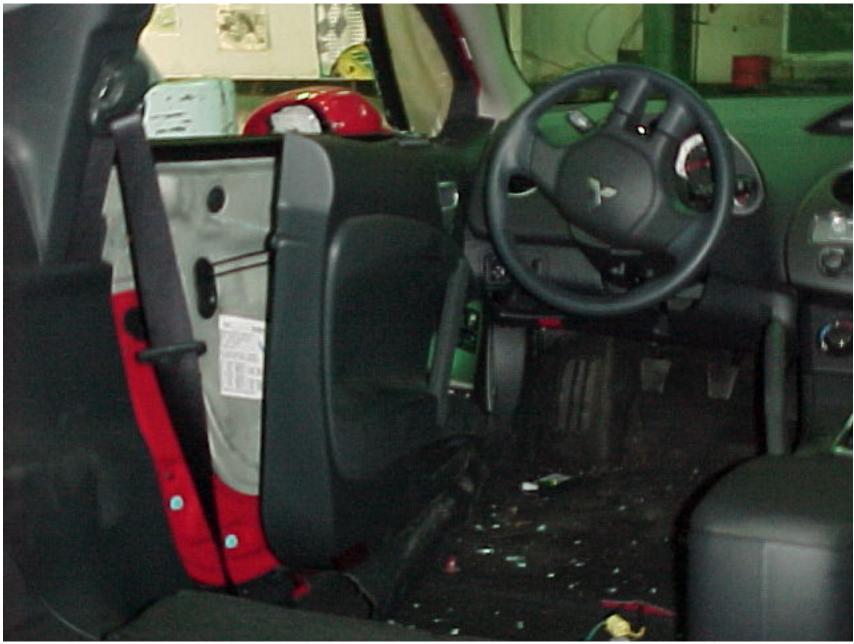
FIGURE 5.17 POST TEST DOOR INSIDE – TEST 1

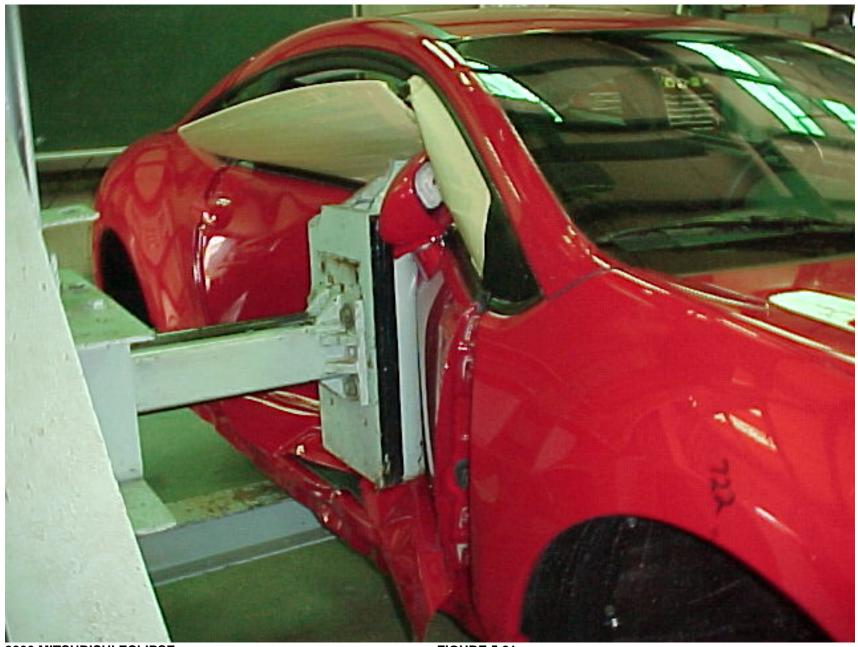
FIGURE 5.21 LOAD DEVICE AGAINST DOOR @ MAX LOAD -TEST 2

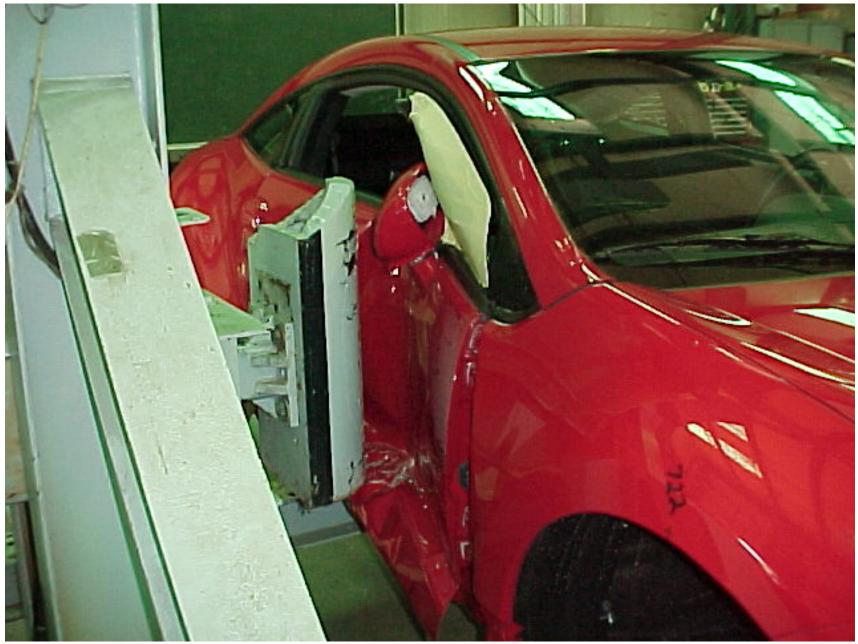
FIGURE 5.23 POST TEST DOOR OUTSIDE – TEST 2

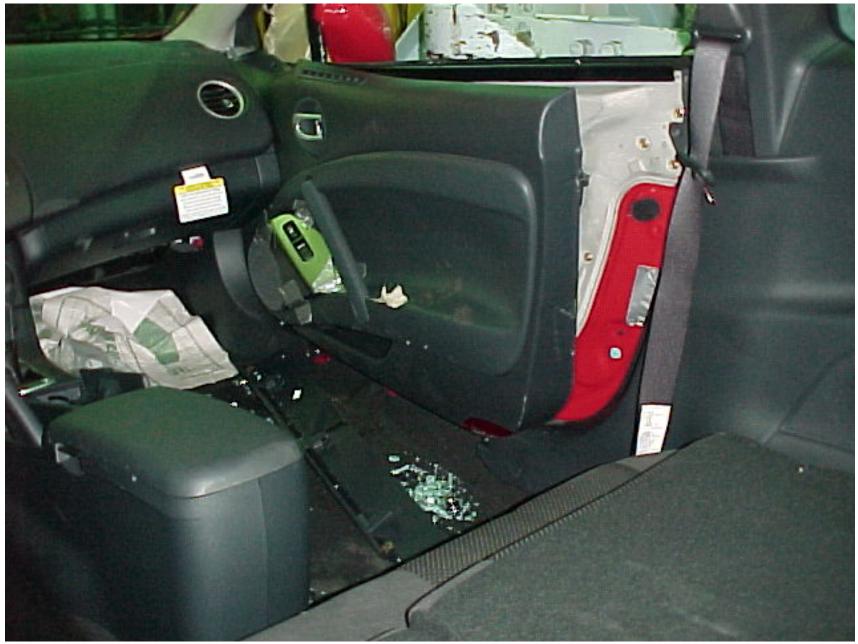
FIGURE 5.24 POST TEST DOOR INSIDE – TEST 2

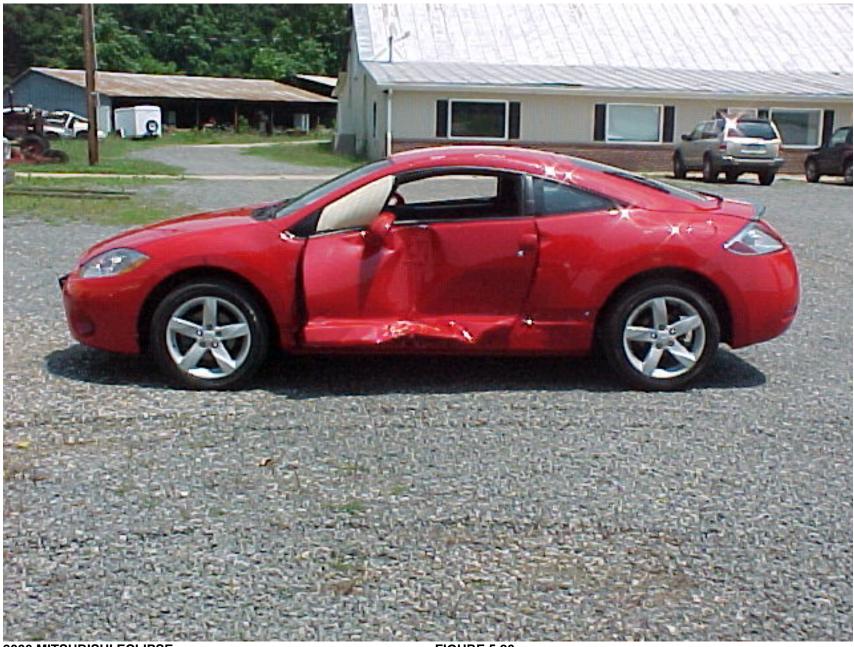
FIGURE 5.26 LEFT SIDE VIEW OF VEHICLE POST TEST

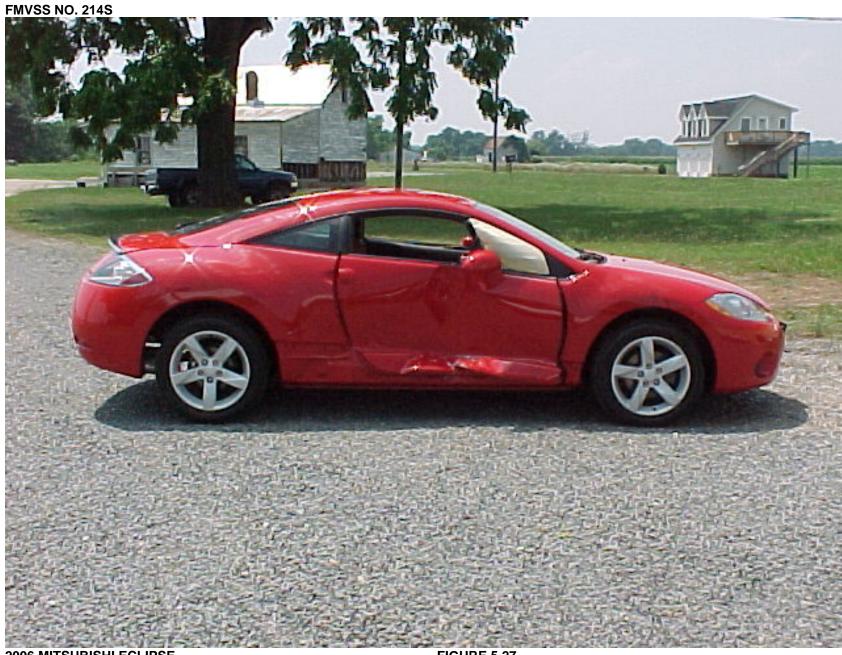
FIGURE 5.27 RIGHT SIDE VIEW OF VEHICLE POST TEST
