REPORT NUMBER: 301-CAL-09-01

SAFETY COMPLIANCE TESTING FOR FMVSS 301 FUEL SYSTEM INTEGRITY – REAR IMPACT

HYUNDAI MOTOR COMPANY 2009 HYUNDAI ACCENT 4-DOOR SEDAN

FINAL REPORT

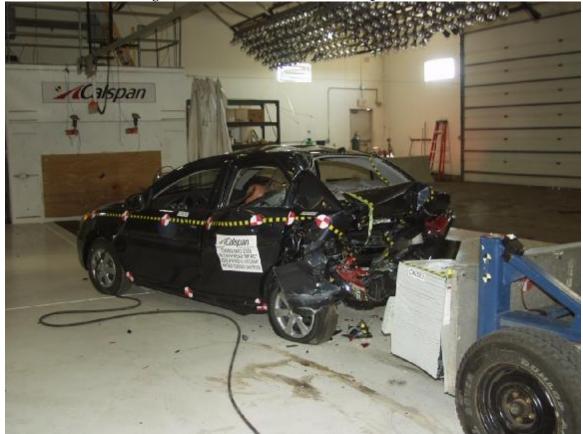
Figure A-14: Post-Test Left Rear Three-Quarter View

Left Side	Centerline	Right Side
Pre-Test	4153	4279	4153
Post-Test	3555	3613	3580
Crush	598	666	573

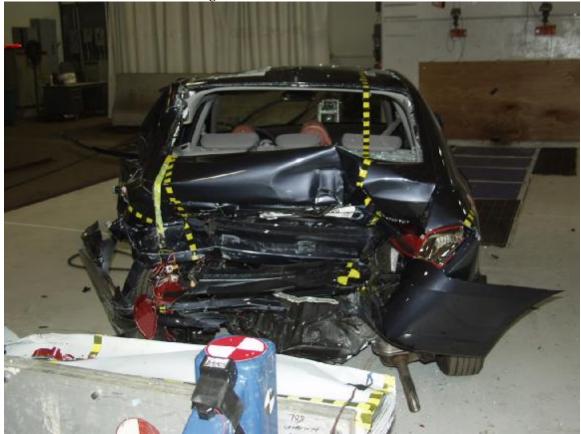
Figure A-18: Post-Test Rear View

There was no fuel system fluid spillage following the impact or during any portion of the static rollover test. The average vehicle longitudinal crush was 666 millimeters. The vehicle appeared to comply with all the requirements of FMVSS No. 301 "Fuel System Integrity."

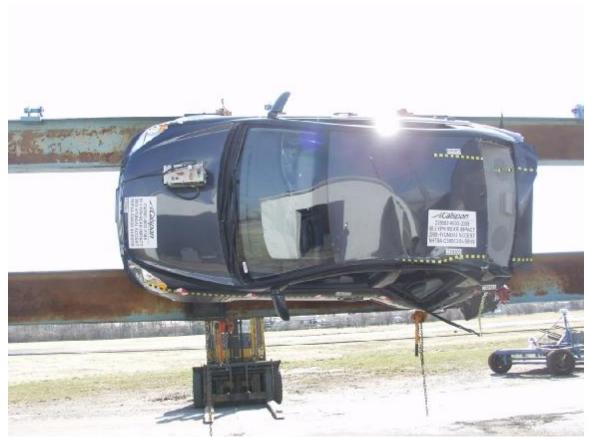
Figure A-38: Rollover 90° View

Rollover Stage	Spillage Location
0° - 90°	None
90° - 180°	None
180°-270°	None
270°-360°	None
