REPORT NUMBER: 201-MGA-2009-001

**SAFETY COMPLIANCE TESTING FOR FMVSS 201
RIGID POLE SIDE IMPACT TEST**

**GENERAL MOTORS CORPORATION
2009 CHEVROLET MALIBU 1LS
NHTSA NUMBER: C90110**

**PREPARED BY:
MGA RESEARCH CORPORATION
5000 WARREN ROAD
BURLINGTON, WI 53105**

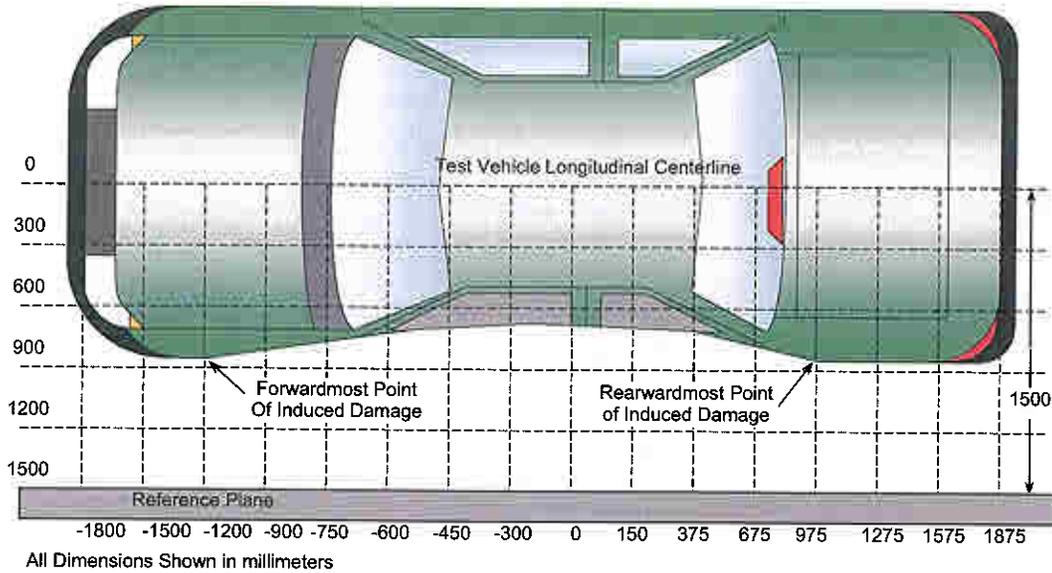
DATA SHEET NO. 11
VEHICLE DAMAGE PROFILE DISTANCES

Level	Measured Parameter	Units	Maximum Crush	Above Ground
Level 1	Sill Top Height	mm	264	270
Level 2	Occupant H-Point	mm	291	445
Level 3	Mid Door	mm	329	642
Level 4	Window Sill	mm	281	958
Level 5	Window Top	mm	107	1372
N/A	Maximum Penetration	mm	329	642

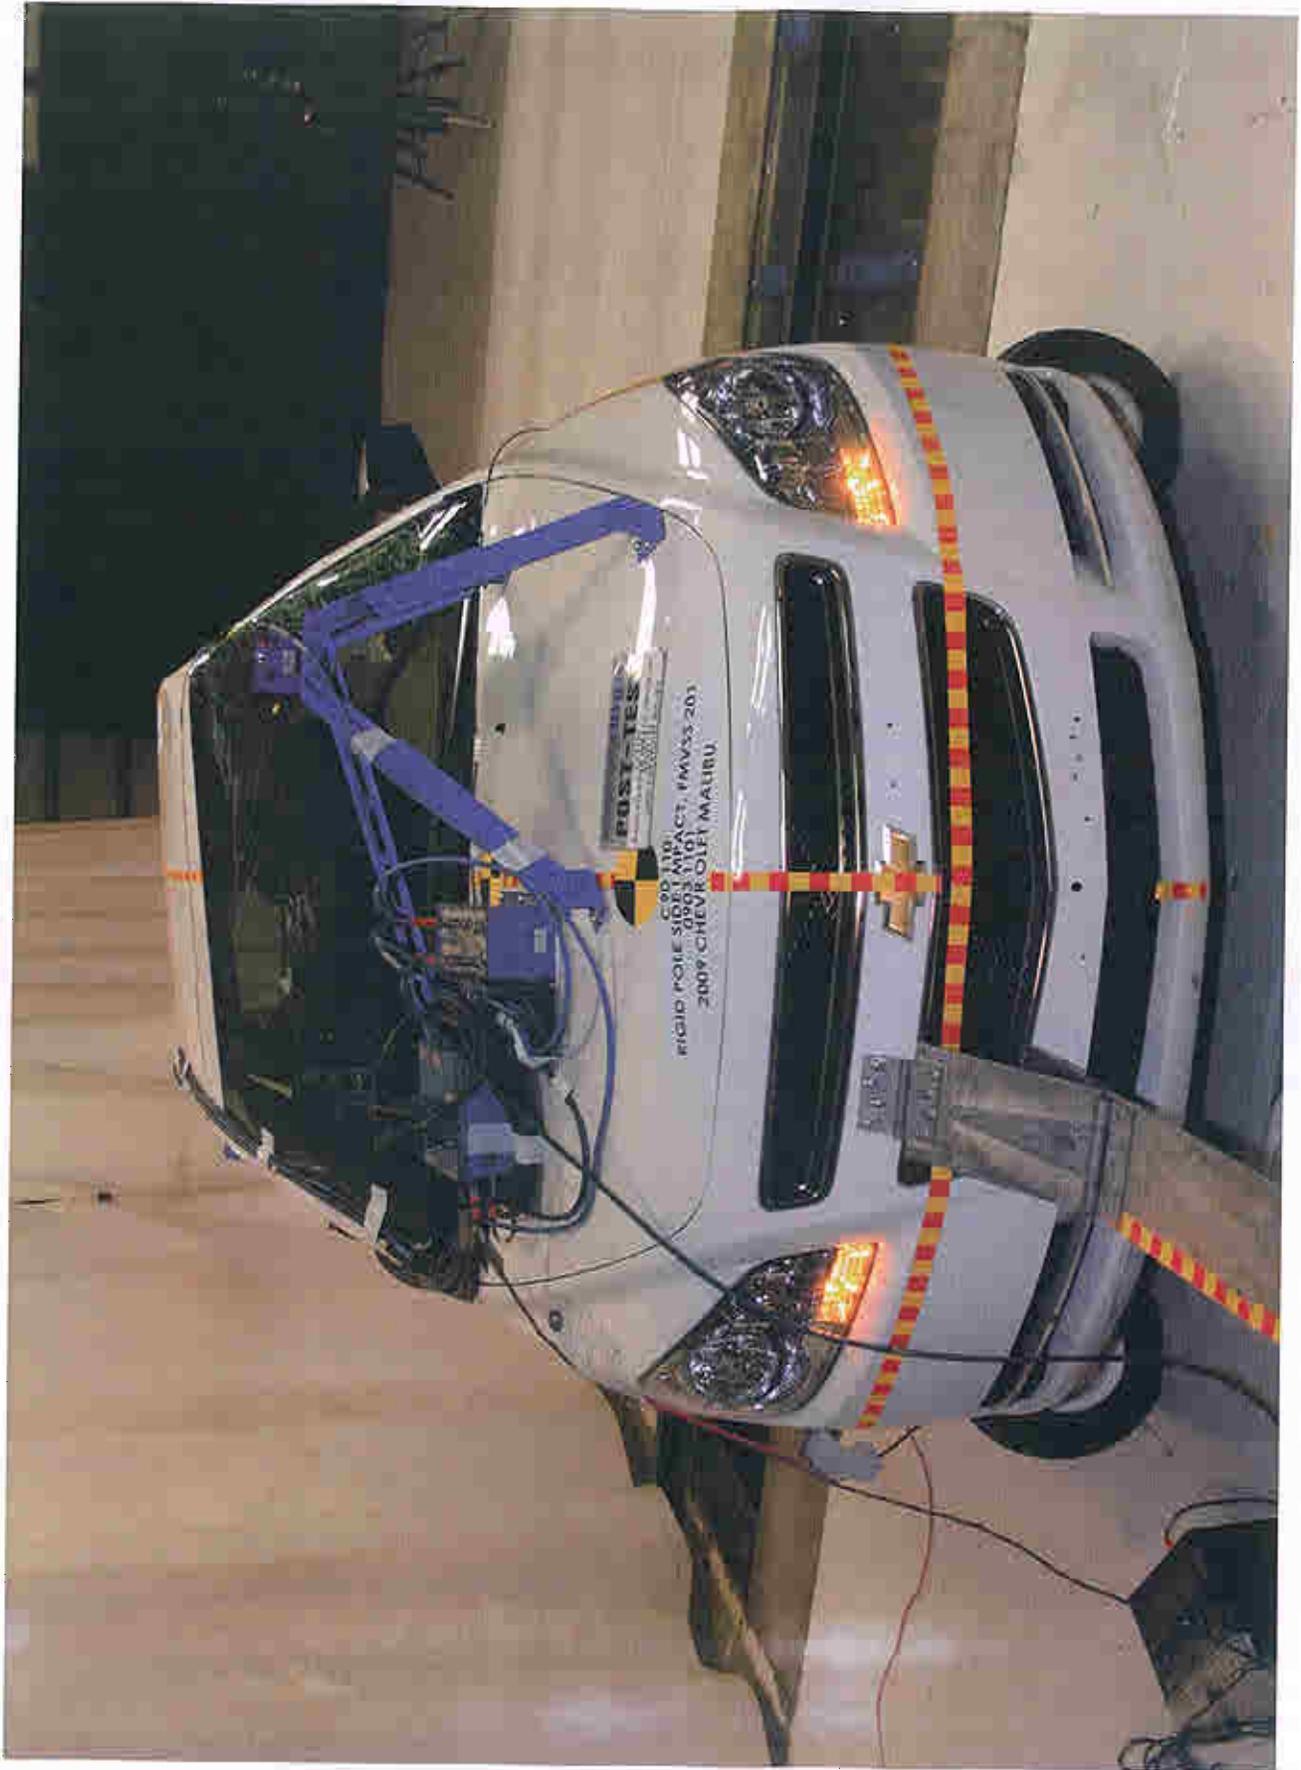
Critical Areas of Performance	Observations and Conclusions
Pillar Performance	No failures
Sill Separation	None
Windshield Damage	Cracked
Window Damage	Left side windows down for test
Other Notable Effects	None

Post-Test Front View of Test Vehicle

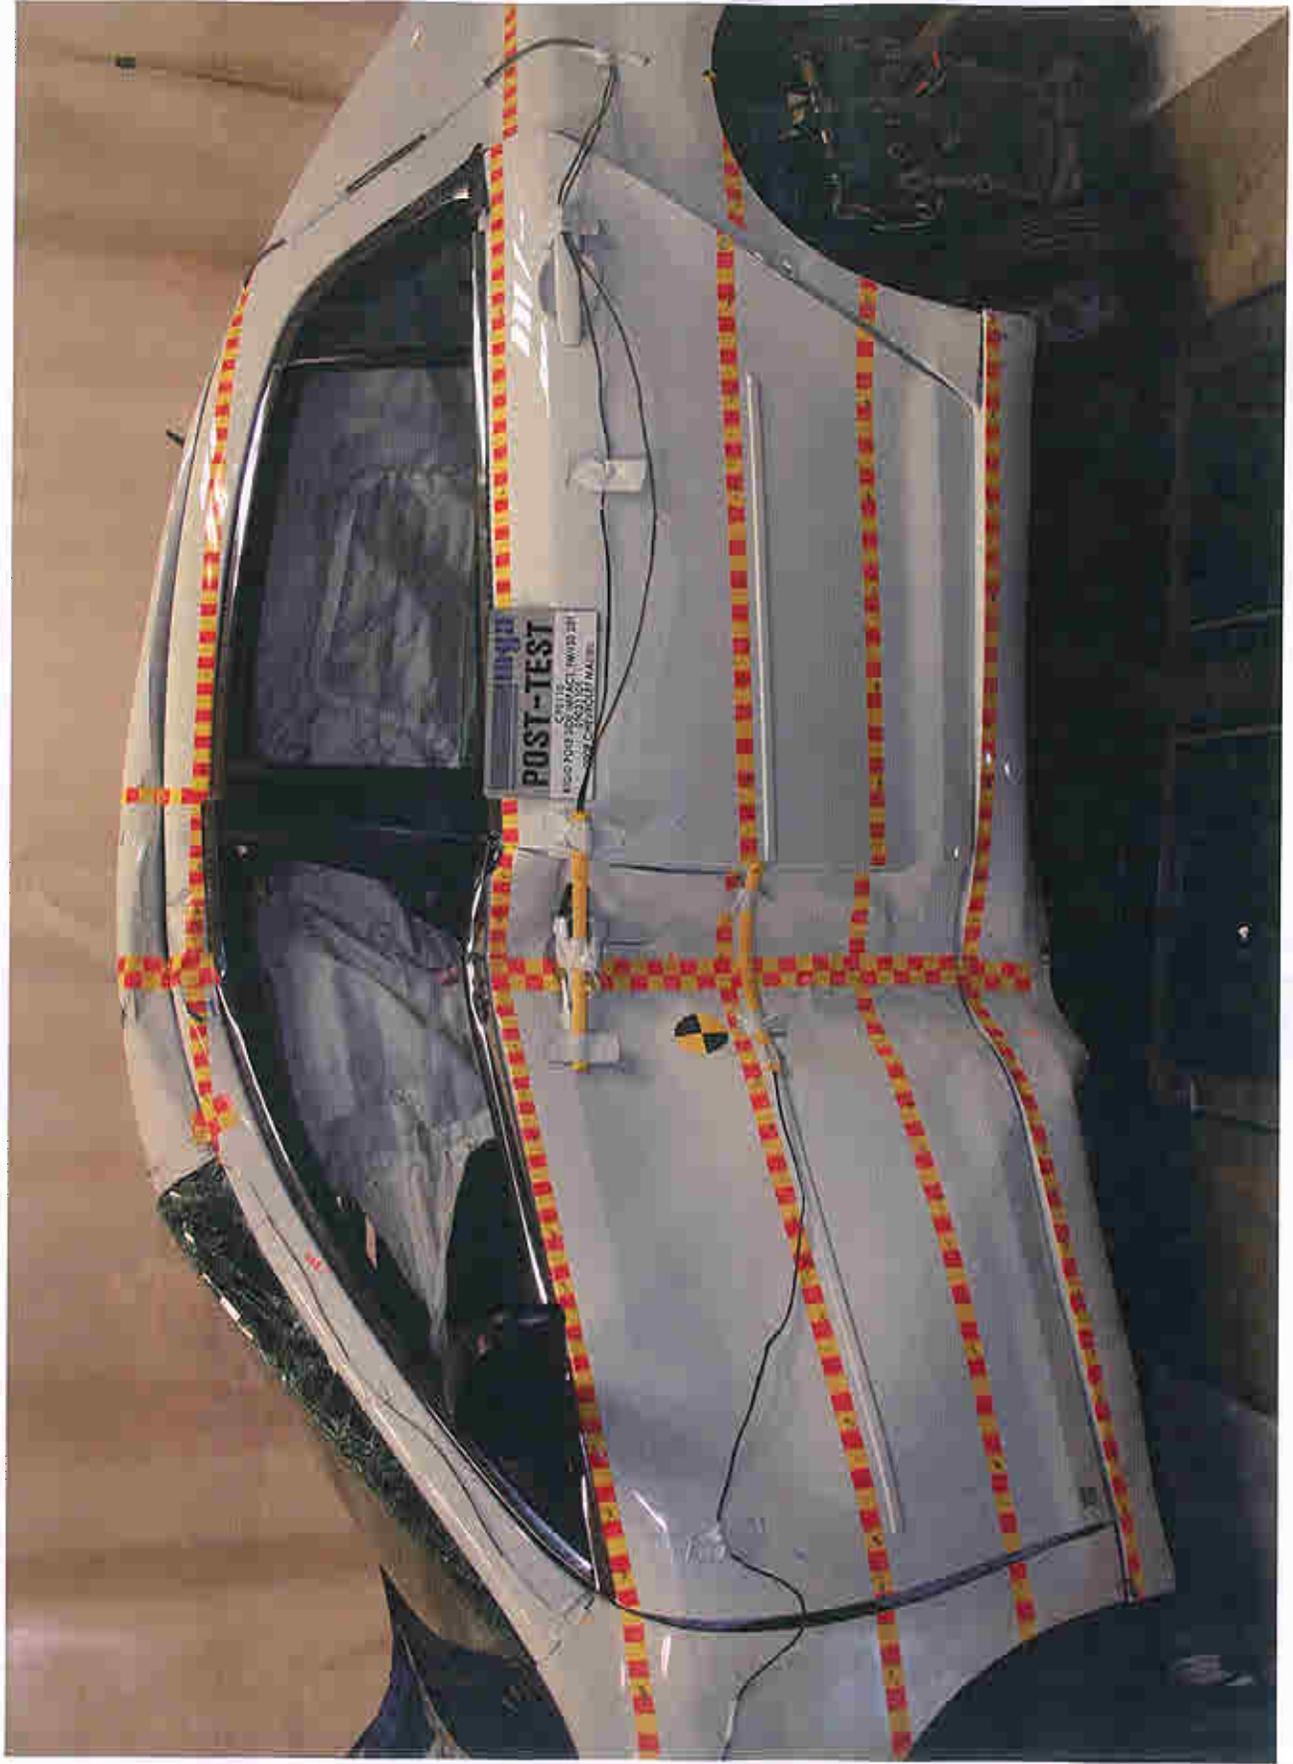
The test vehicle sustained a maximum static crush of 329 mm at level 3, at the vertical impact line. The driver SID/HIII, Serial No. 036, was calibrated just prior to this test. The SID/HIII's injury criteria are summarized as follows:

Post-Test Impact Zone Close-up View
